I hereby summon you to attend a meeting of the **RECREATION COMMITTEE** on Thursday 11th September 2025 at 7:30 PM, to be held at The Pavilion, Hunter Park, SO21 1QS

10 Play Inspection Reports

To Receive the Annual Play Inspection report for Hunter Park.

Recreation Committee 13th September 2025

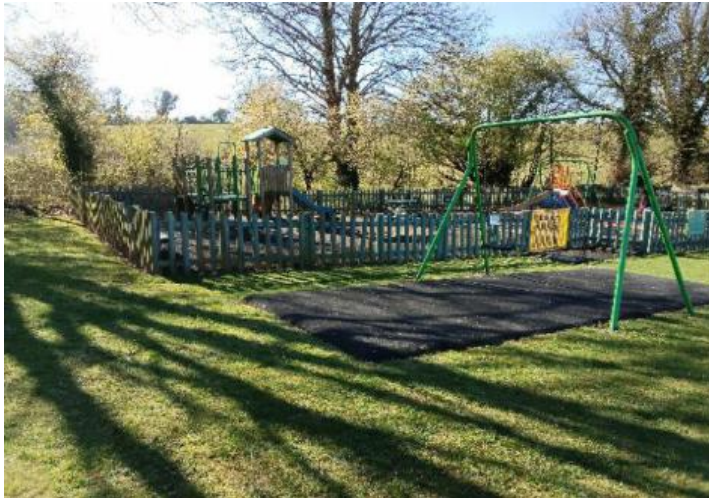
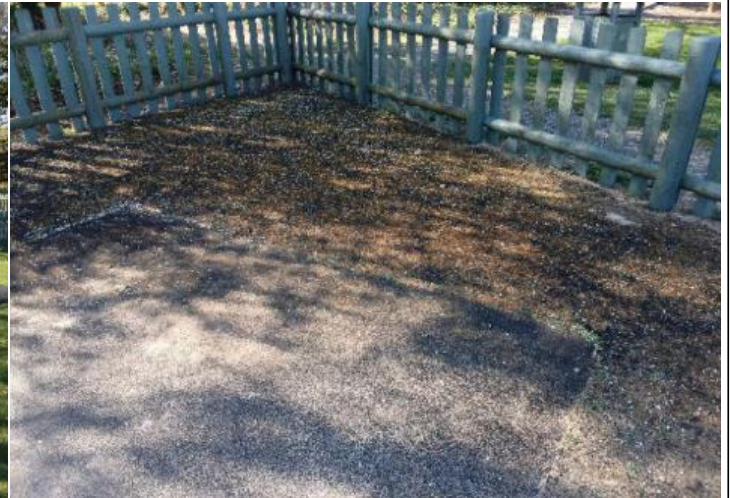
Item: Ancillary Items - Site General
Manufacturer: Owner/Operator

Finding: There is algae, silt or moss growth on the surface resulting in slippery conditions

Action: Clean and treat appropriately

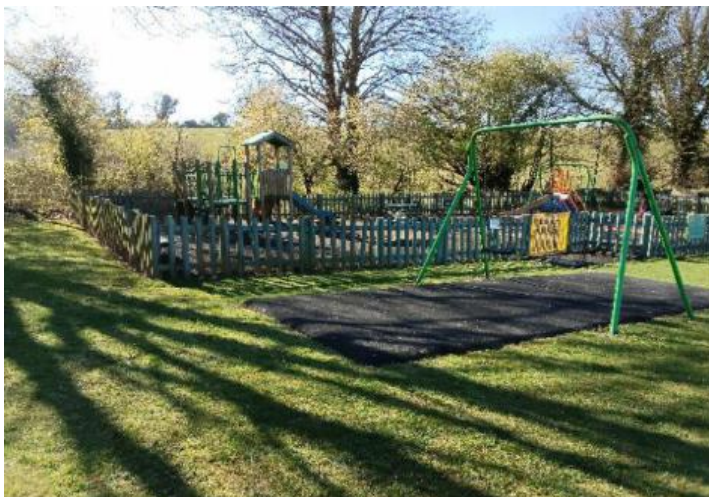
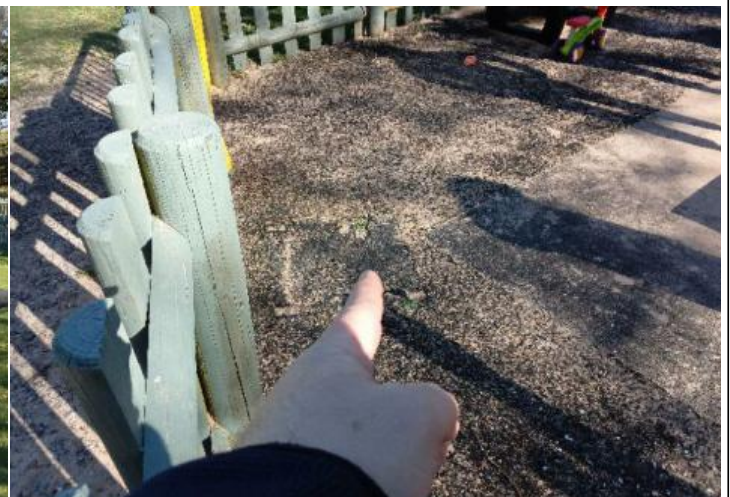
Item: Ancillary Items - Site General
Manufacturer: Owner/Operator

Finding: There is moderate damage to the surface

Action: Repair the damaged areas of surfacing

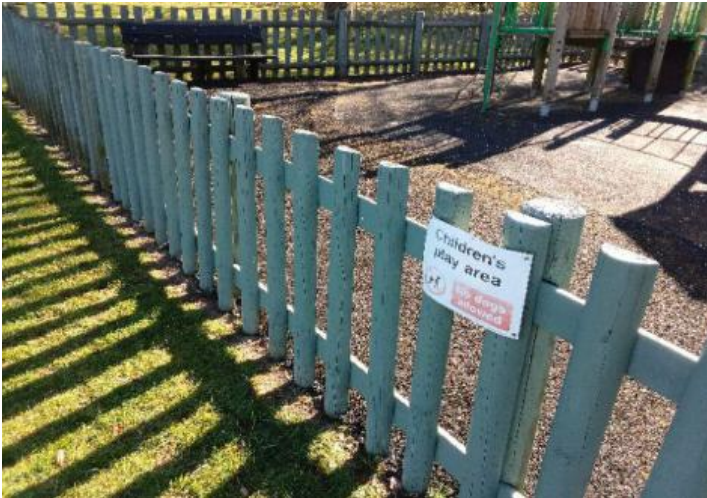
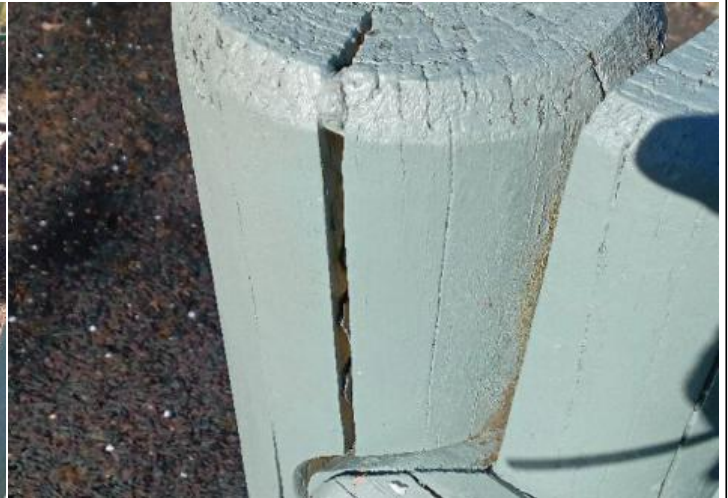
Item: Fences - Fencing - Timber
Manufacturer: Not Identified

Finding: The timber has a number of splits/shakes or air cracks and this may affect the stability or allow water ingress which will accelerate the rotting process

Action: Monitor to ensure the splits do not cross through fixing points of the structure and/or cause any instability

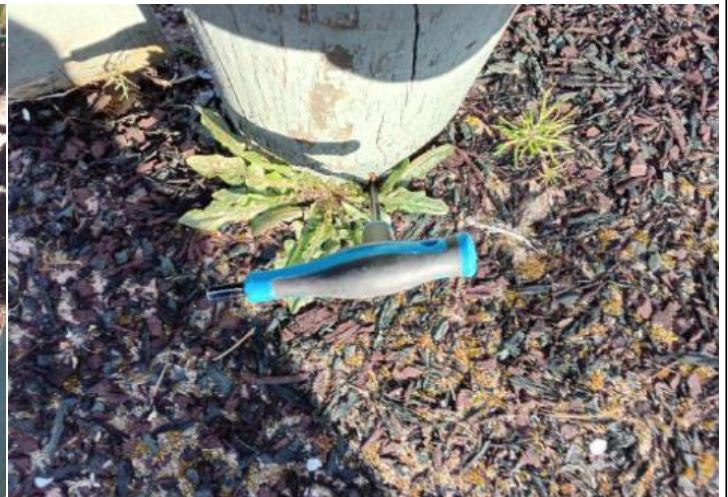
Item: Fences - Fencing - Timber
Manufacturer: Not Identified

Finding: There is some evidence of rot in the timber

Action: Monitor for any further deterioration and replace as required

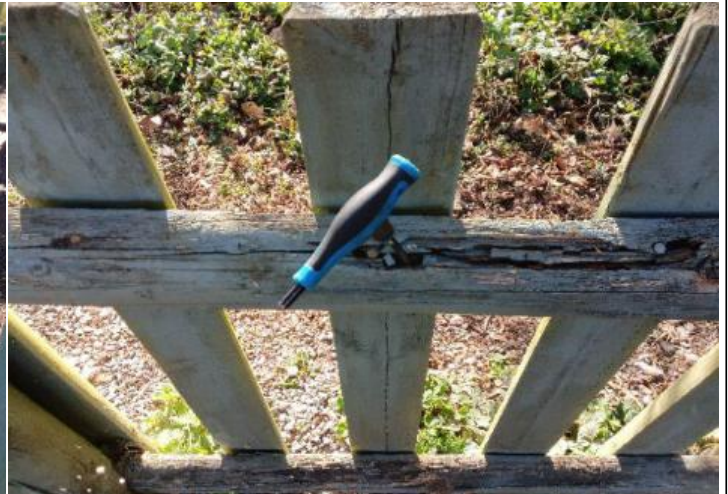
Item: Fences - Fencing - Timber
Manufacturer: Not Identified

Finding: There are areas or parts of the timber on the structure that have rotted

Action: Replace all affected timbers

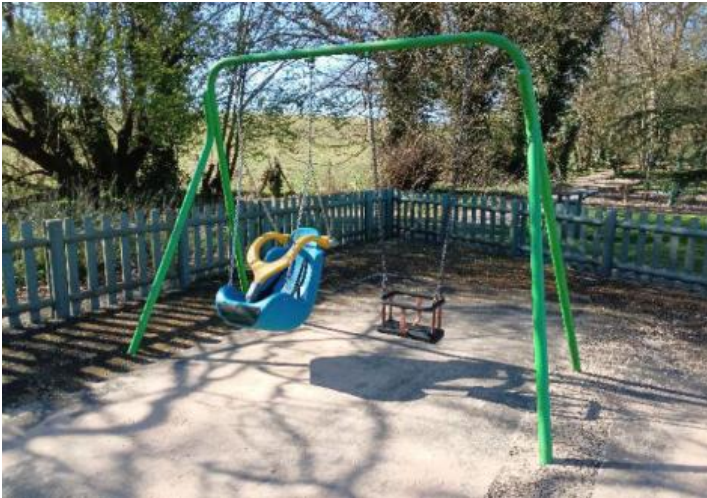
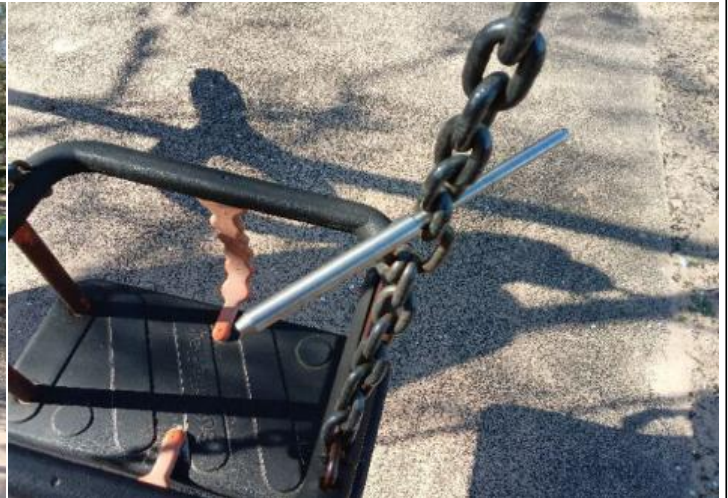
Item: Swings - 1 Bay 2 Seat Swing
Manufacturer: Not Identified

Finding: The chain openings are in excess of the 8.6mm as recommended by BS EN 1176

Action: Monitor - No action given the risk assessment

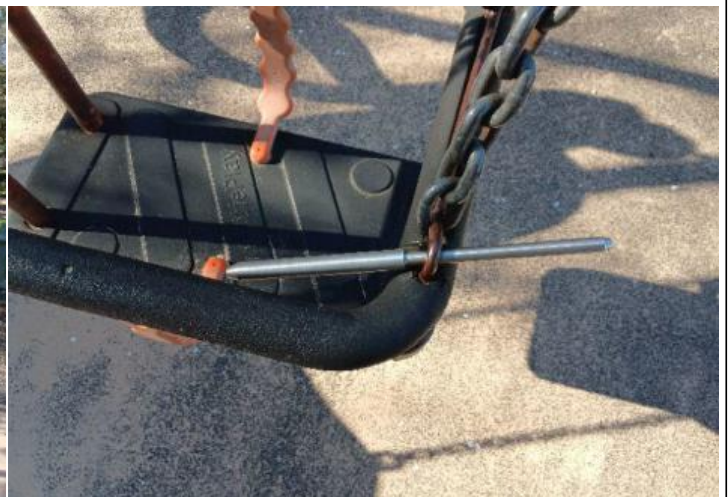
Item: Swings - 1 Bay 2 Seat Swing
Manufacturer: Not Identified

Finding: The connecting links are in excess of 8.6mm and less than 12mm and fail the requirements of BS EN 1176 Part 1; clause 4.2.13, Chains

Action: Monitor - No action given the risk assessment

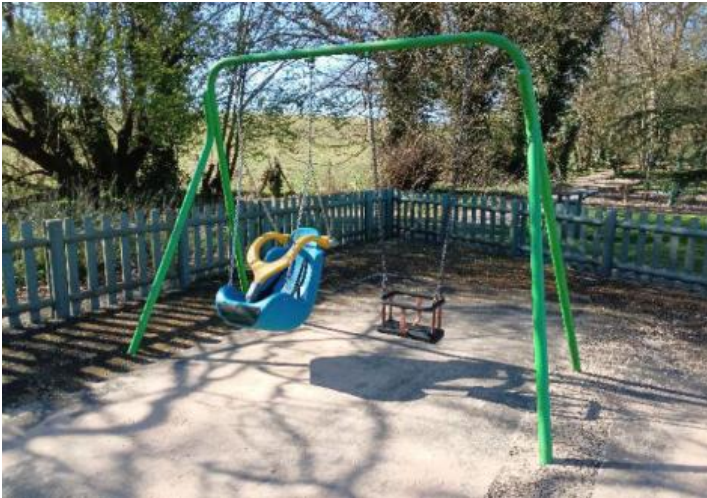
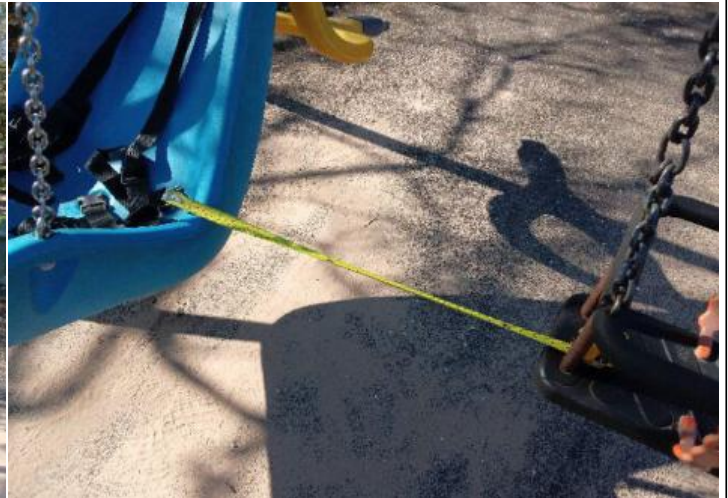
Item: Swings - 1 Bay 2 Seat Swing
Manufacturer: Not Identified

Finding: The seats are too close to each other as defined in BS EN 1176 Part 2; this is a low risk failure and no remedial action is required

Action: Monitor - No action given the risk assessment

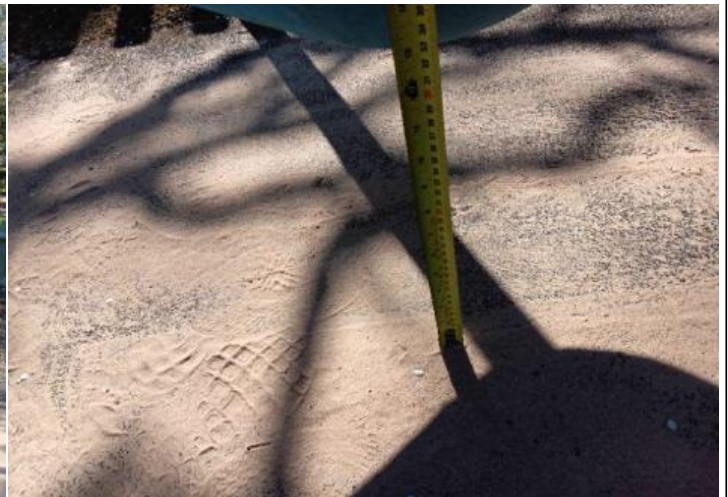
Item: Swings - 1 Bay 2 Seat Swing
Manufacturer: Not Identified

Finding: The seat clearance from finished surface level to the underside of the seat is too low and does not meet the requirements of BS EN 1176 Part 2 (350mm minimum clearance required)

Action: Adjust seat height/s (400mm-500mm is recommended)

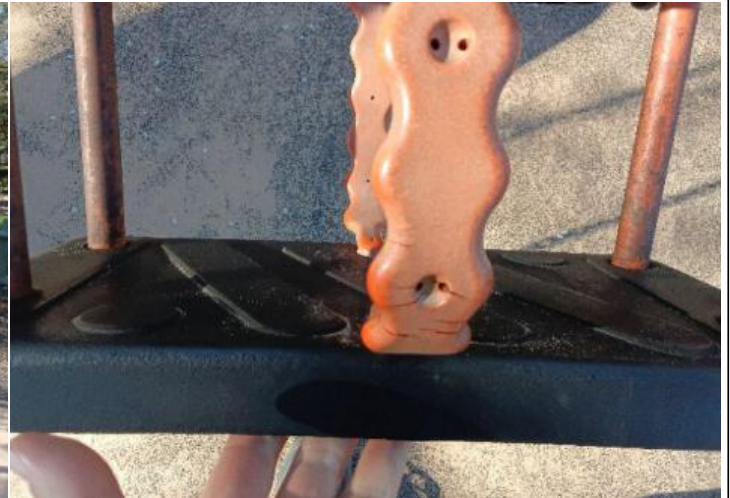
Item: Swings - 1 Bay 2 Seat Swing
Manufacturer: Not Identified

Finding: The seat has minor damage or wear

Action: Monitor for any further deterioration and replace as required

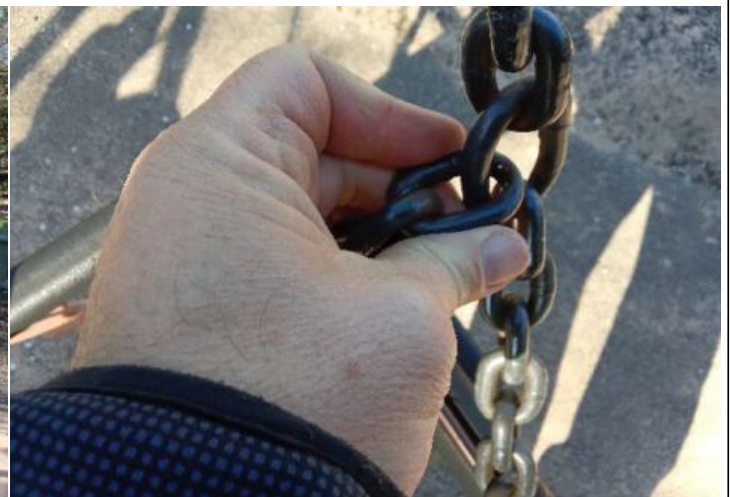
Item: Swings - 1 Bay 2 Seat Swing
Manufacturer: Not Identified

Finding: There is some notable evidence of chain wear

Action: Monitor for any further deterioration and replace when 40% worn

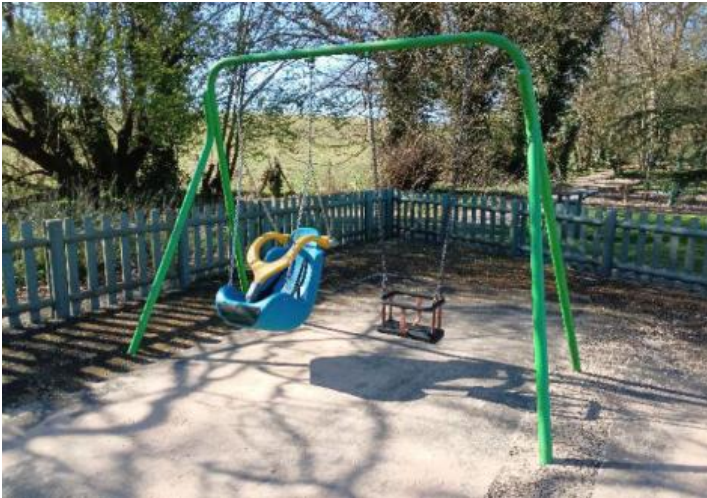
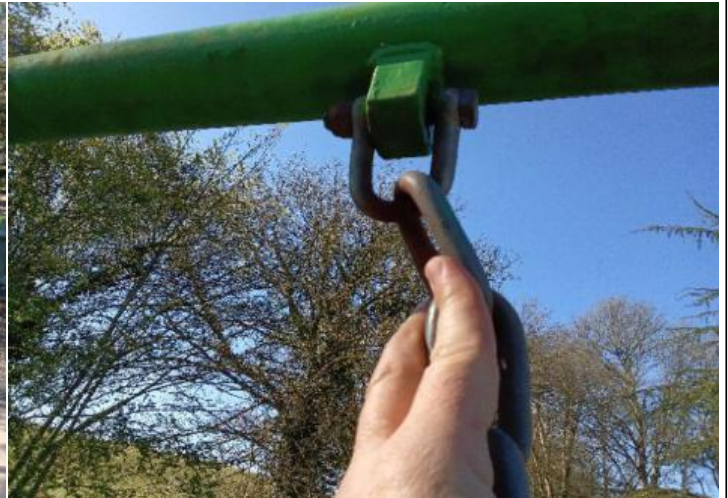
Item: Swings - 1 Bay 2 Seat Swing
Manufacturer: Not Identified

Finding: There is some wear to the shackles.

Action: Monitor for any further deterioration and replace when 40% worn

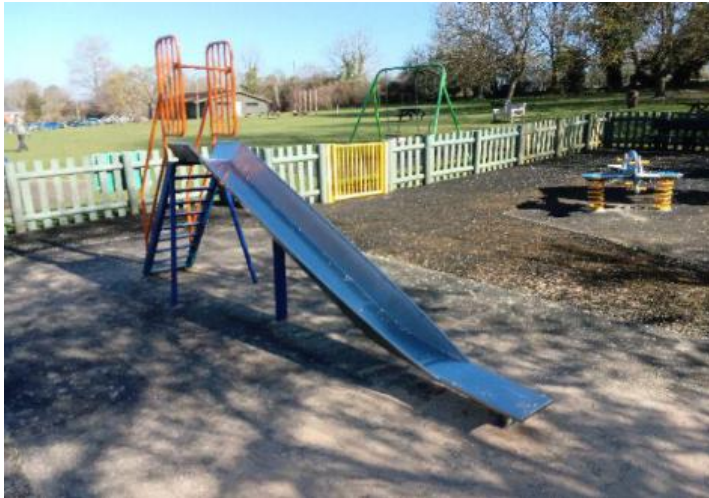
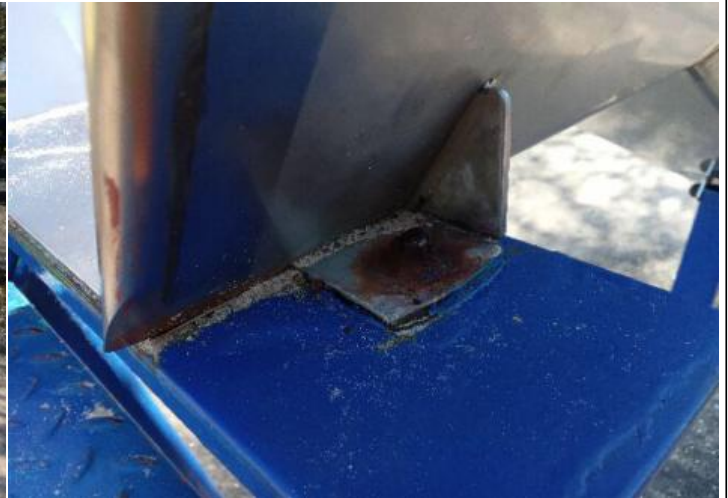
Finding: The fixings have corroded excessively

Action: Replace all corroded fixings

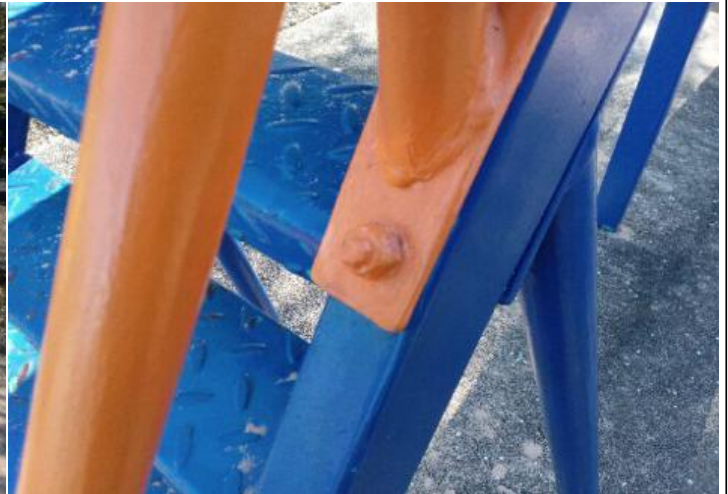
Finding: There is/are bolt cap covers missing or damaged on the item

Action: Replace missing or damaged bolt cap covers

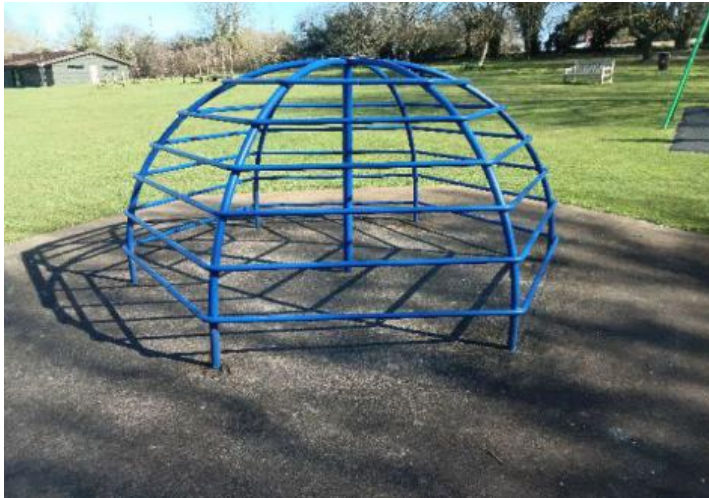
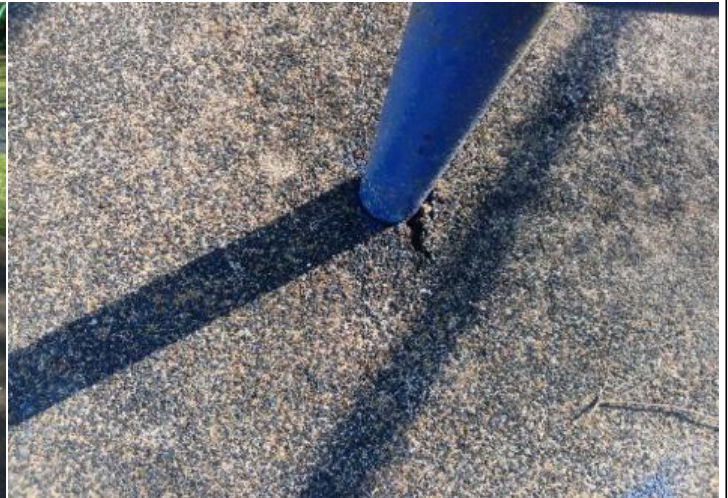
Finding: There is some damage to the surface

Action: Monitor for any further deterioration and repair as required

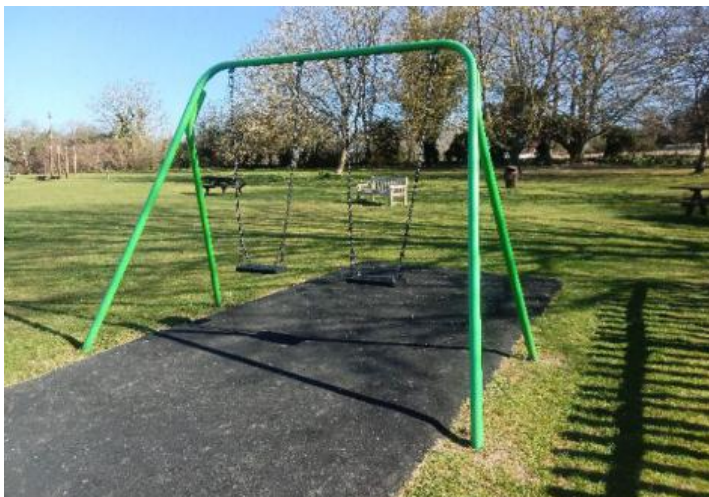
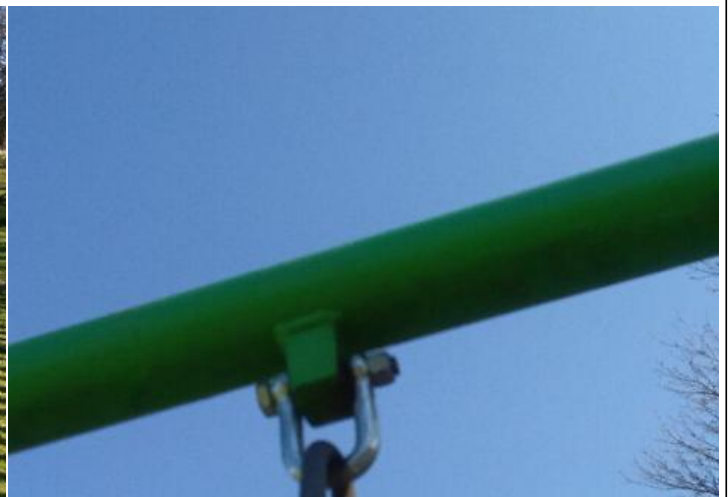
Finding: The bush / bushes is / are showing signs of wear

Action: Monitor for any further deterioration and replace as required

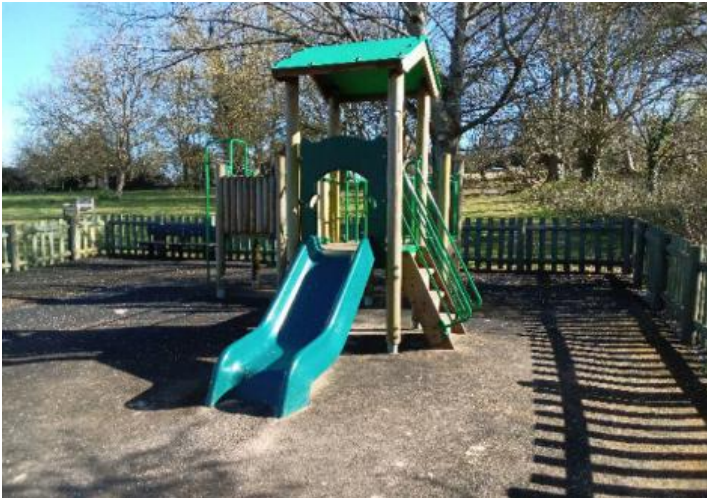
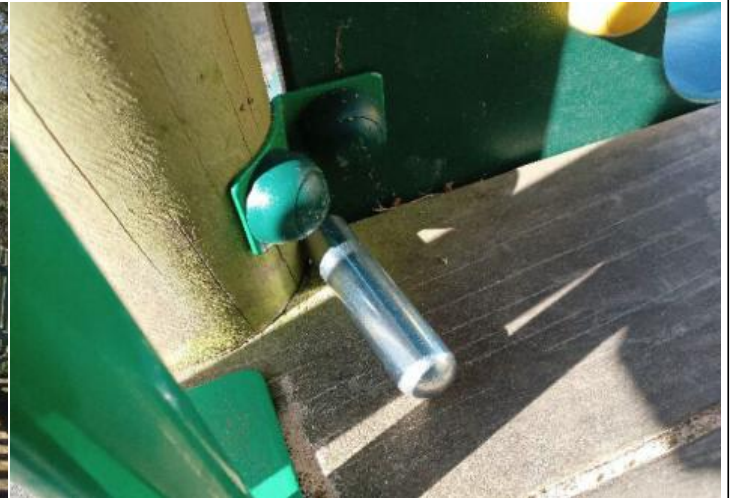
Finding: There is/are finger entrapment/s adjacent to the slide and the item fails to meet the requirements of BS EN 1176 Part 1 4.2.7.6 Entrapment of fingers

Action: Monitor - No action given the risk assessment

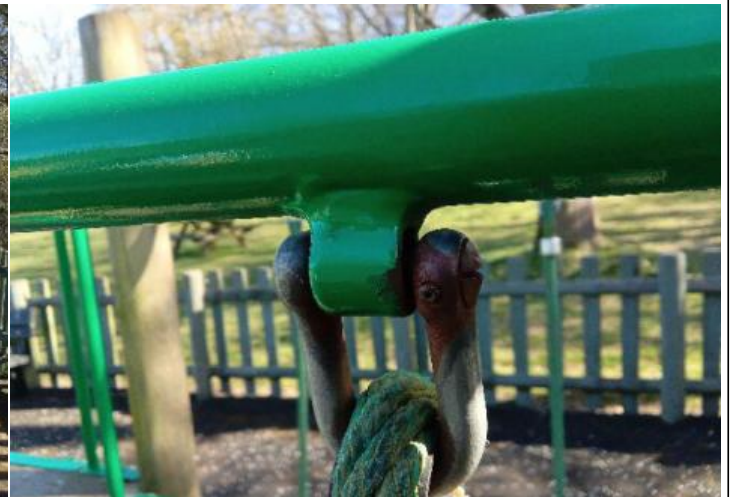
Finding: The bush / bushes is / are worn or missing

Action: Replace worn or missing bushes

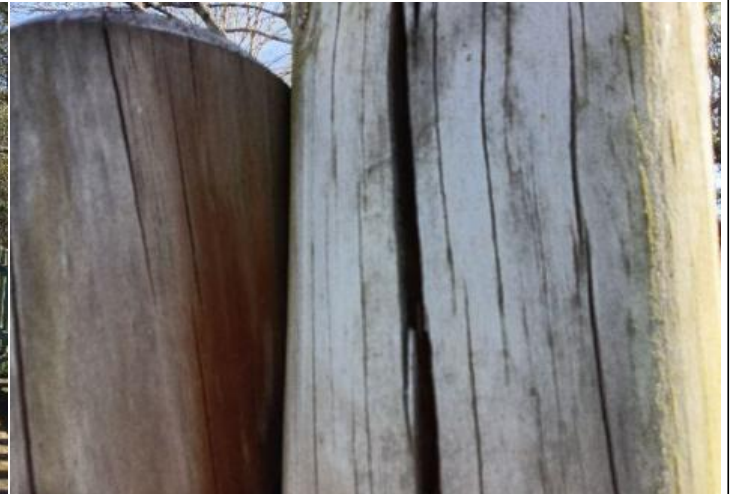
Finding: The timber has a number of splits/shakes or air cracks and this may affect the stability or allow water ingress which will accelerate the rotting process

Action: Monitor to ensure the splits do not cross through fixing points of the structure and/or cause any instability

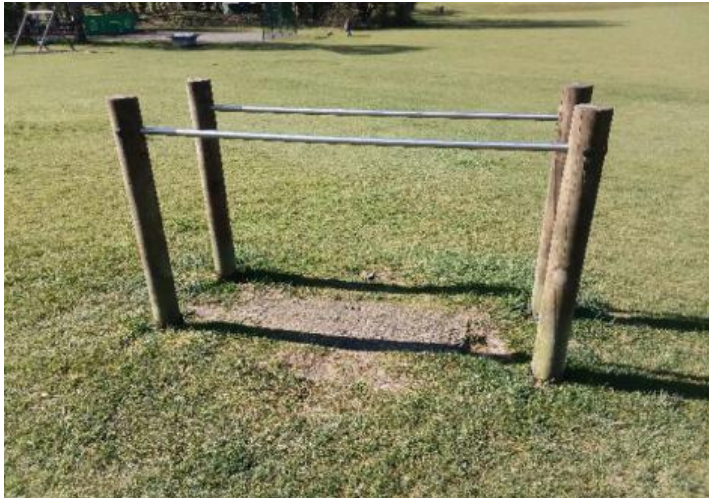
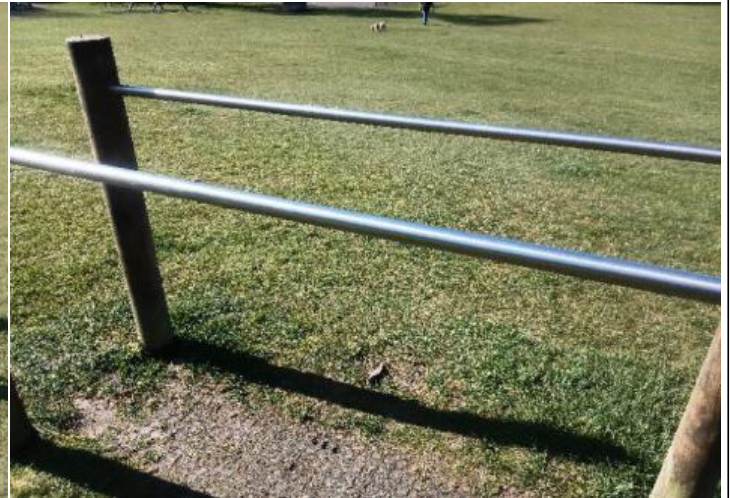
Finding: The handrails are loose

Action: Secure

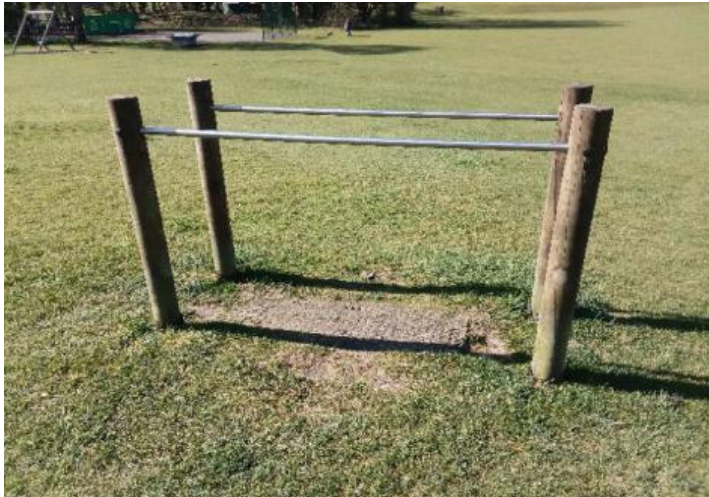
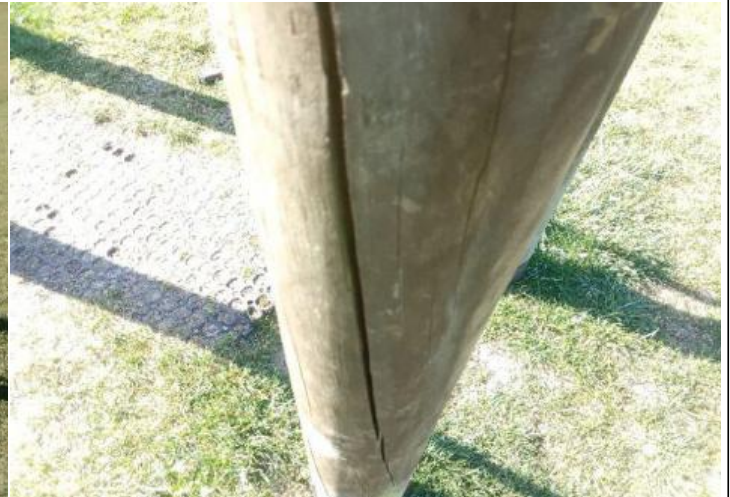
Finding: The timber has a number of splits/shakes or air cracks and this may affect the stability or allow water ingress which will accelerate the rotting process

Action: Monitor to ensure the splits do not cross through fixing points of the structure and/or cause any instability

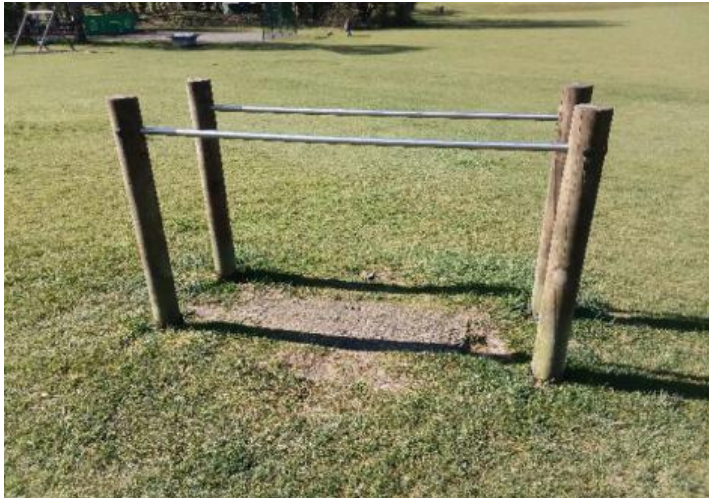
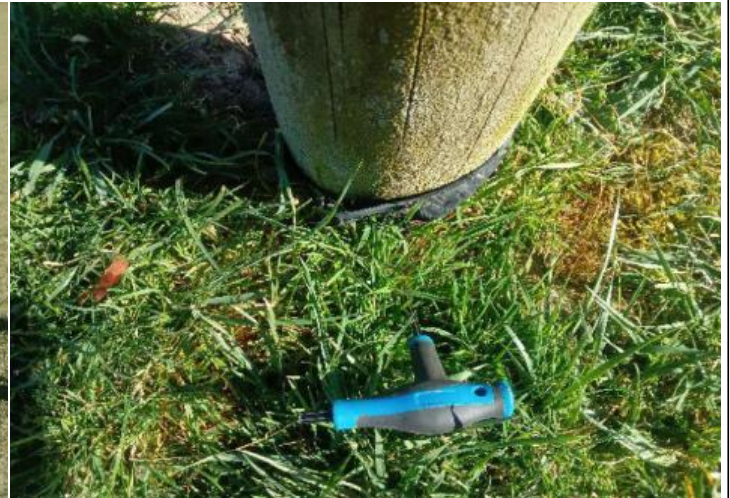
Finding: There is some evidence of rot in the posts

Action: Monitor for any further deterioration and replace as required

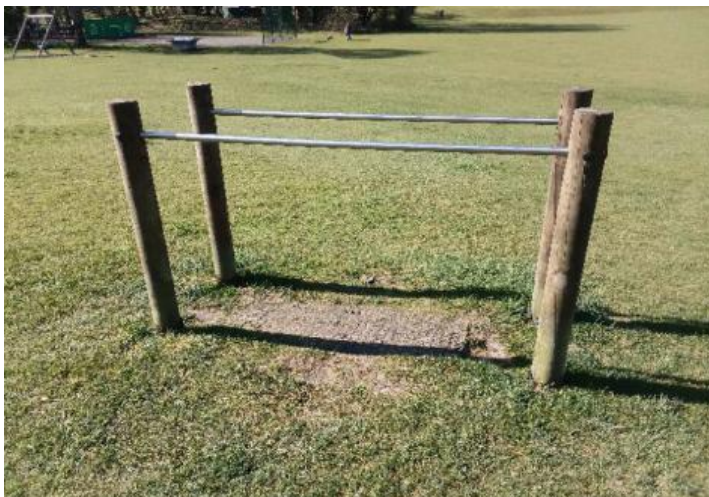
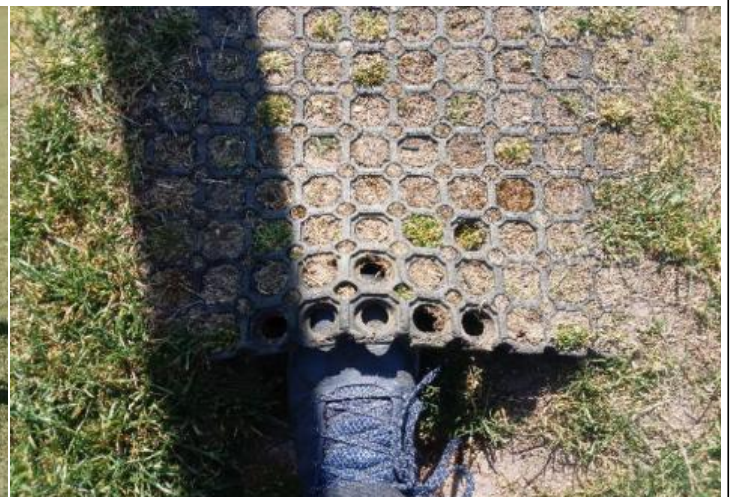
Finding: The surface is lifting at the edges and creating trip points

Action: Repair perimeter of surfacing to remove trip points

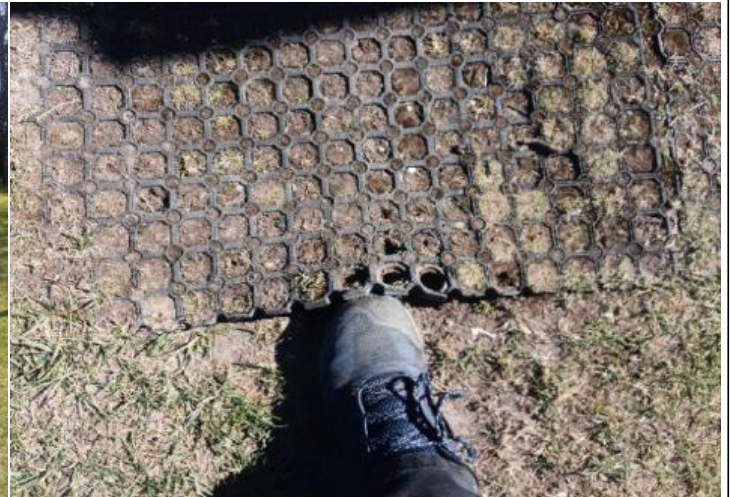
Finding: The surface is lifting at the edges and creating trip points

Action: Repair perimeter of surfacing to remove trip points

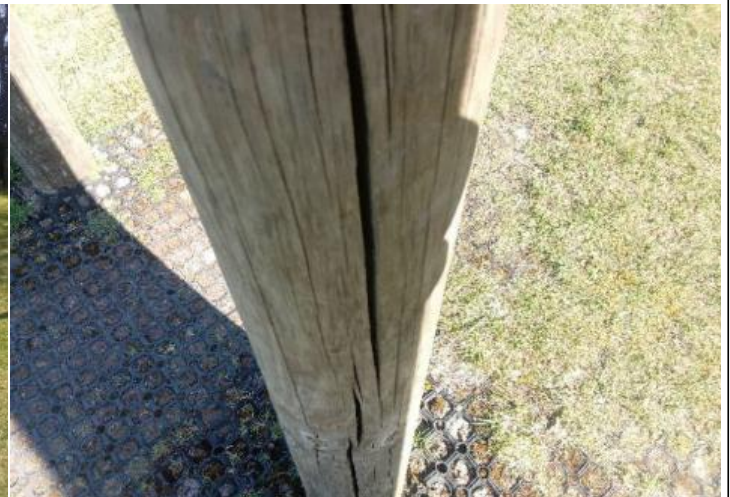
Finding: The timber has a number of splits/shakes or air cracks and this may affect the stability or allow water ingress which will accelerate the rotting process

Action: Monitor to ensure the splits do not cross through fixing points of the structure and/or cause any instability

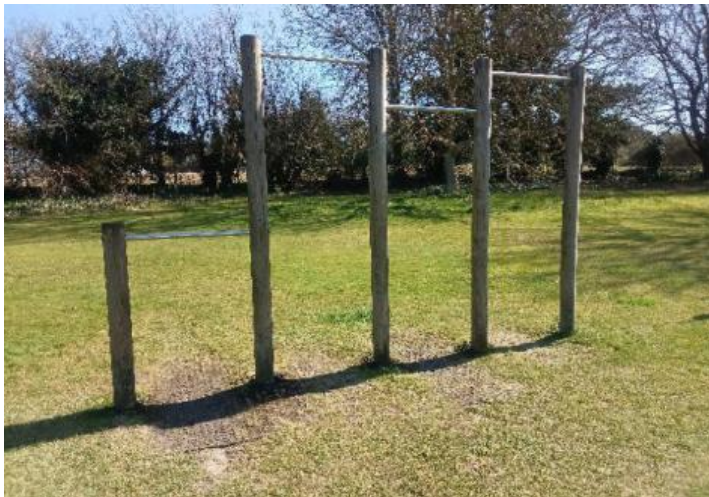
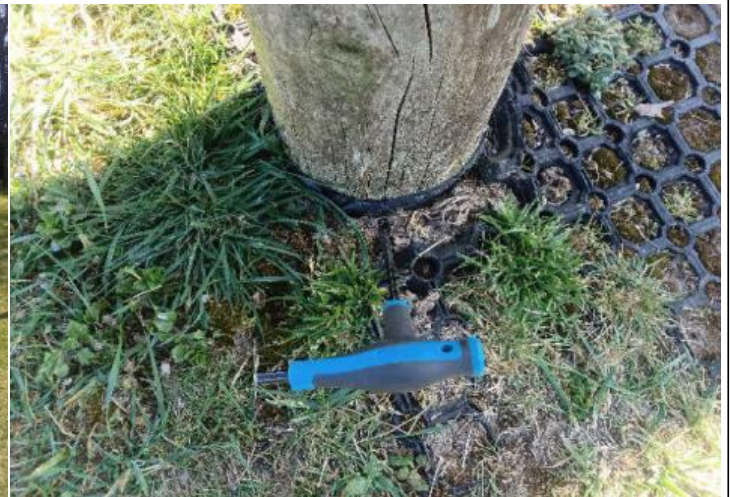
Finding: There is some evidence of rot in the posts

Action: Monitor for any further deterioration and replace as required

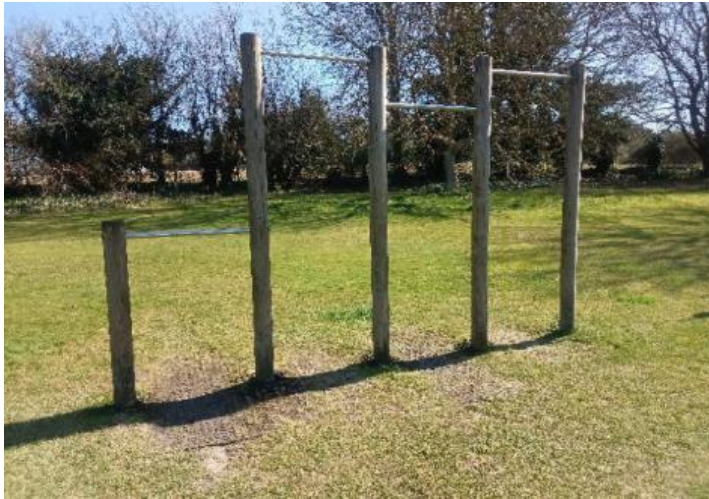
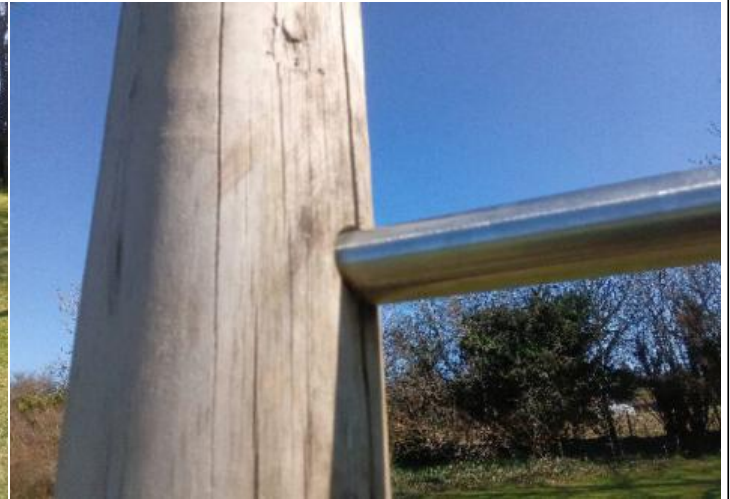
Finding: The handrails are working loose

Action: Secure

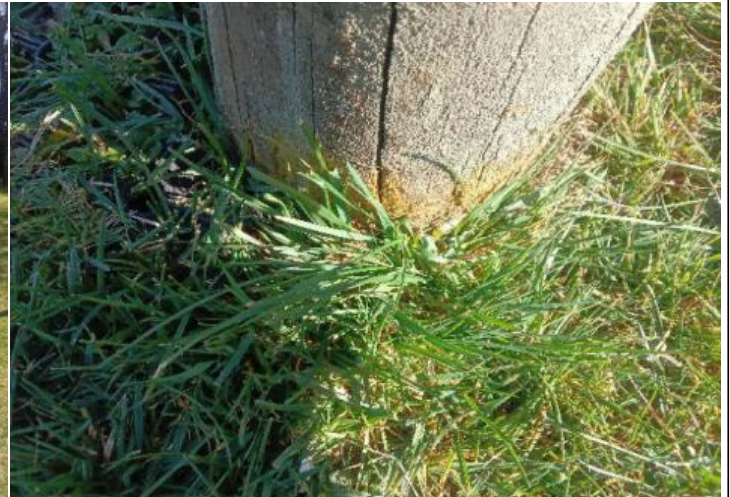
Finding: There is some strimmer / machinery damage apparent on the posts, this can penetrate the preservative applied to the timber and accelerate the rotting process

Action: Monitor for any deterioration (rot) and replace as required

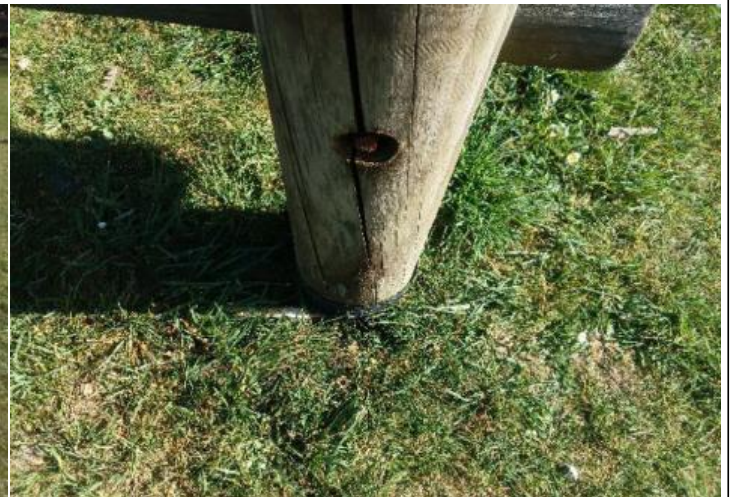
Finding: There is/are bolt cap covers missing or damaged on the item

Action: Replace missing or damaged bolt cap covers

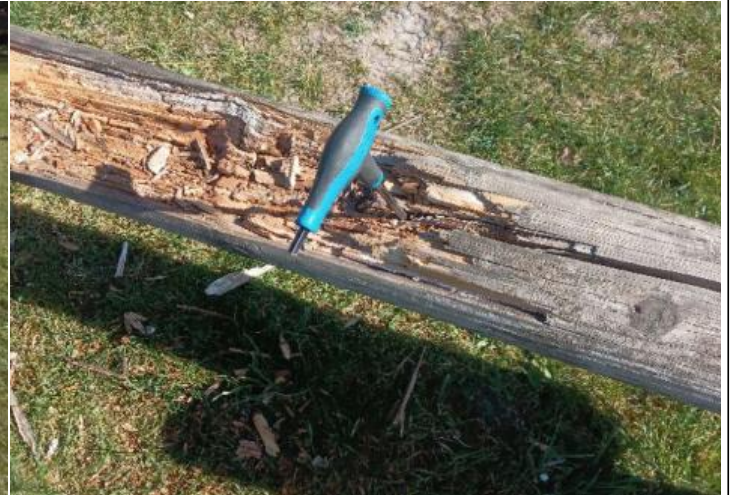
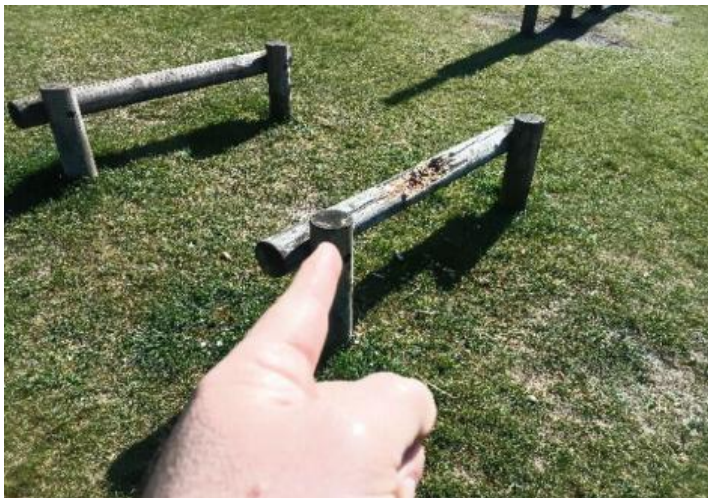
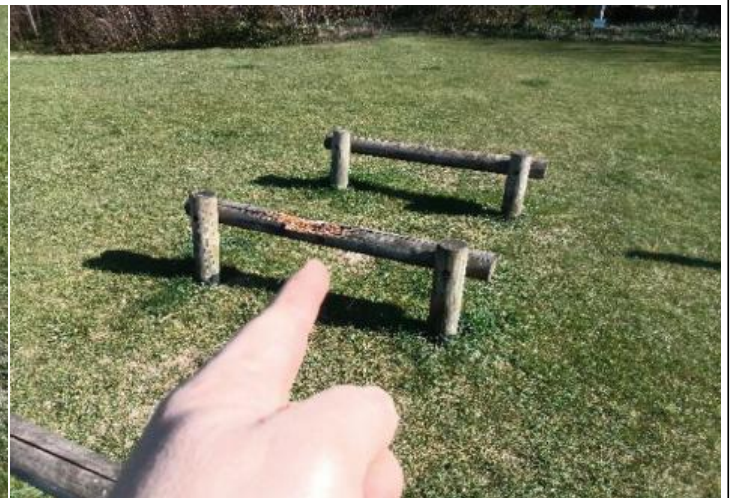
Finding: There are areas or parts of the timber on the structure that have rotted

Action: Replace all affected timbers

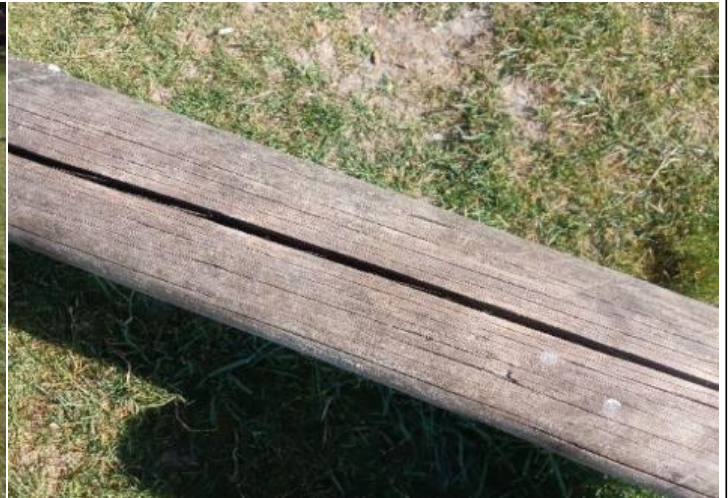
Finding: The timber has a number of splits/shakes or air cracks and this may affect the stability or allow water ingress which will accelerate the rotting process

Action: Monitor to ensure the splits do not cross through fixing points of the structure and/or cause any instability

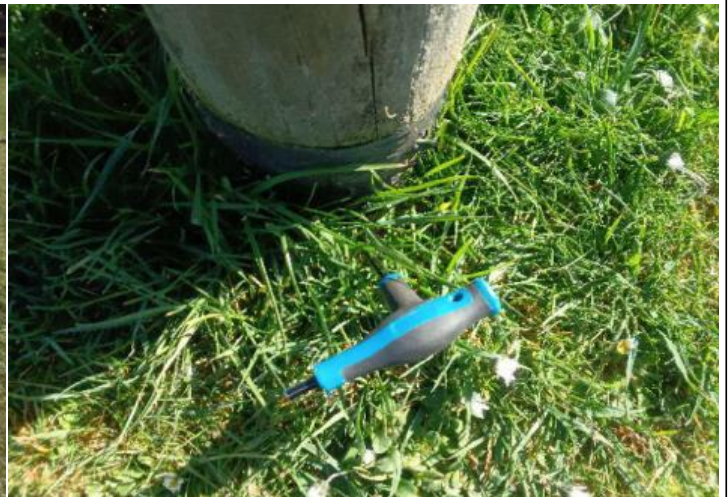
Finding: There is some evidence of rot in the timber

Action: Monitor for any further deterioration and replace as required

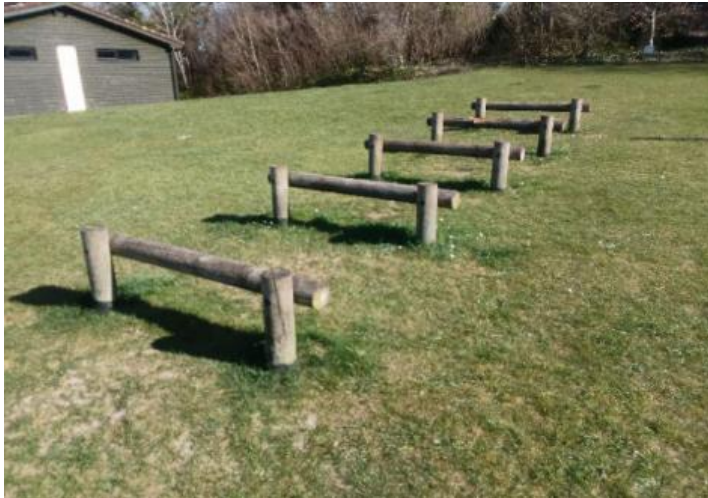
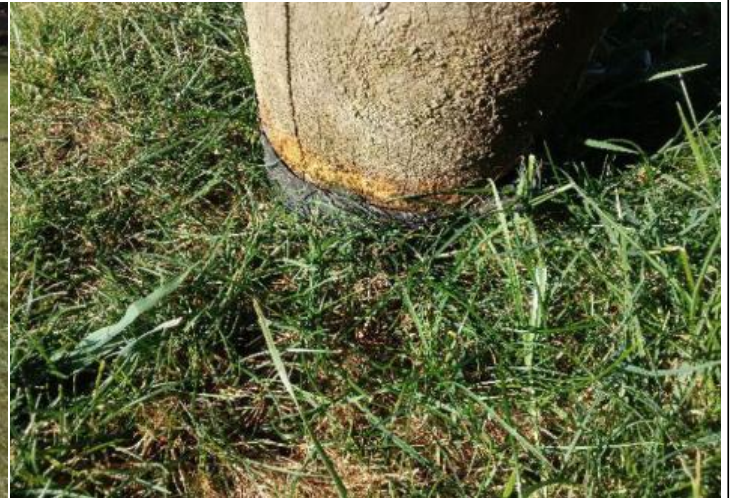
Finding: There is some strimmer / machinery damage apparent on the posts, this can penetrate the preservative applied to the timber and accelerate the rotting process

Action: Monitor for any deterioration (rot) and replace as required

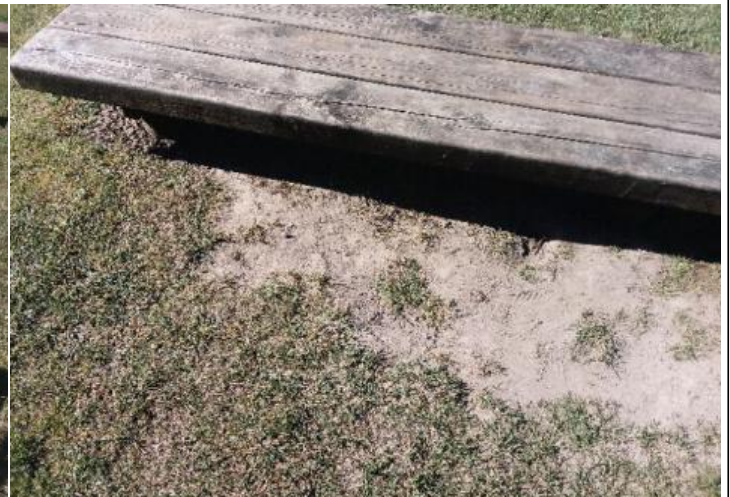
Finding: The surface has eroded in some areas and may be slippery in wet conditions

Action: Reinstate the surface

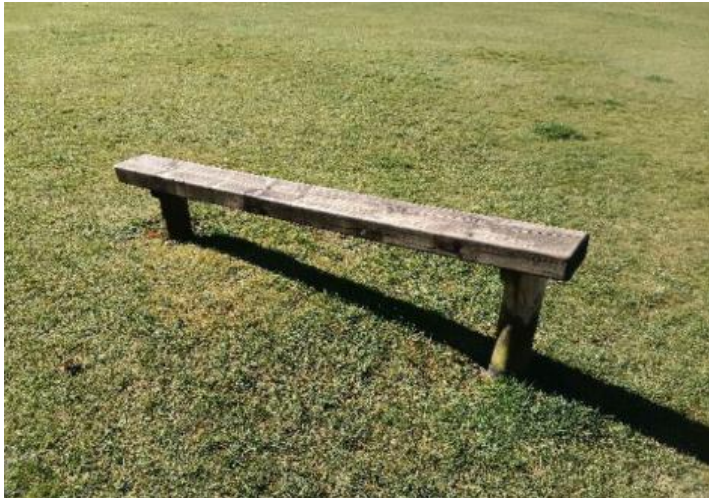
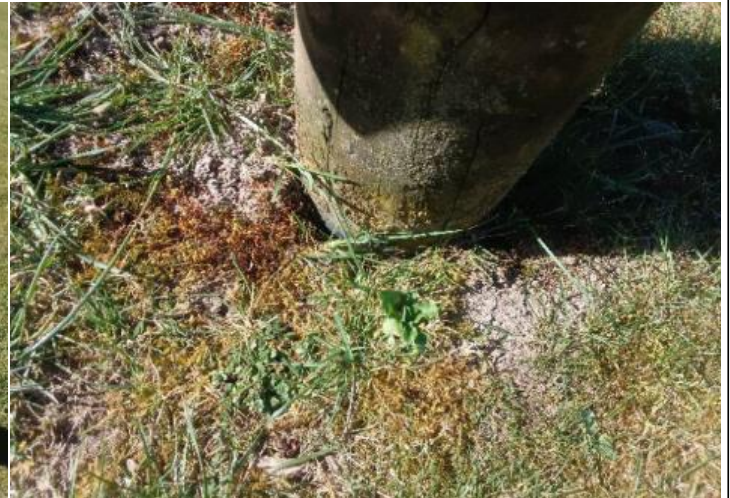
Item: Outdoor Fitness Equipment - Sit Up Station **Risk Level:** L - Low Risk
Manufacturer: Not Identified **Surface:** Grass

Finding: There is some strimmer / machinery damage apparent on the posts, this can penetrate the preservative applied to the timber and accelerate the rotting process

Action: Monitor for any deterioration (rot) and replace as required

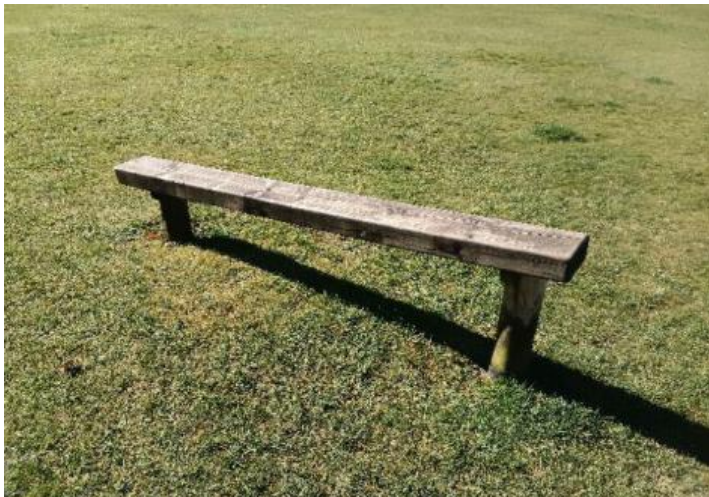
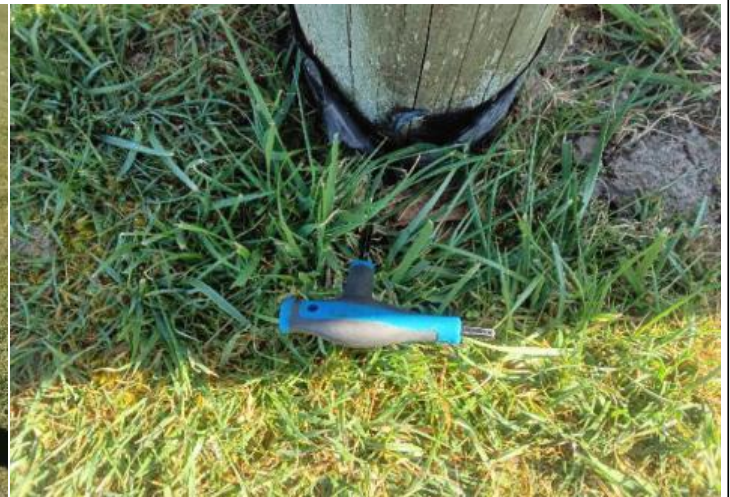
Item: Outdoor Fitness Equipment - Sit Up Station **Risk Level:** L - Low Risk
Manufacturer: Not Identified **Surface:** Grass

Finding: There is some evidence of rot in the timber

Action: Monitor for any further deterioration and replace as required

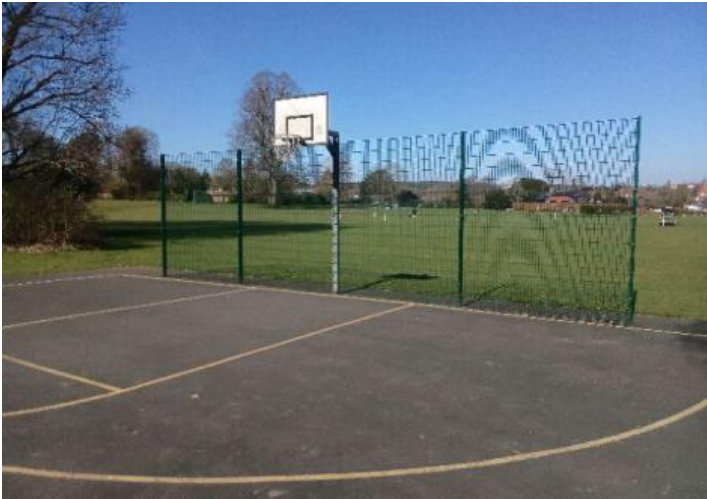
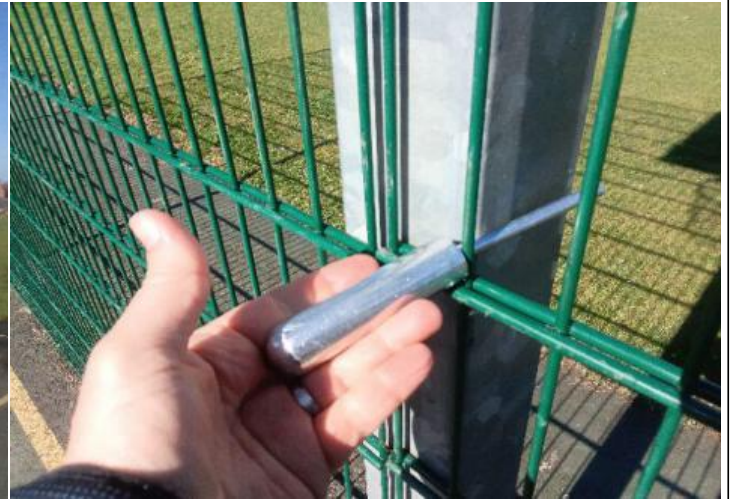
Finding: There is/are finger entrapments in the framework and the item fails to meet the requirements of BS EN 15312 Clause 4.4.2.2 Entrapment of fingers

Action: Monitor - No action given the risk assessment
