I hereby summon you to attend a meeting of the **RECREATION COMMITTEE** on Thursday 11th September 2025 at 7:30 PM, to be held at The Pavilion, Hunter Park, SO21 1QS

10 Play Inspection Reports

To Receive the Annual Play Inspection report for Hunter Park.

Recreation Committee 13th September 2025

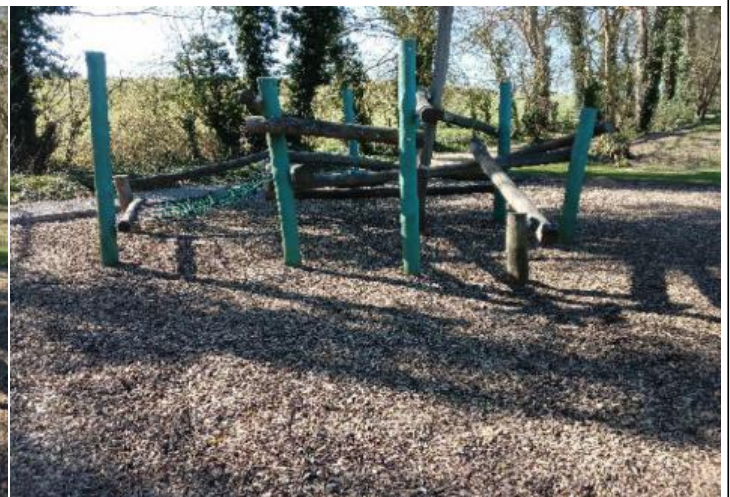
Finding: The depth of the loose fill surfacing is lower than the recommended depth specified in BS EN 1176; the free height of fall of the equipment is less than 2.0m and a minimum of 300mm depth should be provided (including an extra 100mm to allow for compaction and displacement as per BS EN 1176 Part 1 - Table 4)

Action: Top up loose fill surfacing to recommended levels

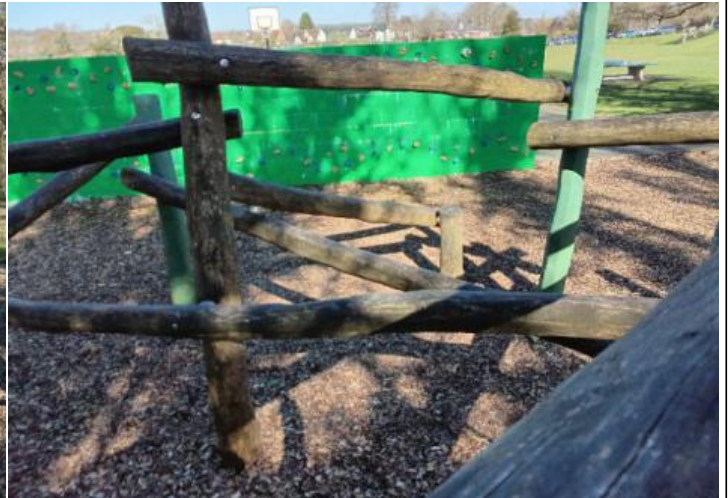
Finding: There are falls in excess of 600mm between adjacent components on the structure, in contravention of the recommendations set out in BS EN 1176 Part 1; 4.2.8.4

Action: Monitor - No action given the risk assessment

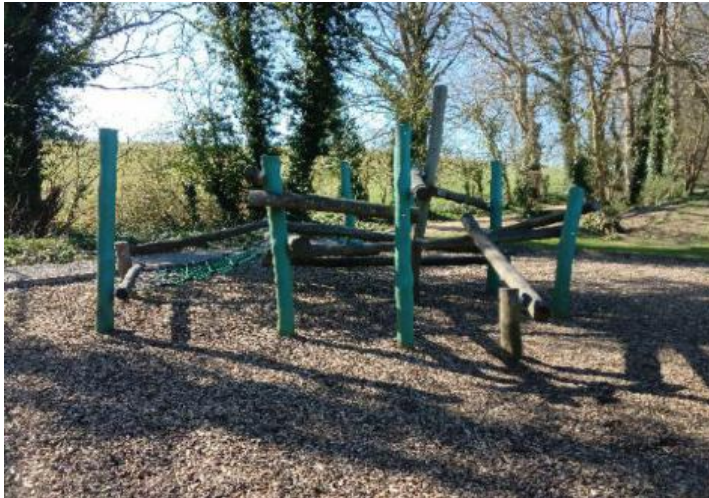
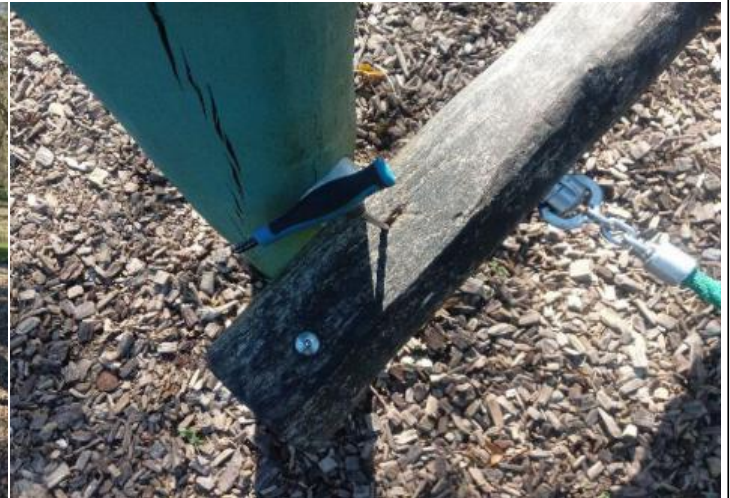
Finding: There is some evidence of rot in the timber

Action: Monitor for any further deterioration and replace as required

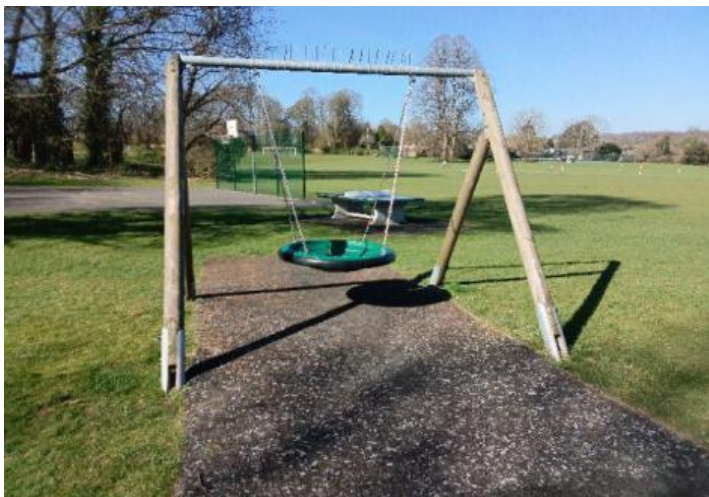
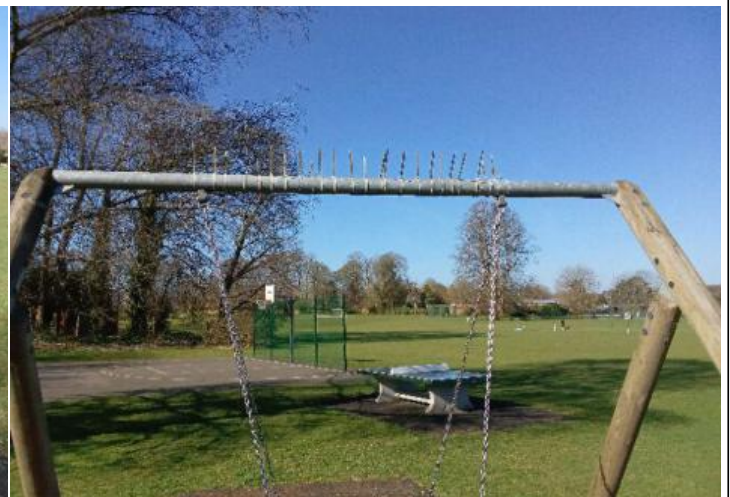
Finding: Swings of this design should have a secondary safety mechanism fitted to prevent collapse of the seat in the event of a joint failure to comply with BS EN 1176 Part 2, however this swing was installed prior to the standards being updated in 2018 and the manufacturer has confirmed that the joint was independently cycle tested by BSi

Action: Monitor use and check the joint and fixing security regularly

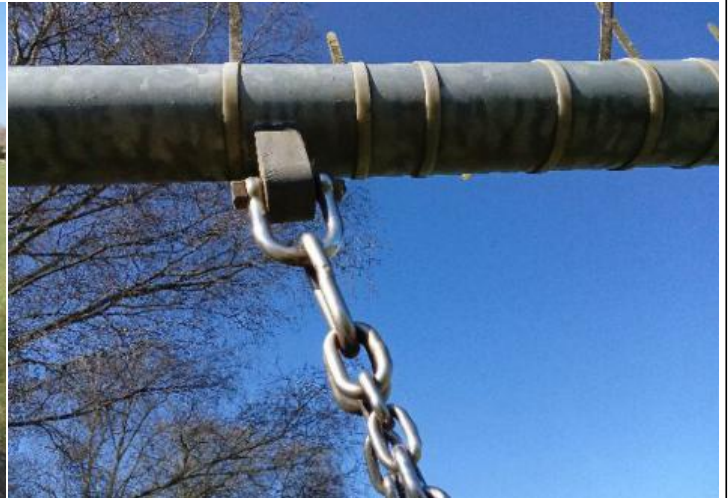
Finding: There is some notable evidence of chain wear

Action: Monitor for any further deterioration and replace when 40% worn

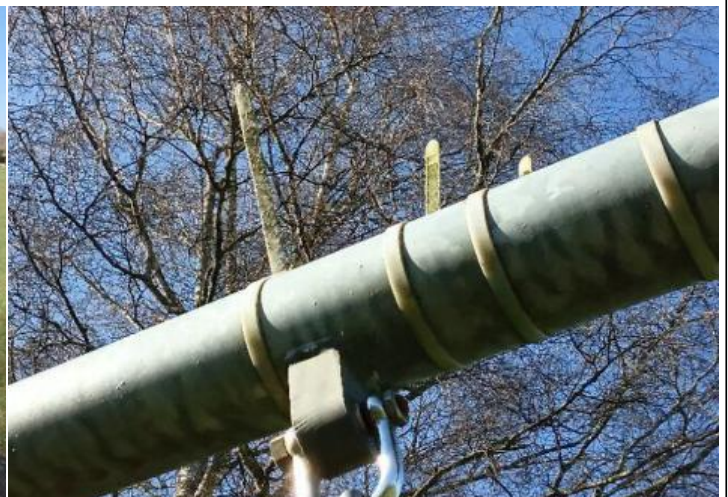
Finding: The bush / bushes is / are showing signs of wear

Action: Monitor for any further deterioration and replace as required

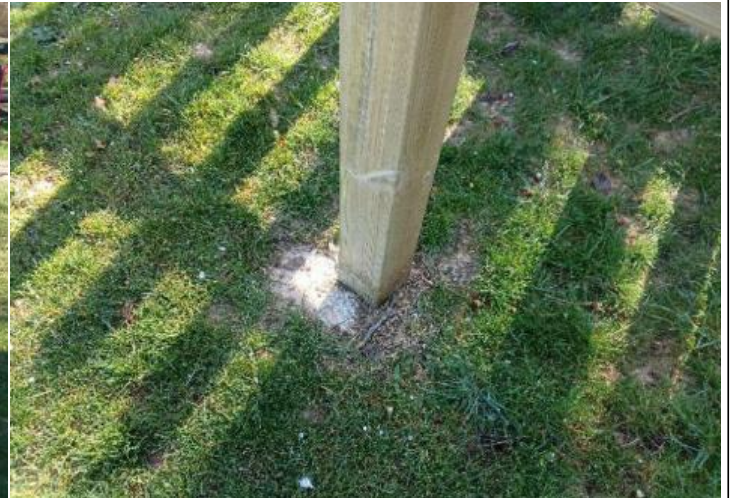
Finding: The surface has eroded and the foundations are exposed

Action: Reinstate surrounding surfaces to cover the foundations

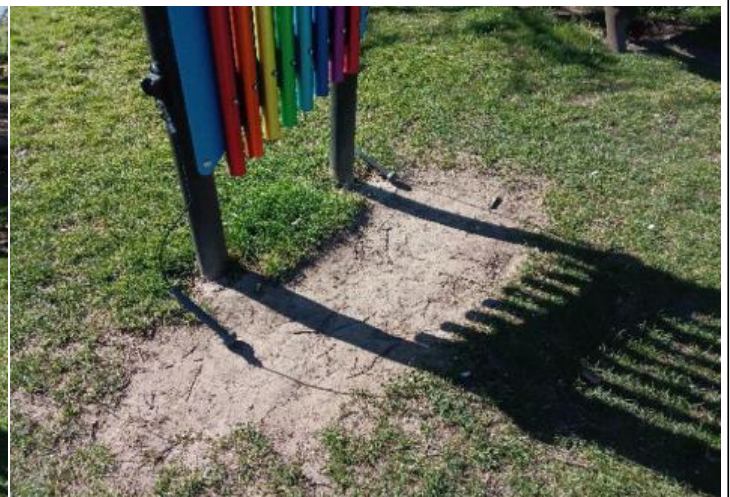
Finding: The surface has eroded in some areas and may be slippery in wet conditions

Action: Reinstate the surface

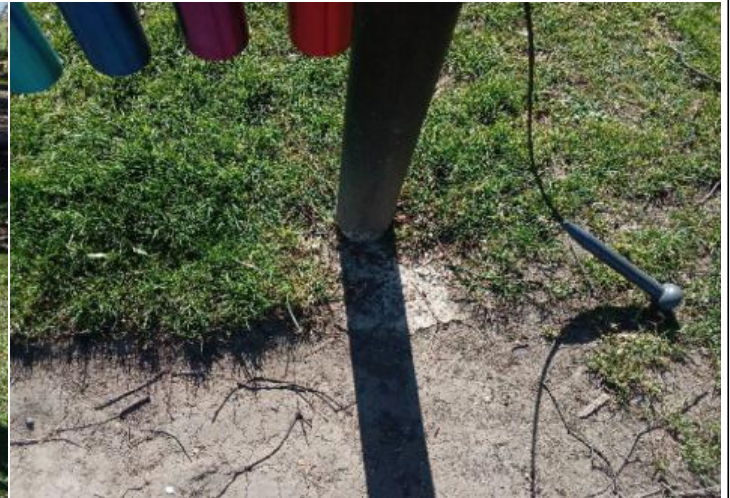
Finding: The surface has eroded and the foundations are exposed

Action: Reinststate surrounding surfaces to cover the foundations
