I hereby summon you to attend a meeting of the **RECREATION COMMITTEE** on Thursday 10th September 2026 at 7:30 PM, to be held at The Pavilion, Hunter Park, SO21 1QS

**To Receive** the Visual Tree Assessment conducted in May 2026 and **consider** the recommendations.

The Visual Tree Assessment (VTA) was carried out in July 2026 to assess the condition and safety of trees at Northfields and Hunter Park.

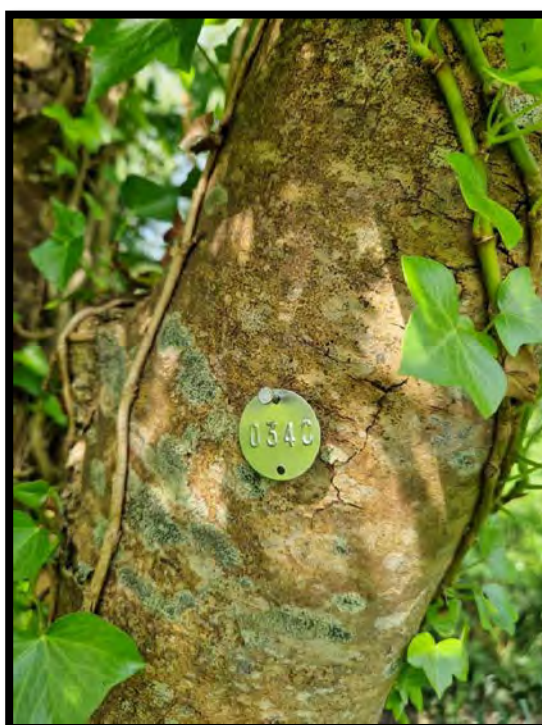
**Photo 1: Tree ident marking.**

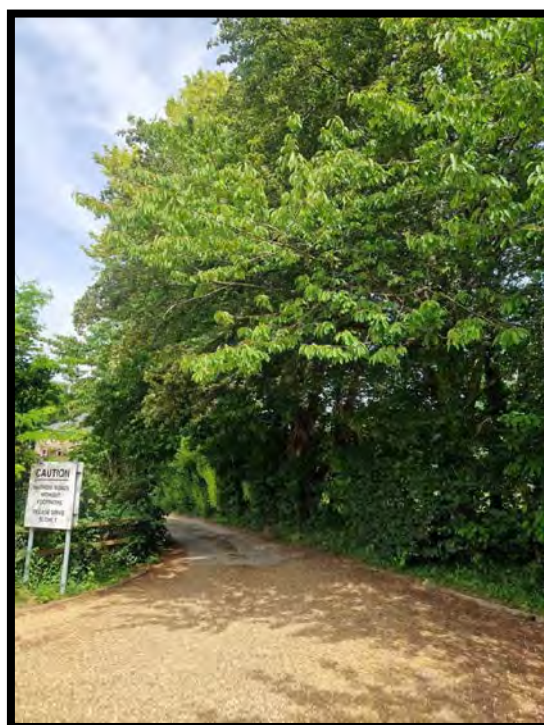
**3.1.2** A number of trees were observed to be growing adjacent to the highway and footway. Trees and vegetation that overhang the highway should be crown-lifted to at least 5.2 m to allow safe passage of high sided vehicles as well as being cut back sufficiently from the edge of the carriageway to allow clearance for wing mirrors. Trees and vegetation that overhang footways and footpaths should be crown-lifted to at least 2.5 m and cut back to ensure the footpath/way is at least 1.2 m in width. This is to allow safe passage for all footpath/way users including wheelchairs, mobility scooters, etc.

**Plate 2: Low hanging branches alongside car parking access road at Huner Park.**

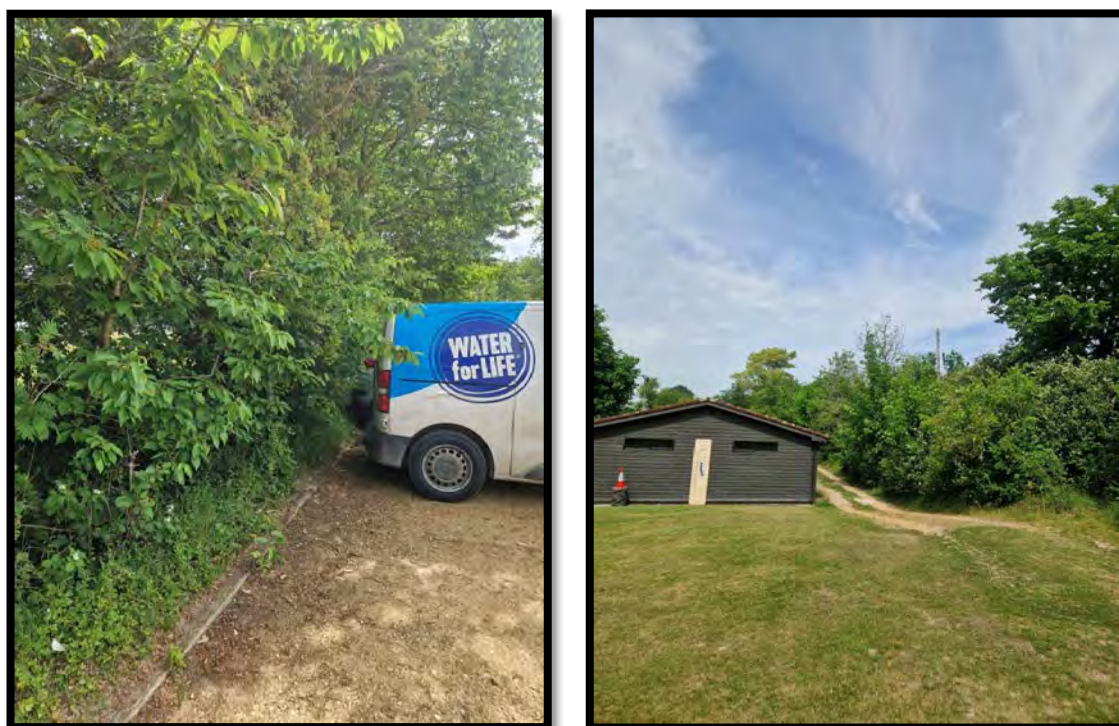
Plate 3: Group of trees adjacent to car parking bays and building.

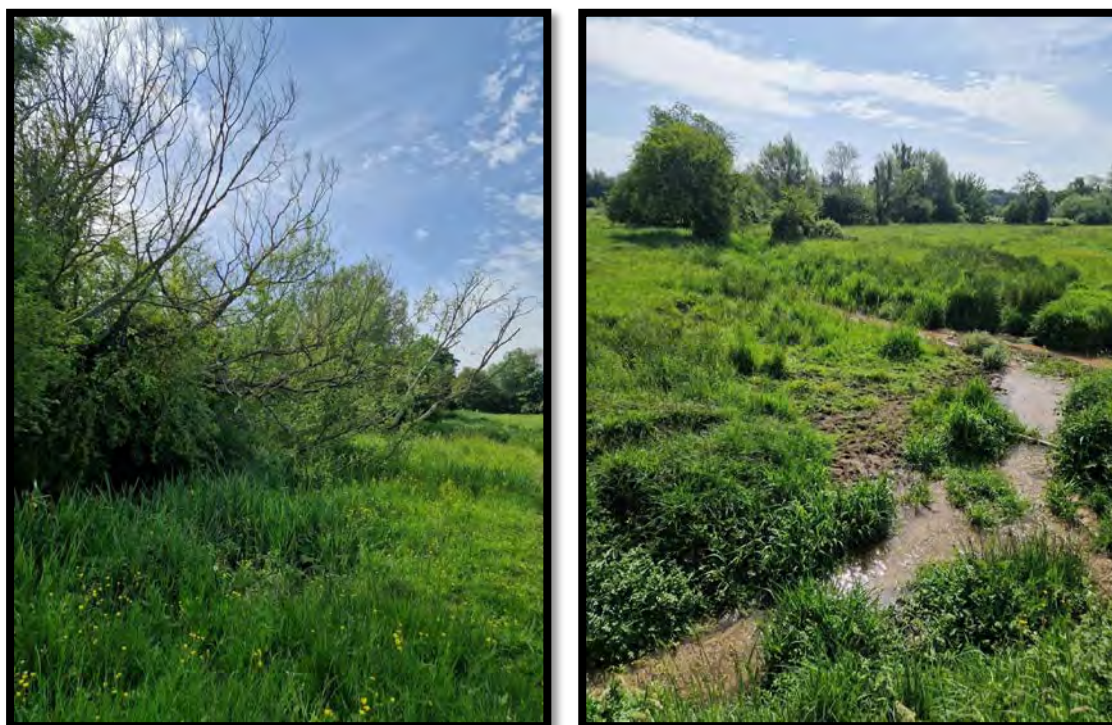
**Plate 6: Montage of trees and watercourses.**

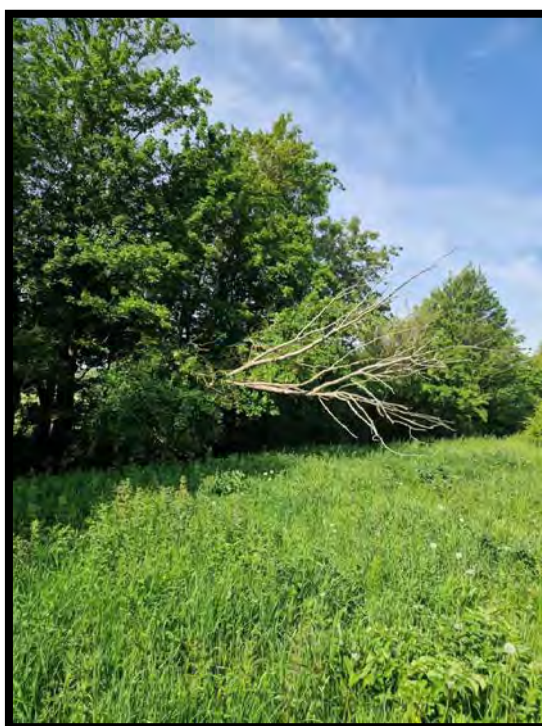
**Plate 7: Neighbouring tree has damaged the boundary fence.**

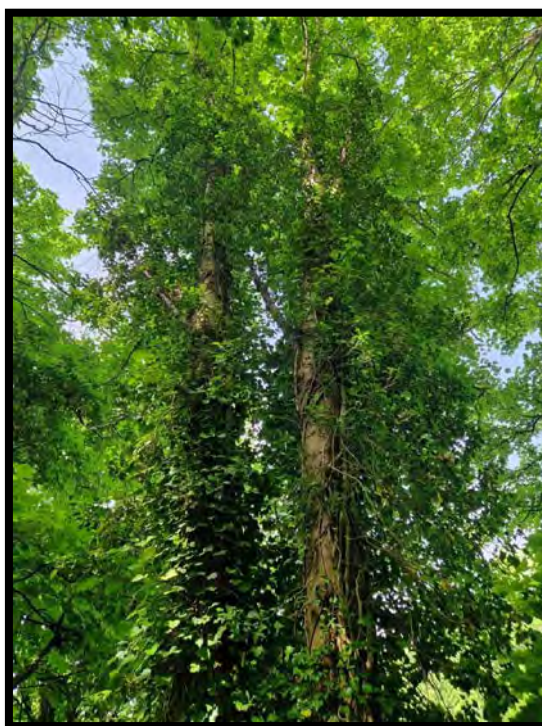
Plate 9: Ivy suppressed trees adjacent to highway.

Ivy is a relatively simple plant to eradicate on a tree. It can be done cutting a ring from the stem of the ivy plant leaving a gap between broken or cut parts of about 100 mm. These ivy rings will prevent water and nutrients from reaching the leaves and the leaves and stems will eventually fall from the tree from where they were attached.

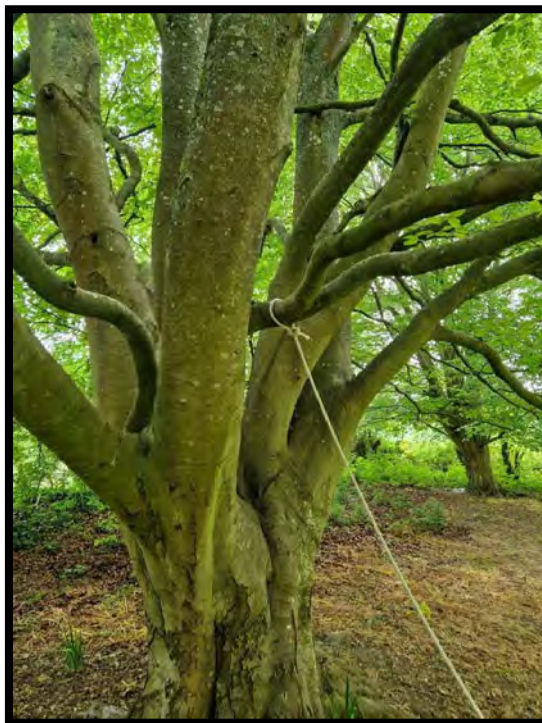
**Plate 12: Rope swing at Hunter Park.**

It is therefore recommended that the rope swings are removed and signage discouraging their use posted within the sites.

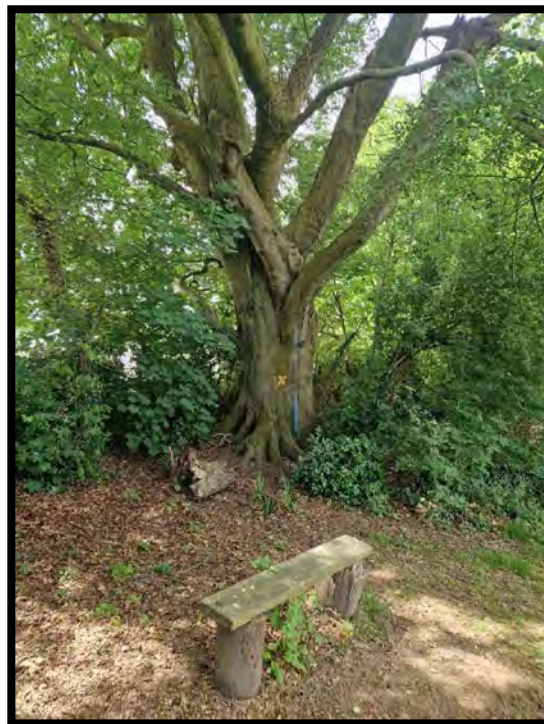
It was noted that benches were placed beneath trees. To prevent accidental injury to person or damage to property it is recommended that these items are relocated. During the survey it became apparent that the first point of refuge and cover was beneath a tree (hot day = shade). It is therefore important that all trees are managed and there are no areas considered less than a high-risk zone.

Plate 13: Tree beneath a Beech tree that sheds branches.

Users of this site shading from the weather (sun, wind or rain) will be beneath a tree at some point during the day (as was observed during the survey). It is recommended that benches are positioned away from mature trees and would be better placed alongside a hedgerow if shade was a requirement.

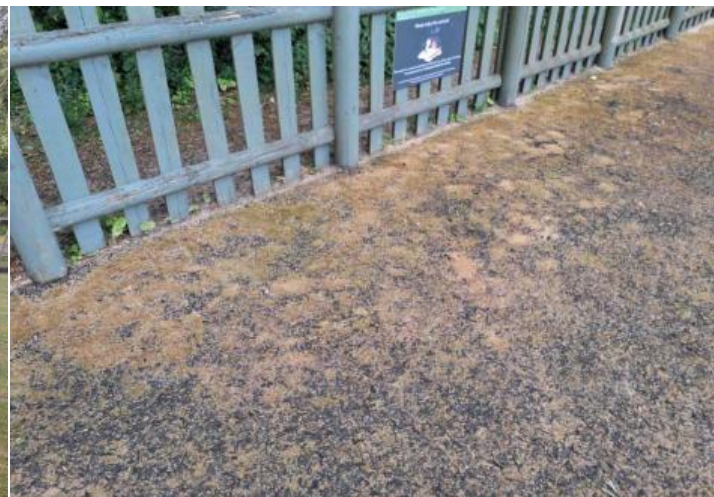
**Risk Level:** L - Low Risk  
**Surface:** N/A

**Finding:** There is algae, silt or moss growth on the surface resulting in slippery conditions

**Action:** Clean and treat appropriately

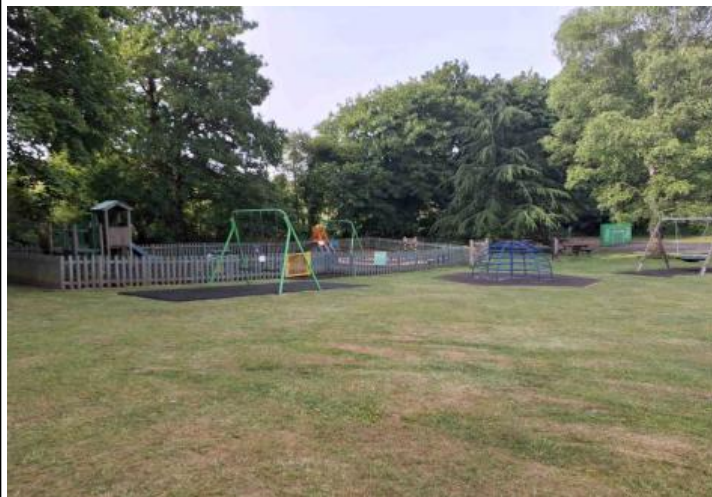
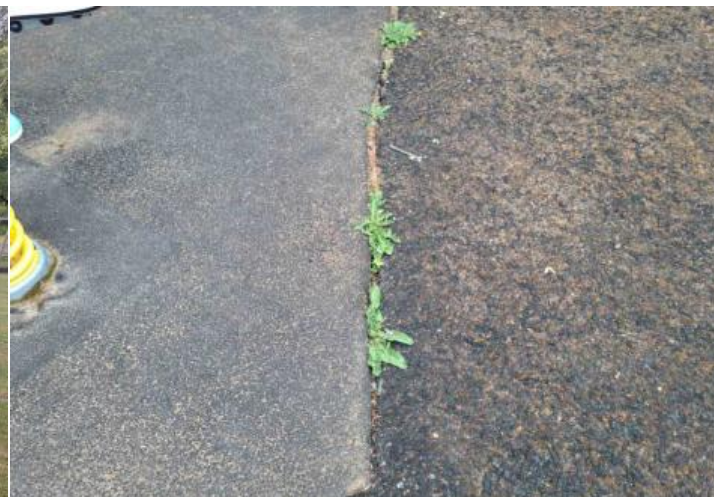
**Risk Level:** V - Very Low Risk  
**Surface:** N/A

**Finding:** There is some minor damage to the surface

**Action:** Monitor for any further deterioration and repair as required

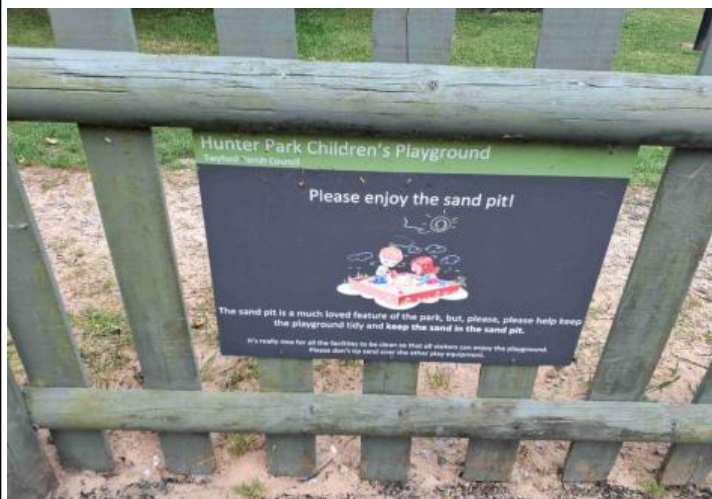
**Finding:** It is recommended that signage, with information including the site address, contact information for maintenance issues and emergency contact details are provided for the facility

**Action:** Provide in accordance with the recommendations

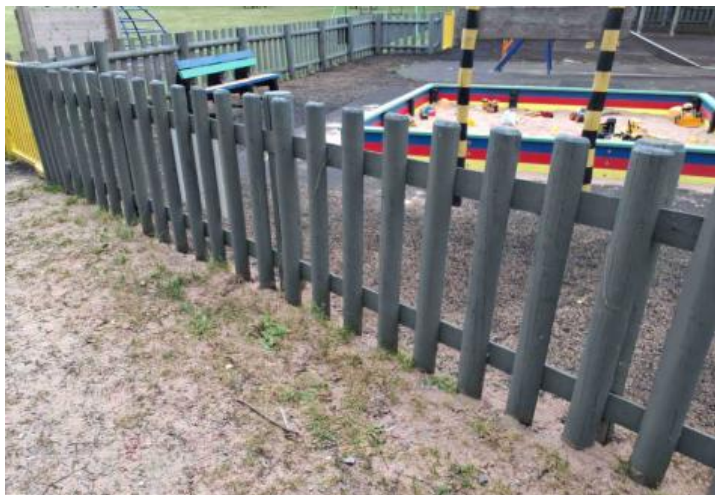
**Risk Level:** L - Low Risk  
**Surface:** Bonded Rubber Mulch

**Finding:** There is some evidence of rot in the timber

**Action:** Monitor for any further deterioration and replace as required

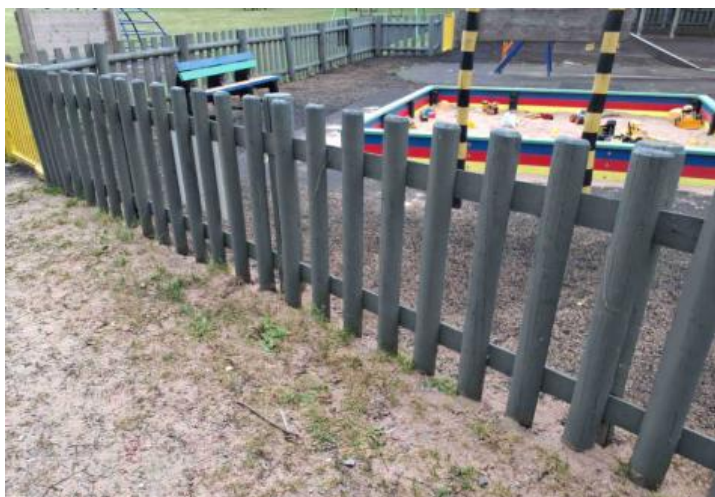
**Risk Level:** L - Low Risk  
**Surface:** Bonded Rubber Mulch

**Finding:** There are areas or parts of the timber on the structure that have rotted

**Action:** Replace all affected timbers

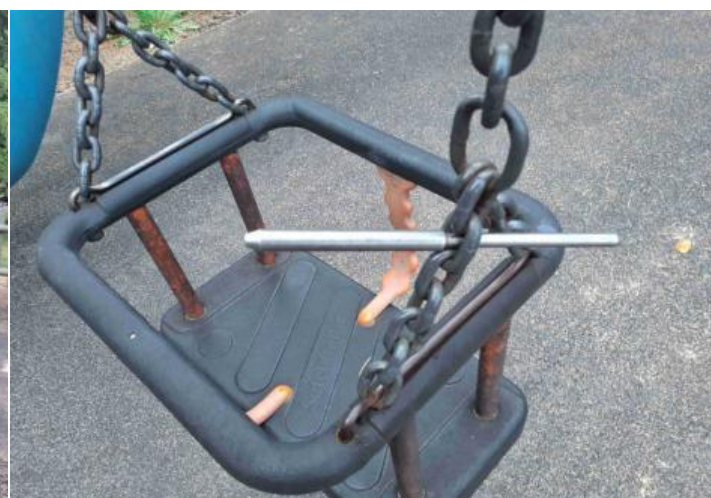
**Risk Level:** V - Very Low Risk  
**Surface:** Bonded Rubber Mulch

**Finding:** The chain openings are in excess of the 8.6mm as recommended by BS EN 1176

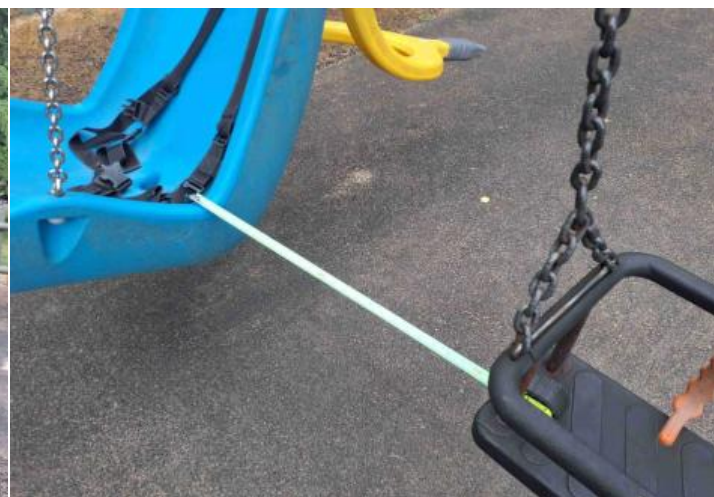
**Risk Level:** L - Low Risk  
**Surface:** Bonded Rubber Mulch

**Finding:** The seats are too close to each other as defined in BS EN 1176 Part 2; this is a low risk failure and no remedial action is required

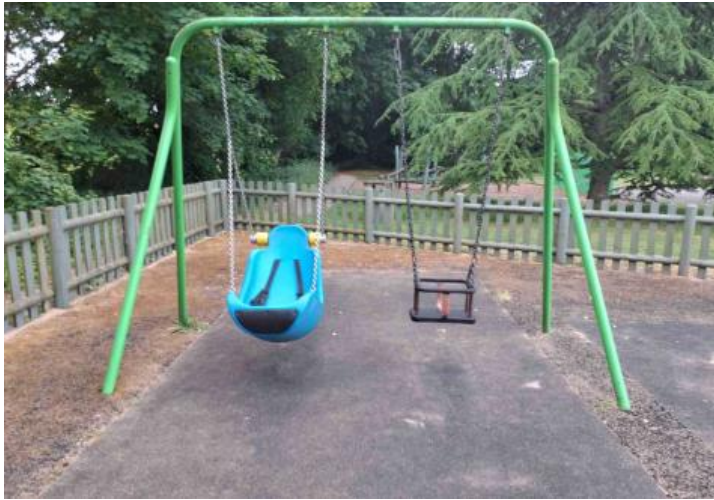
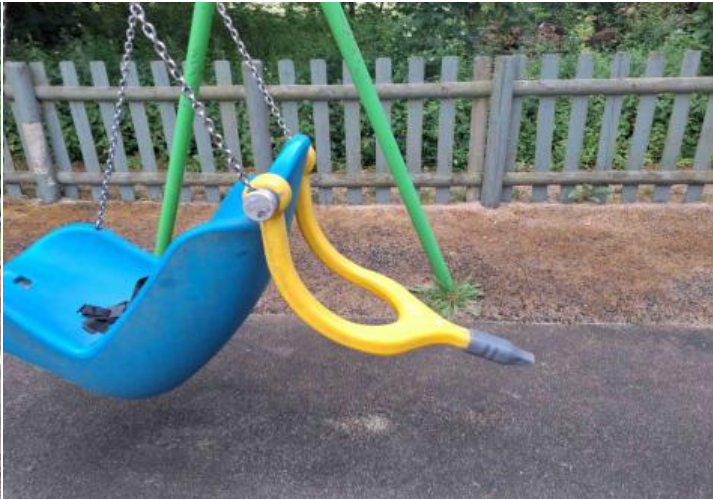
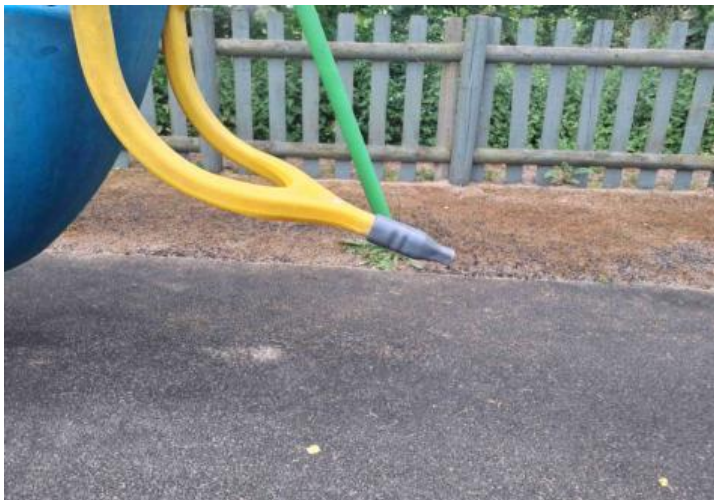
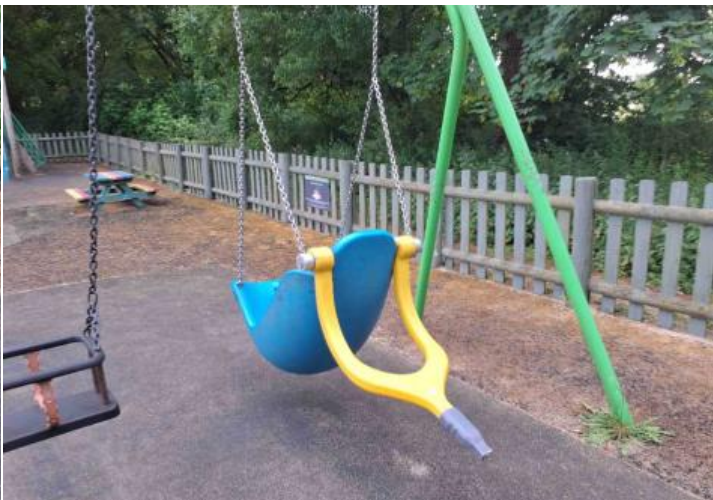
| <b>Finding:</b> The shoulder harness can extend fully to the rear while in use and the chain or bar stop to prevent this may be missing | | <b>Action:</b> Refer to manufacturer's for correct installation | |

**i** 10 - Low Risk (Finding 6)

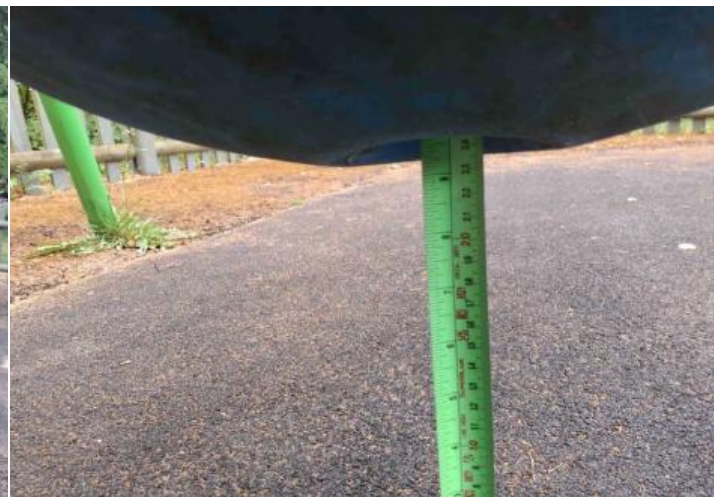
**Risk Level:** L - Low Risk  
**Surface:** Bonded Rubber Mulch

**Finding:** The seat clearance from finished surface level to the underside of the seat is too low and does not meet the requirements of BS EN 1176 Part 2 (350mm minimum clearance required)

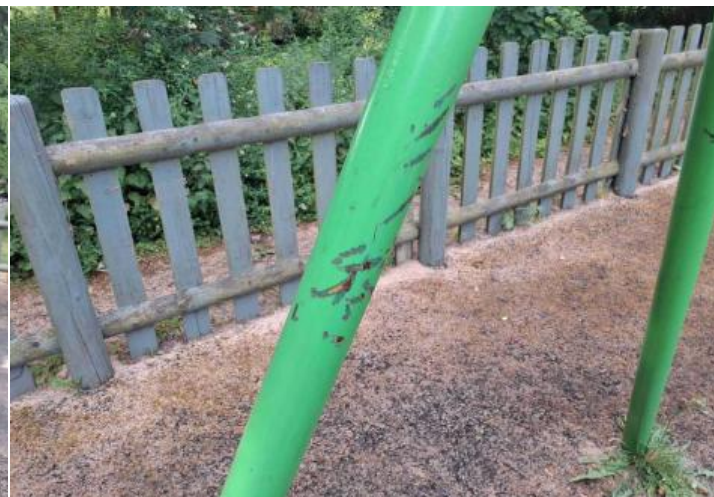
**Risk Level:** L - Low Risk  
**Surface:** Bonded Rubber Mulch

**Finding:** The paintwork on this item has been damaged or worn exposing the metal underneath which is rusting / corroding

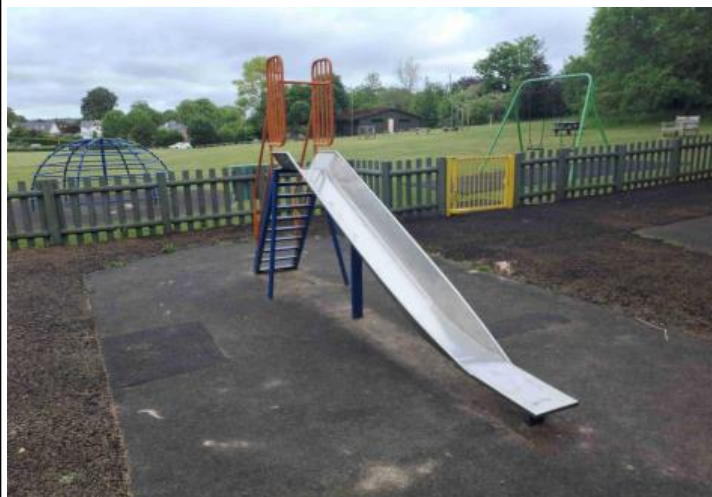
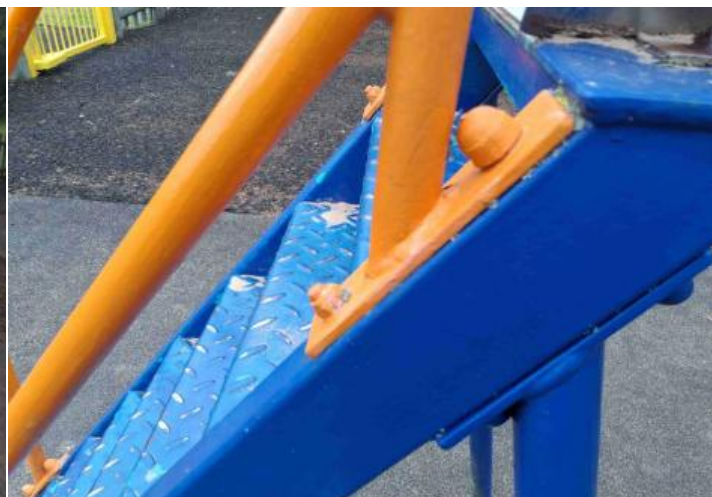
**Risk Level:** V - Very Low Risk  
**Surface:** Bonded Rubber Mulch

**Finding:** Bolt cap cover/s missing or damaged

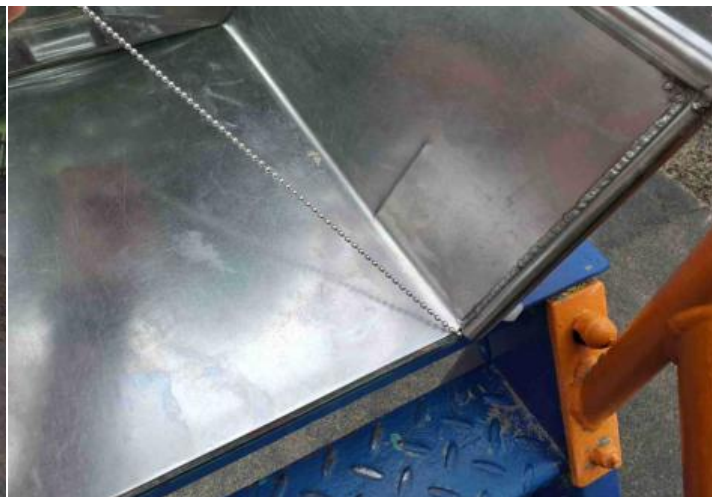
**Risk Level:** V - Very Low Risk  
**Surface:** Bonded Rubber Mulch

**Finding:** There is / are toggle entrapment/s present in contravention of the recommendations set out in BS EN 1176 Part 1

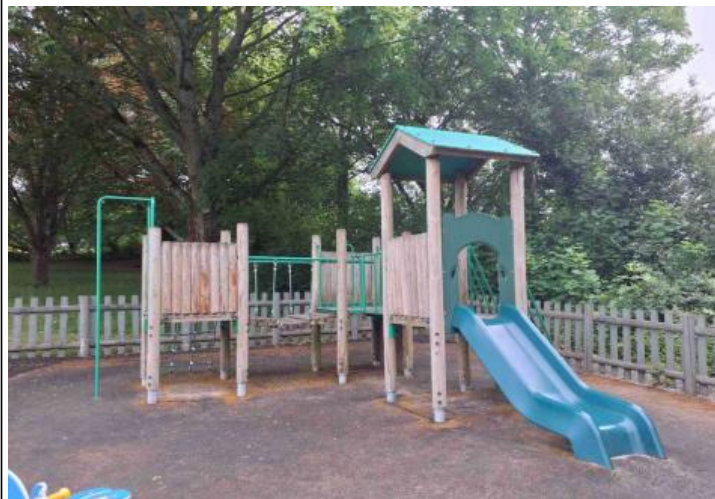
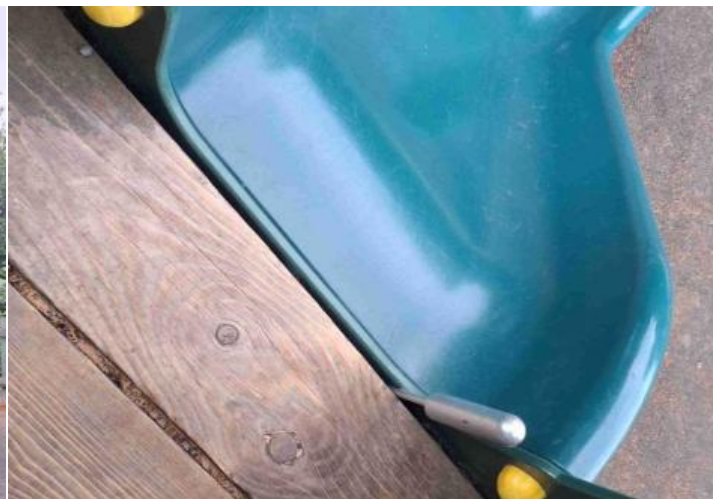
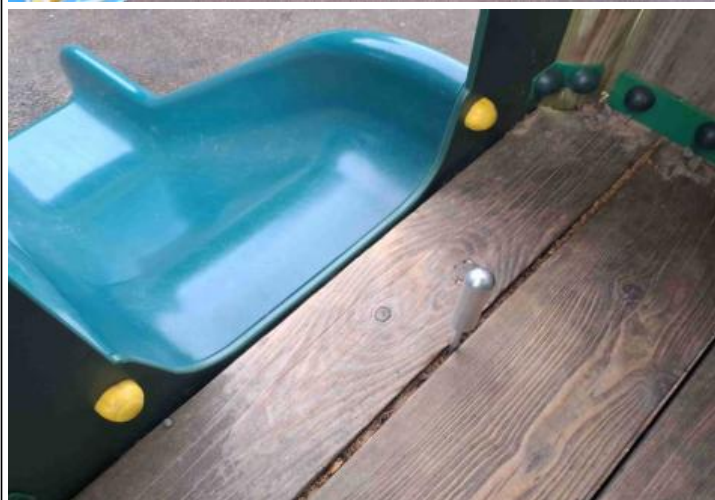
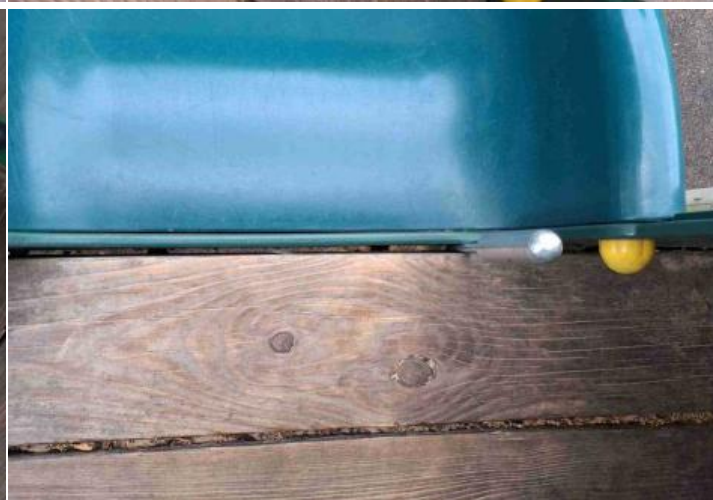
**Risk Level:** L - Low Risk  
**Surface:** Bonded Rubber Mulch

**Finding:** There is/are finger entrapment/s in the slide starting section and the item fails to meet the requirements of BS EN 1176 Part 1 4.2.7.6 Entrapment of fingers

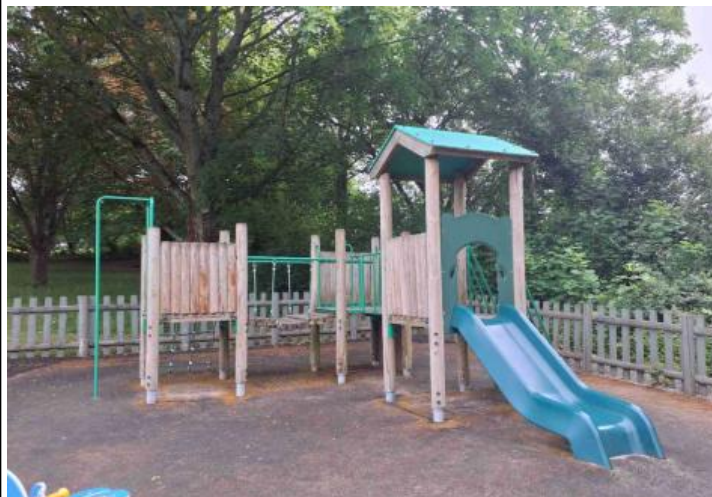
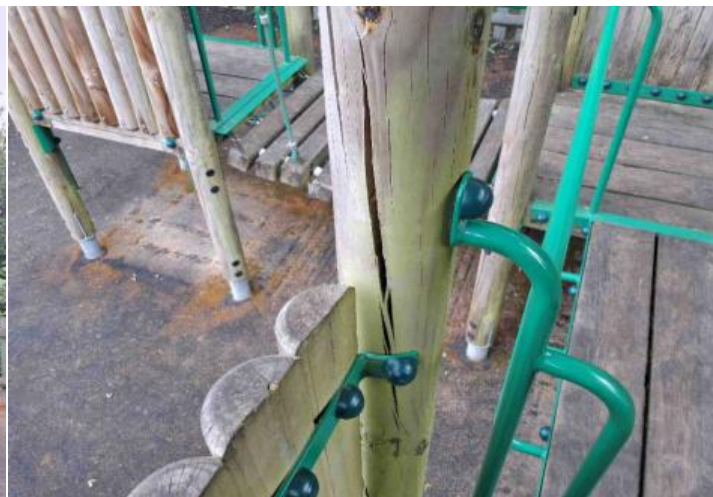
**Risk Level:** L - Low Risk  
**Surface:** Bonded Rubber Mulch

**Finding:** The timber has a number of splits/shakes or air cracks and this may affect the stability or allow water ingress which will accelerate the rotting process. Timber splits may also create rough / splintering edges.

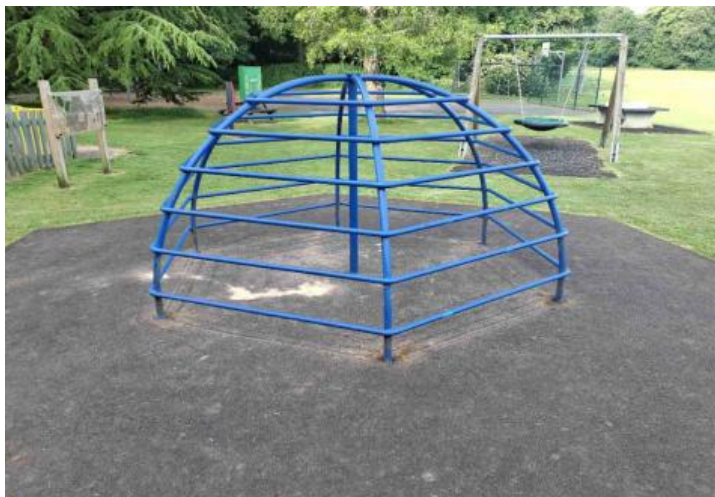
**Risk Level:** L - Low Risk  
**Surface:** Wet Pour

**Finding:** There is some minor damage to the surface

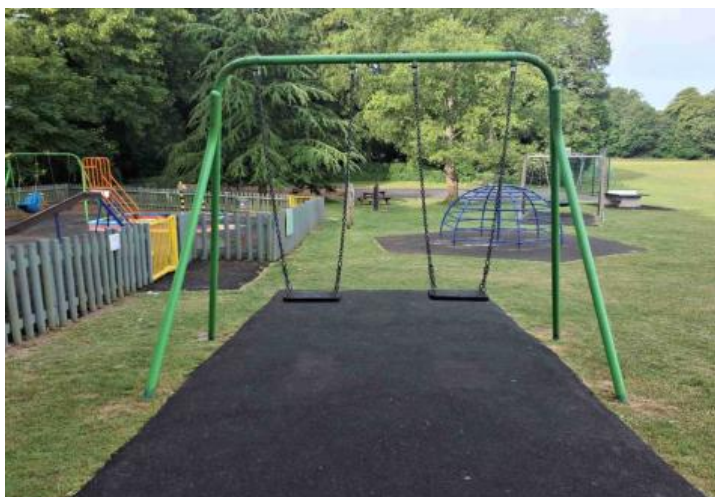
**Risk Level:** V - Very Low Risk  
**Surface:** Wet Pour

**Finding:** The chain openings are in excess of the 8.6mm as recommended by BS EN 1176

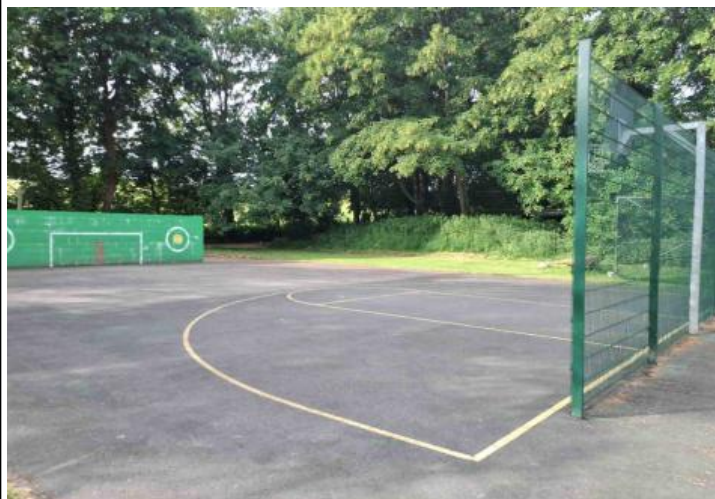
**Finding:** A clearly visible facility sign should be provided in a prominent position with the wording as detailed BS EN 15312 - the equipment is not intended for children less than 3 years old - the warning - Do not climb on the framework or nets - the warning - Do not hang on the ring (if provided) - the warning - Do not wear rings or other jewellery - name and telephone number of the administrator - number to call in case of accident

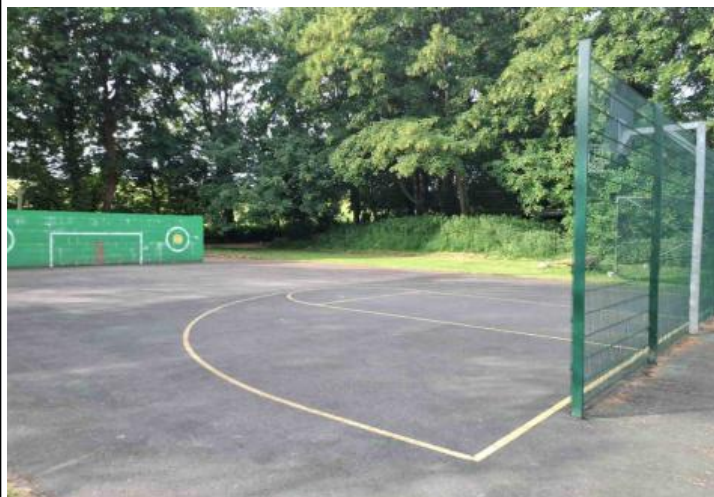
**Finding:** There is/are finger entrapments in the mesh and the item fails to meet the requirements of BS EN 15312 Clause 4.4.2.2 Entrapment of fingers

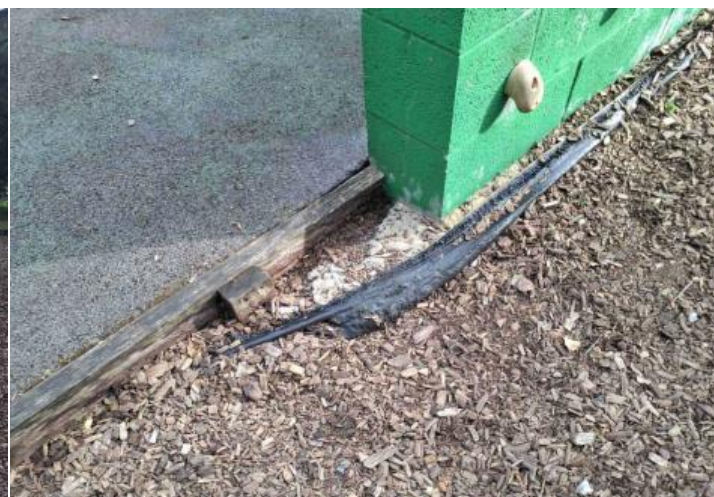
**Risk Level:** L - Low Risk  
**Surface:** Woodchip

**Finding:** The surface has eroded and the foundations are exposed

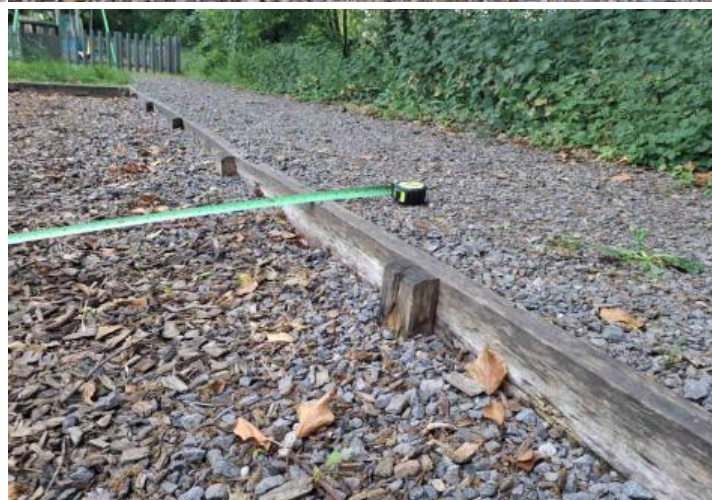
**Risk Level:** L - Low Risk  
**Surface:** Woodchip

**Finding:** The timber edging forms a projecting obstacle / hard object within the falling space of the equipment, in contravention of the requirements of BS EN 1176 Part 1

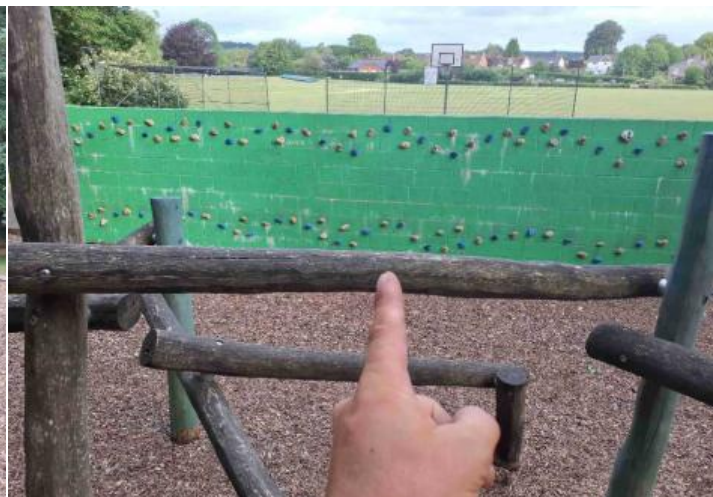
**Risk Level:** L - Low Risk  
**Surface:** Woodchip

**Finding:** A number of fixing(s) have worked loose

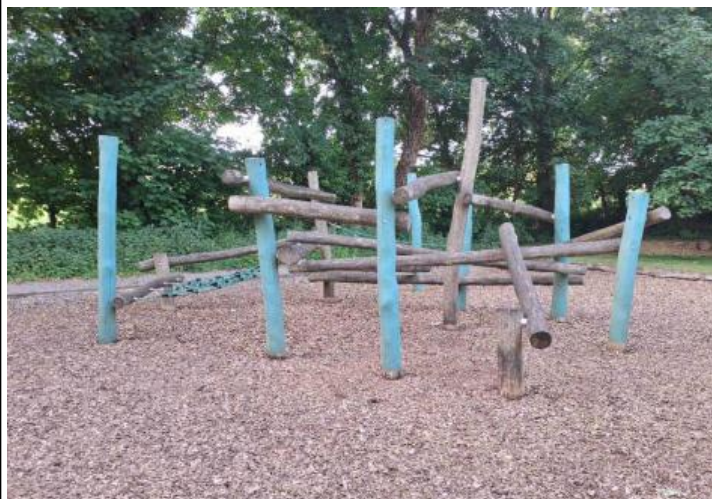
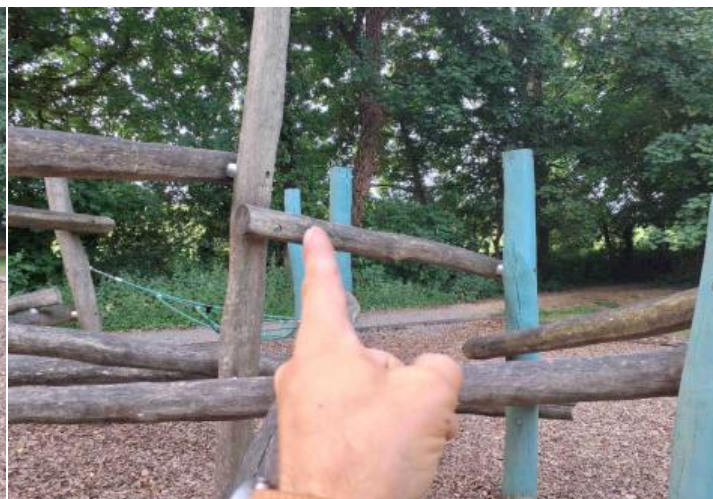
**Risk Level:** L - Low Risk  
**Surface:** Woodchip

**Finding:** A number of fixing(s) have worked loose

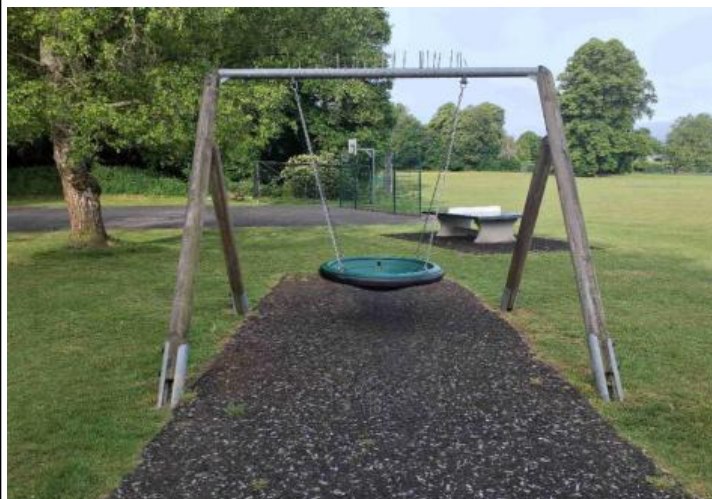
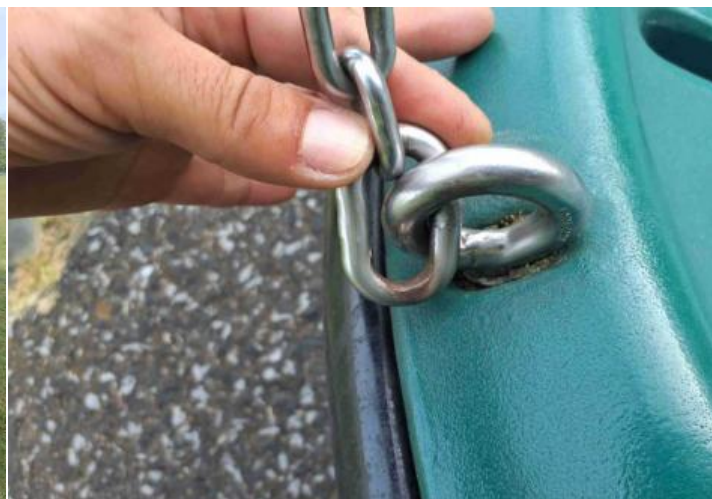
**Risk Level:** L - Low Risk  
**Surface:** Bonded Rubber Mulch

**Finding:** There is some notable evidence of chain wear

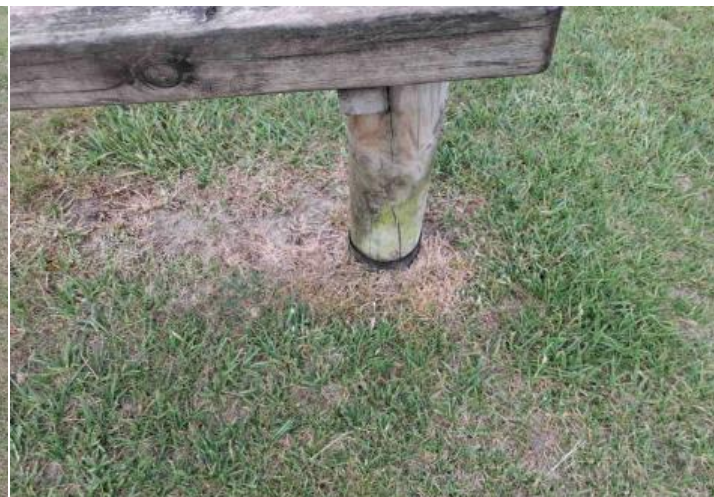
**Item:** Outdoor Fitness Equipment - Sit Up Station **Risk Level:** L - Low Risk  
**Manufacturer:** Not Identified **Surface:** Grass

**Finding:** The item is slightly loose in its foundations

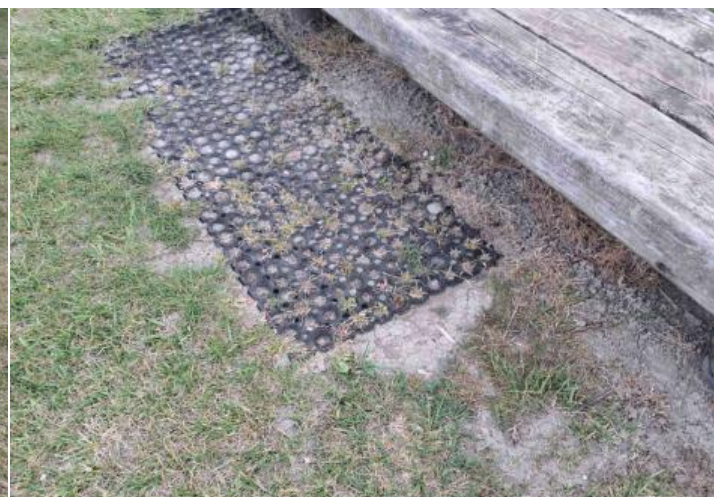
**Item:** Outdoor Fitness Equipment - Ability Bench **Risk Level:** L - Low Risk  
**Manufacturer:** Not Identified **Surface:** Mixed Surface

**Finding:** The edges of the grass mat surface are raised / lifting above the surrounding surface

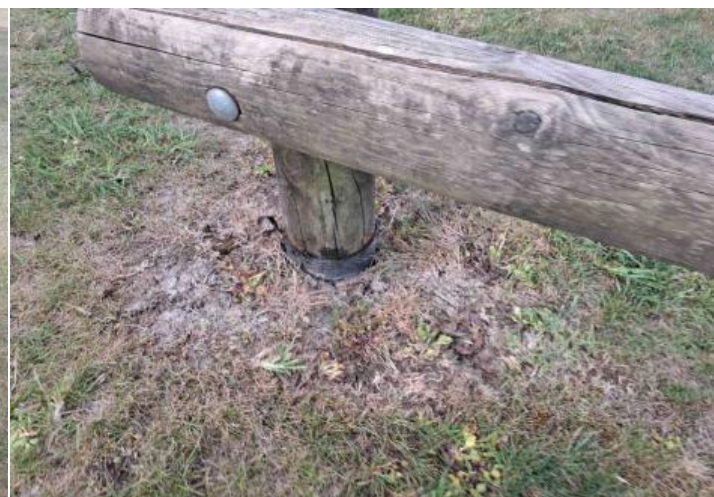
**Item:** Outdoor Fitness Equipment - Hurdles  
**Manufacturer:** Not Identified  
**Risk Level:** N - Risk Assessment not Undertaken  
**Surface:** Grass

**Finding:** There are post protectors around the timber posts that are preventing the inspector from thoroughly testing for signs of decay and we are unable to verify the condition of the posts in these locations. NOTE - timber rot / decay is possible even with the post protectors in place

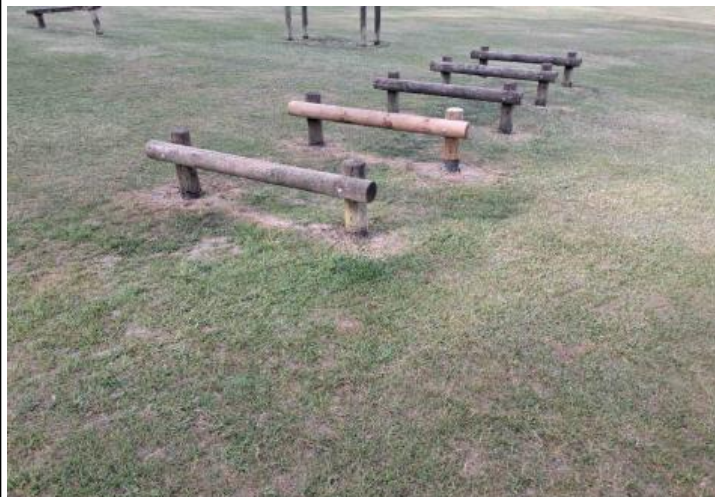
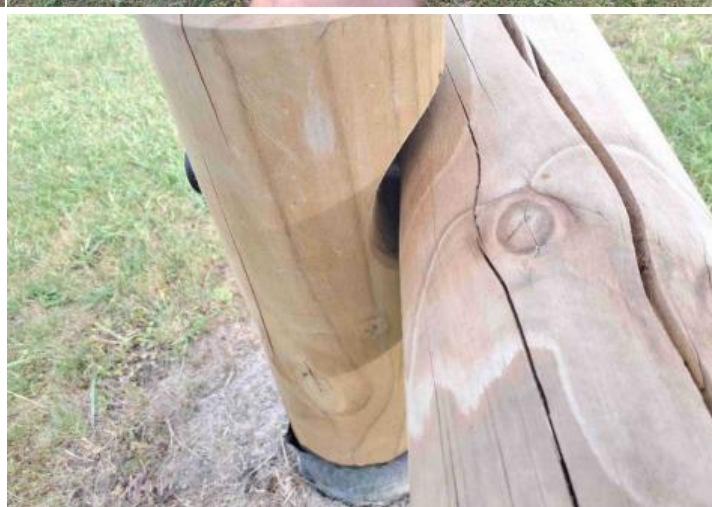
**Risk Level:** L - Low Risk  
**Surface:** Grass

**Finding:** A number of fixing(s) have worked loose

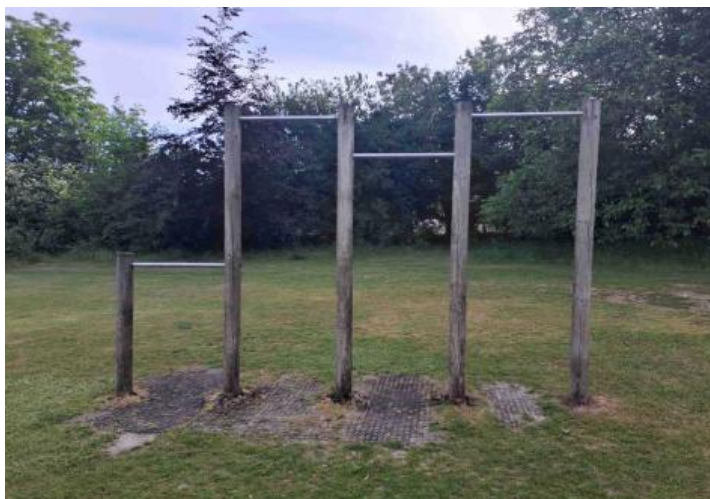
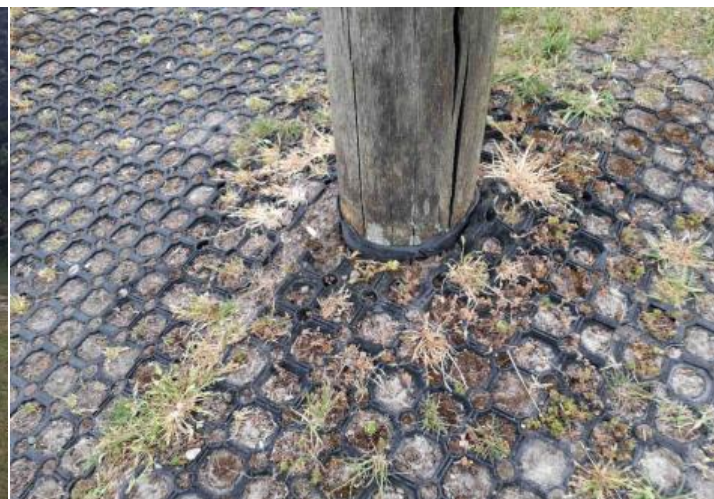
**Finding:** There are post protectors around the timber posts that are preventing the inspector from thoroughly testing for signs of decay and we are unable to verify the condition of the posts in these locations. NOTE - timber rot / decay is possible even with the post protectors in place

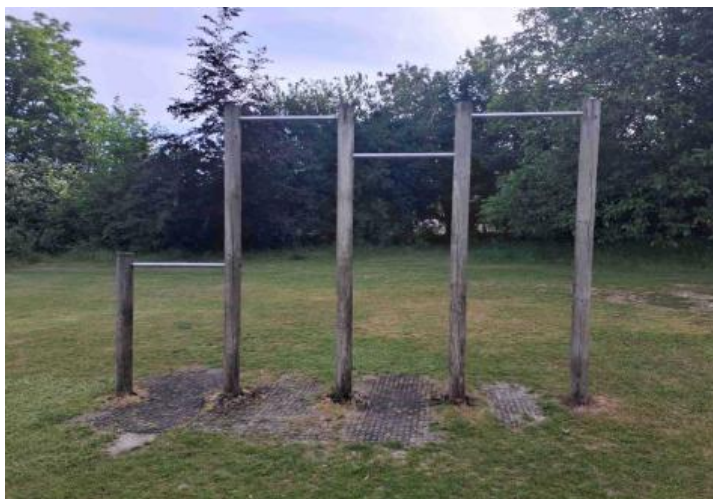
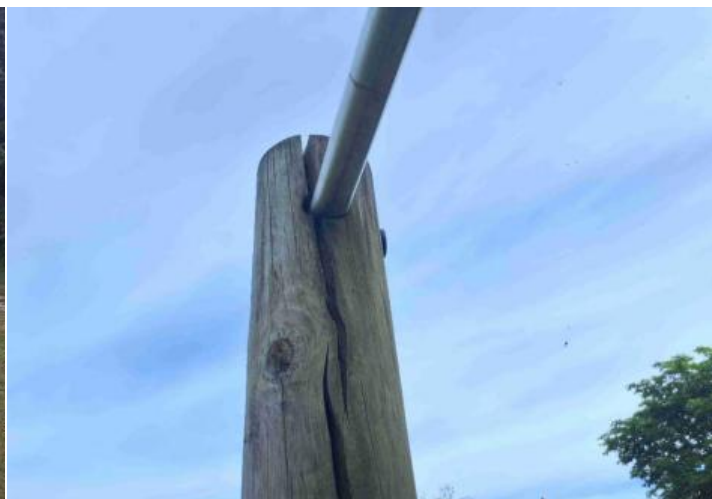
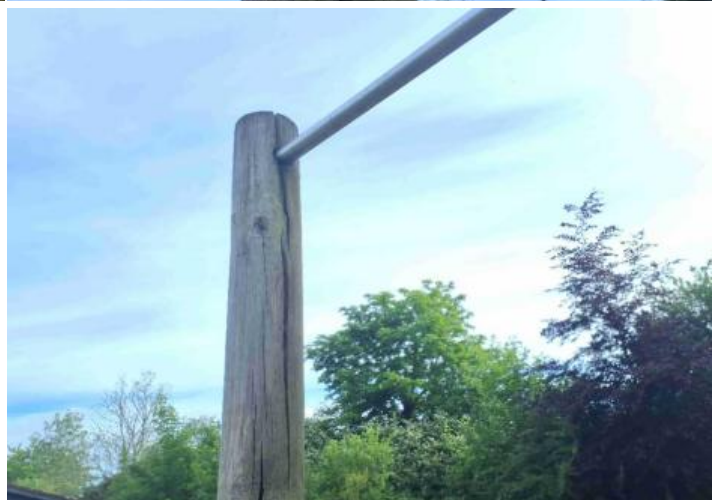
**Finding:** The timber has a number of splits/shakes or air cracks and this may affect the stability or allow water ingress which will accelerate the rotting process. Timber splits may also create rough / splintering edges.

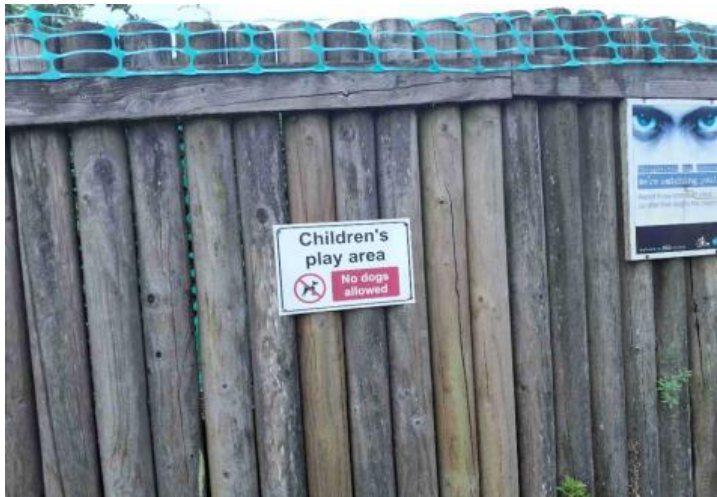
| 5 - Very Low Risk (Finding 1) | | | |
|---|---|---|---|
| <b>Finding:</b> It is recommended that signage, with information including the site address, contact information for maintenance issues and emergency contact details are provided for the facility | | <b>Action:</b> Provide in accordance with the recommendations | |

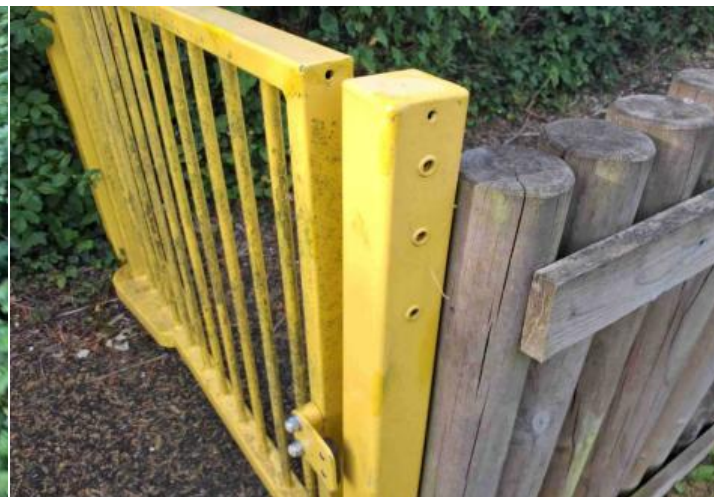
**Risk Level:** V - Very Low Risk  
**Surface:** Bonded Rubber Mulch

**Finding:** Insert/s missing or damaged
