I hereby summon you to attend a meeting of the **RECREATION COMMITTEE** on Thursday 10th September 2026 at 7:30 PM, to be held at The Pavilion, Hunter Park, SO21 1QS

**To Receive** the Visual Tree Assessment conducted in May 2026 and **consider** the recommendations.

The Visual Tree Assessment (VTA) was carried out in July 2026 to assess the condition and safety of trees at Northfields and Hunter Park.

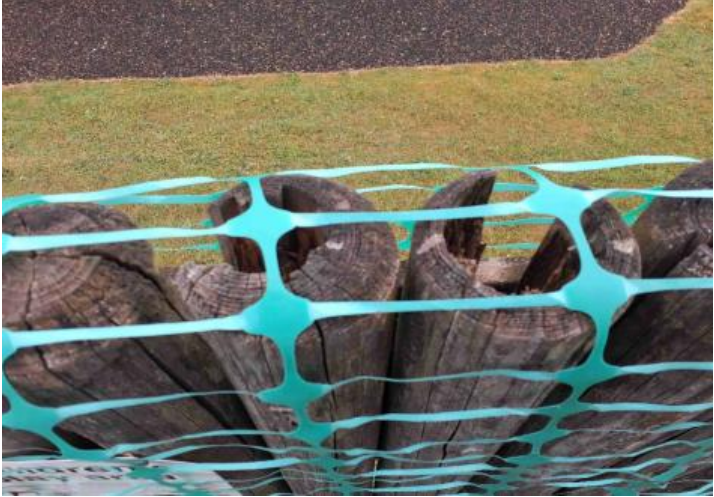
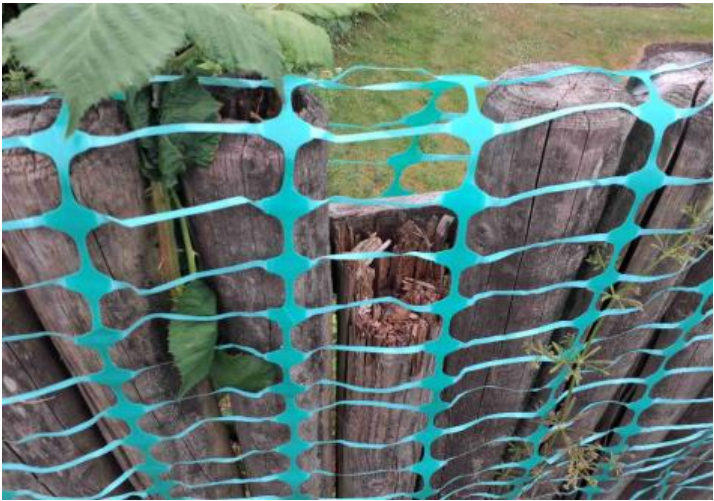
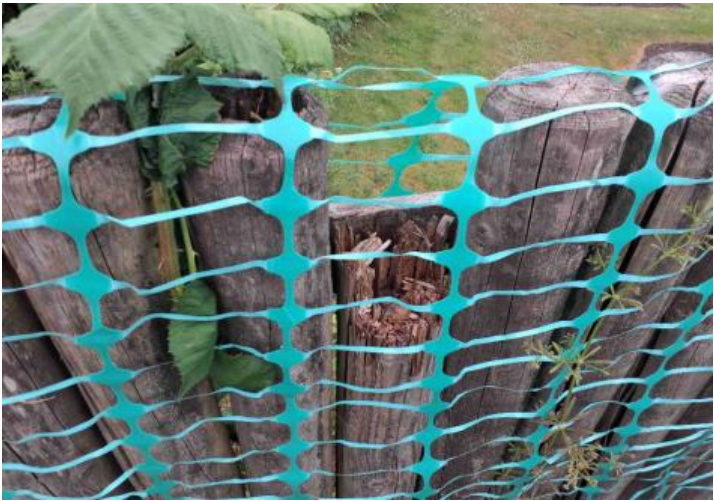
| <div> <div></div> <div>8 - Low Risk (Finding 1)</div> </div> | | | |
|---|--|---|--|
| <div> <div>Finding:</div> <div>There are areas or parts of the timber on the structure that have rotted</div> </div> | | <div> <div>Action:</div> <div>Replace all affected timbers</div> </div> | |

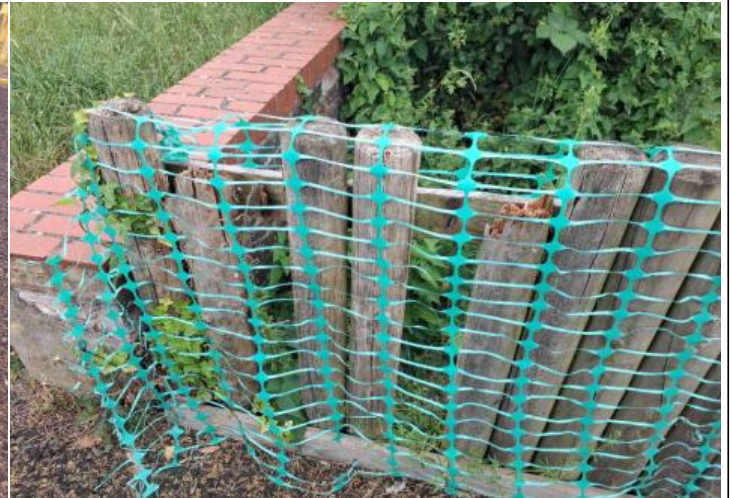
**Risk Level:** L - Low Risk  
**Surface:** Bonded Rubber Mulch

**Finding:** The fence is severely damaged in places

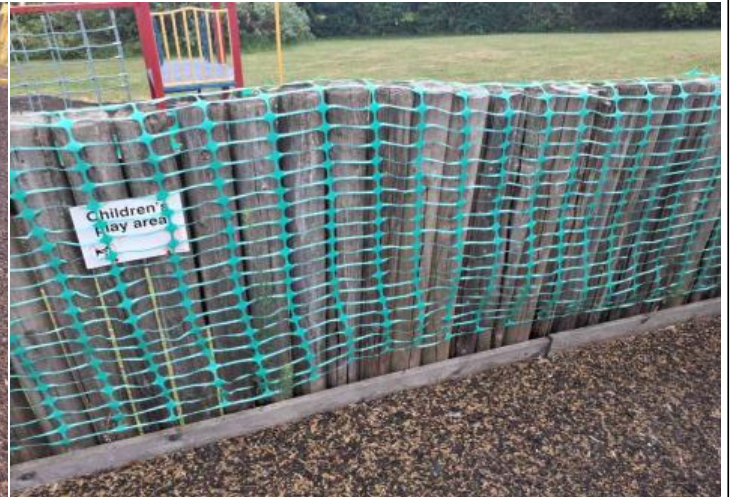
**Risk Level:** L - Low Risk  
**Surface:** Bonded Rubber Mulch

**Finding:** There are a number of loose posts around the fence

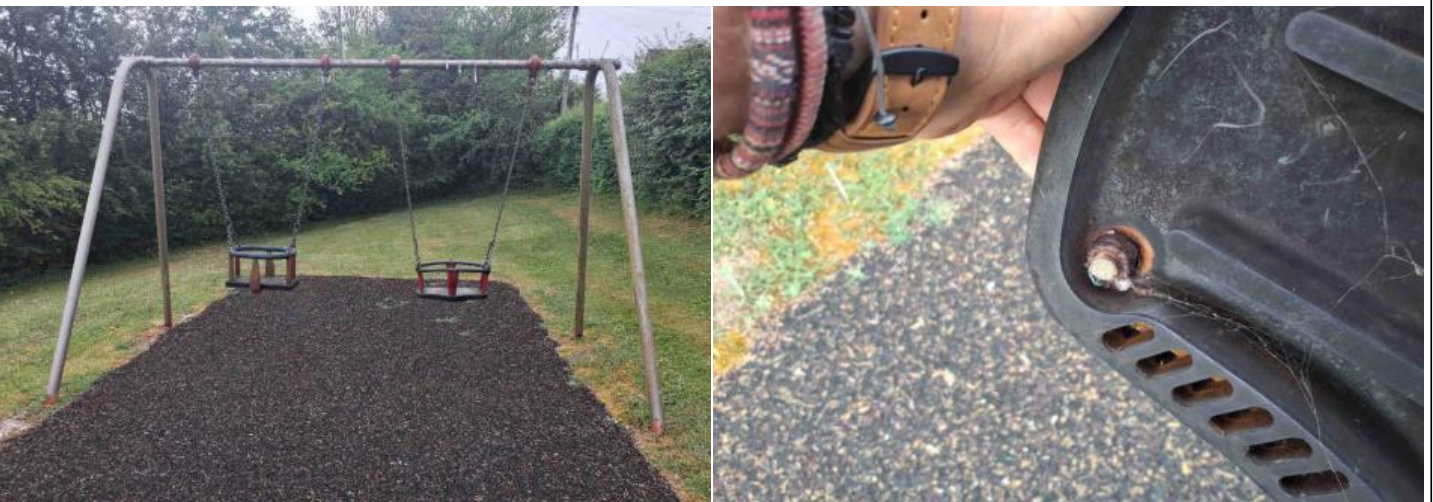
| <b>Finding:</b> | The fixings have corroded excessively | <b>Action:</b> | Replace all corroded fixings |

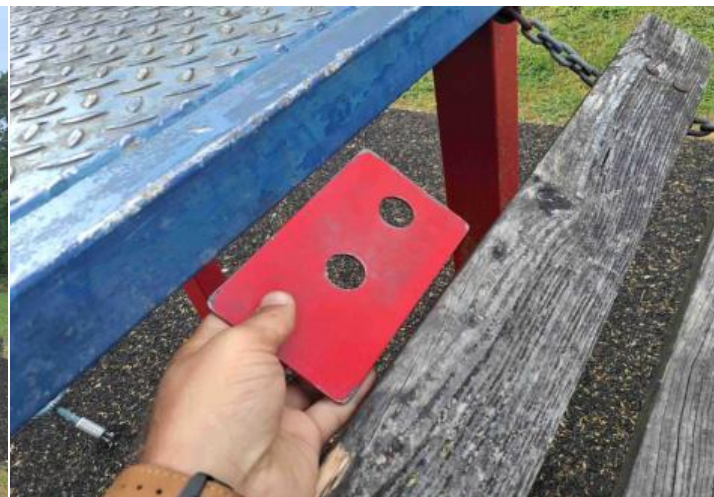
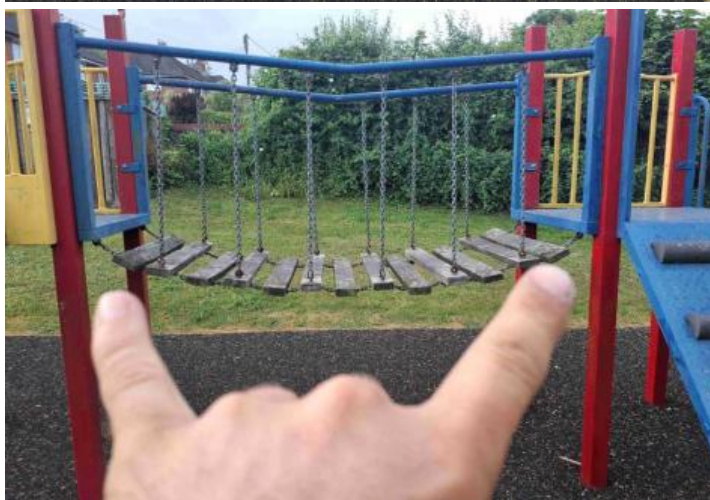
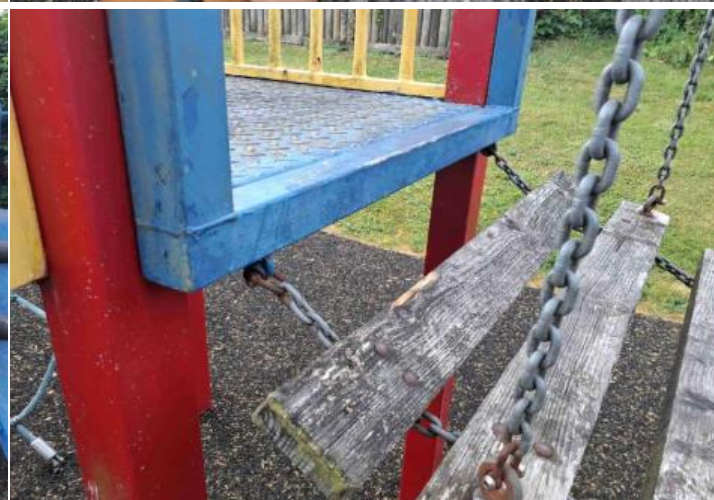
**Risk Level:** L - Low Risk  
**Surface:** Bonded Rubber Mulch

**Finding:** The item fails to meet the requirements of BS EN 1176 Part 1 4.2.7.2 for head and neck entrapment in the bridge

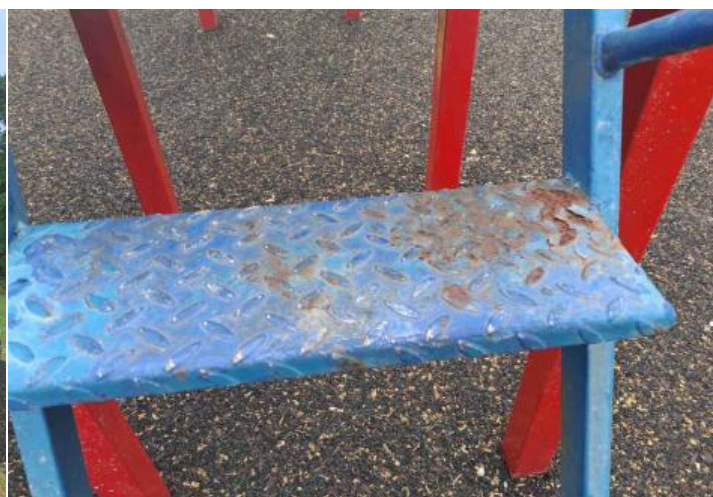
**Risk Level:** L - Low Risk  
**Surface:** Bonded Rubber Mulch

**Finding:** The paintwork on this item has been damaged or worn exposing the metal underneath which is rusting / corroding

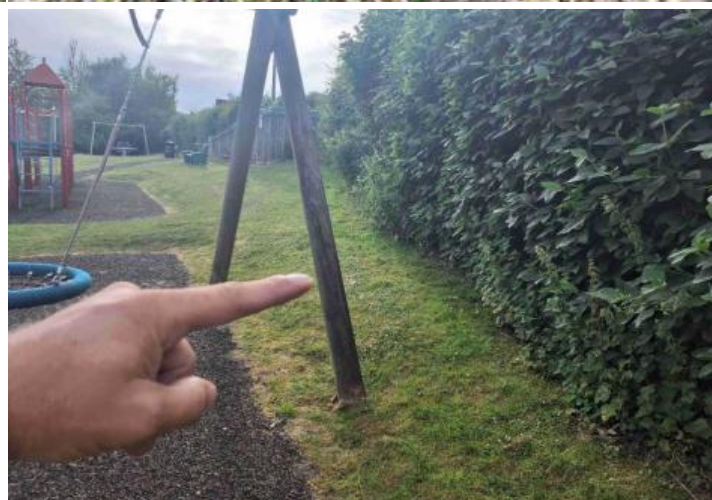
**Risk Level:** L - Low Risk  
**Surface:** Bonded Rubber Mulch

**Finding:** There are areas or parts of the timber on the structure that have rotted

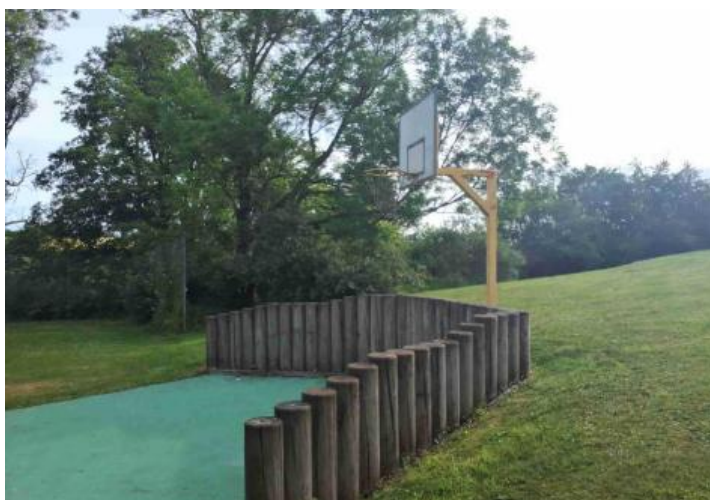
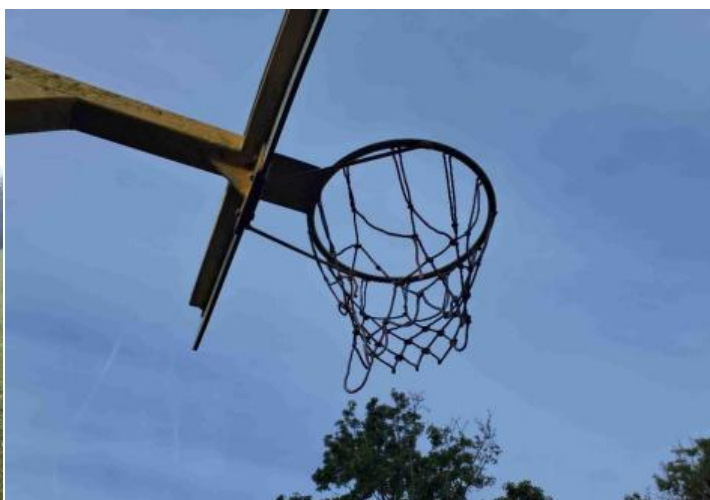
**Risk Level:** L - Low Risk  
**Surface:** Wet Pour

**Finding:** The net has some minor damage

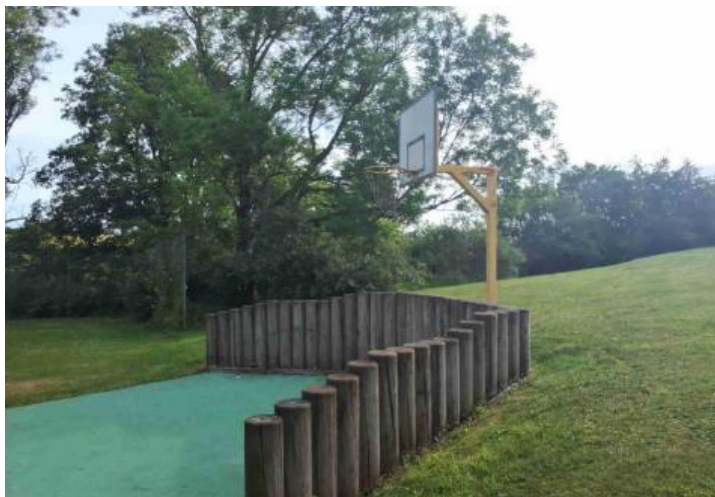
**Risk Level:** L - Low Risk  
**Surface:** Wet Pour

**Finding:** The item is slightly loose in its foundations

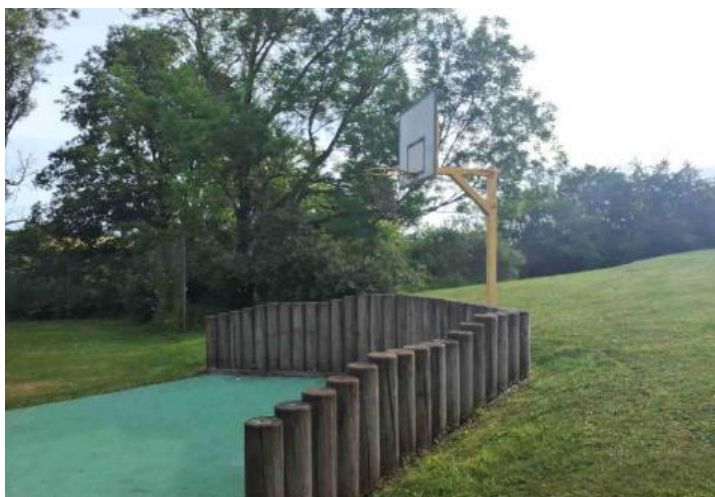
**Risk Level:** L - Low Risk  
**Surface:** Wet Pour

**Finding:** The paintwork on this item has been damaged or worn exposing the metal underneath which is rusting / corroding
