I hereby summon you to attend a meeting of the **RECREATION COMMITTEE** on Thursday 11th September 2025 at 7:30 PM, to be held at The Pavilion, Hunter Park, SO21 1QS

10 Play Inspection Reports

To Receive the Annual Play Inspection report for Hunter Park.

Recreation Committee 13th September 2025

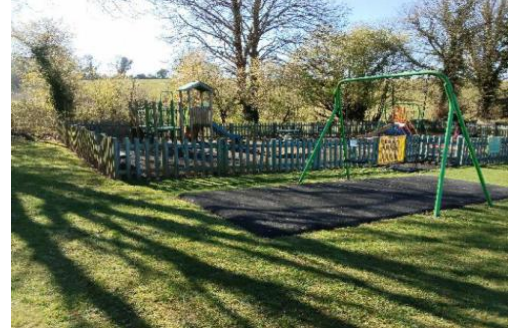
Item: Site General
Manufacturer: Owner/Operator
Surface Type: N/A
Item Quantity: 1
Equipment Compliance: N/A
Surface Area Compliance: N/A

Sand is migrating into the surrounding play area - Clean and maintain area

There is moderate damage to the surface - Repair the damaged areas of surfacing

There is algae, silt or moss growth on the surface resulting in slippery conditions - Clean and treat appropriately

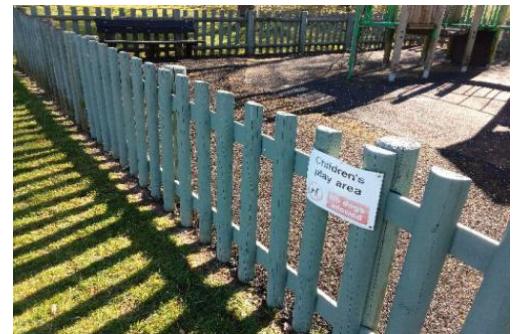
Item: Fencing - Timber
Manufacturer: Not Identified
Surface Type: Bonded Rubber Mulch
Item Quantity: 1
Equipment Compliance: N/A
Surface Area Compliance: N/A

The timber has a number of splits/shakes or air cracks and this may affect the stability or allow water ingress which will accelerate the rotting process - Monitor to ensure the splits do not cross through fixing points of the structure and/or cause any instability

There is some evidence of rot in the timber - Monitor for any further deterioration and replace as required

There are areas or parts of the timber on the structure that have rotted - Replace all affected timbers

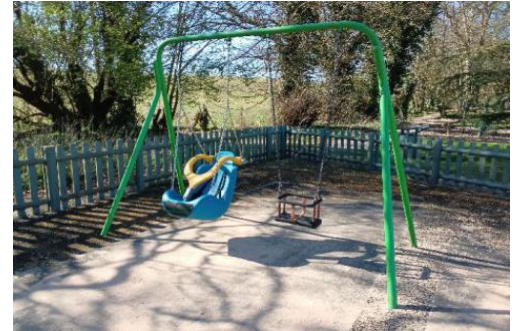
Item: 1 Bay 2 Seat Swing
Manufacturer: Not Identified
Surface Type: Bonded Rubber Mulch
Item Quantity: 1
Equipment Compliance: No
Surface Area Compliance: Yes

The chain openings are in excess of the 8.6mm as recommended by BS EN 1176 - Monitor - No action given the risk assessment

The seats are too close to each other as defined in BS EN 1176 Part 2; this is a low risk failure and no remedial action is required - Monitor - No action given the risk assessment

The seat has minor damage or wear - Monitor for any further deterioration and replace as required

There is some wear to the shackles. - Monitor for any further deterioration and replace when 40% worn

The connecting links are in excess of 8.6mm and less than 12mm and fail the requirements of BS EN 1176 Part 1; clause 4.2.13, Chains - Monitor - No action given the risk assessment

The seat clearance from finished surface level to the underside of the seat is too low and does not meet the requirements of BS EN 1176 Part 2 (350mm minimum clearance required) - Adjust seat height/s (400mm-500mm is recommended)

There is some notable evidence of chain wear - Monitor for any further deterioration and replace when 40% worn

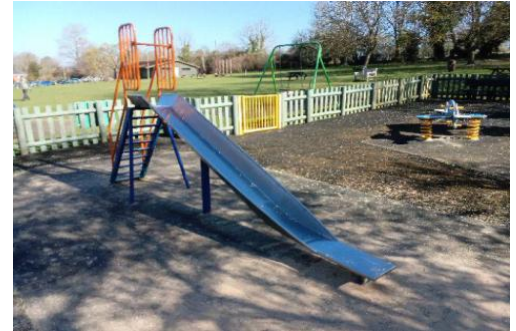
Item: Free Standing Slide
Manufacturer: Not Identified
Surface Type: Bonded Rubber Mulch
Item Quantity: 1
Equipment Compliance: Yes
Surface Area Compliance: Yes

The fixings have corroded excessively - Replace all corroded fixings

There is/are bolt cap covers missing or damaged on the item - Replace missing or damaged bolt cap covers

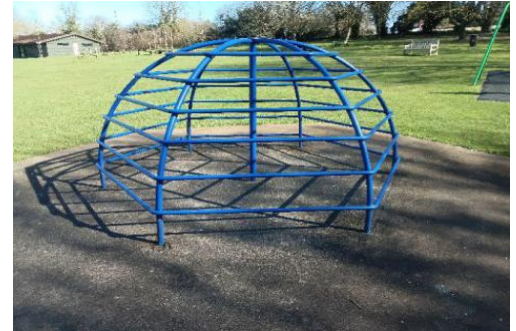
Item: Climbing Frame
Manufacturer: Not Identified
Surface Type: Wet Pour
Item Quantity: 1
Equipment Compliance: Yes
Surface Area Compliance: Yes

There is some damage to the surface - Monitor for any further deterioration and repair as required

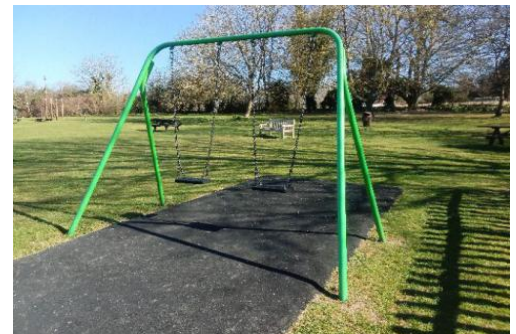
Item: 1 Bay 2 Seat (Flat)
Manufacturer: Not Identified
Surface Type: Wet Pour
Item Quantity: 1
Equipment Compliance: Yes
Surface Area Compliance: Yes

The bush / bushes is / are showing signs of wear - Monitor for any further deterioration and replace as required

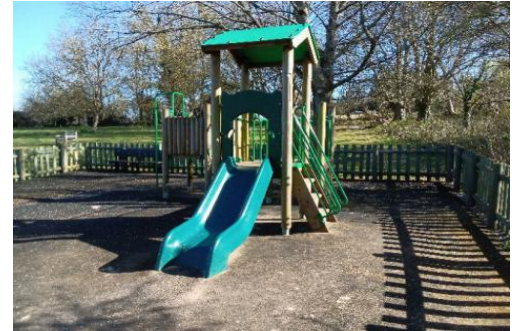
Item: Multi Play (Junior)
Manufacturer: A.E.Evans
Surface Type: Bonded Rubber Mulch
Item Quantity: 1
Equipment Compliance: No
Surface Area Compliance: Yes

There is/are finger entrapment/s adjacent to the slide and the item fails to meet the requirements of BS EN 1176 Part 1 4.2.7.6 Entrapment of fingers - Monitor - No action given the risk assessment

The bush / bushes is / are worn or missing - Replace worn or missing bushes

The timber has a number of splits/shakes or air cracks and this may affect the stability or allow water ingress which will accelerate the rotting process - Monitor to ensure the splits do not cross through fixing points of the structure and/or cause any instability

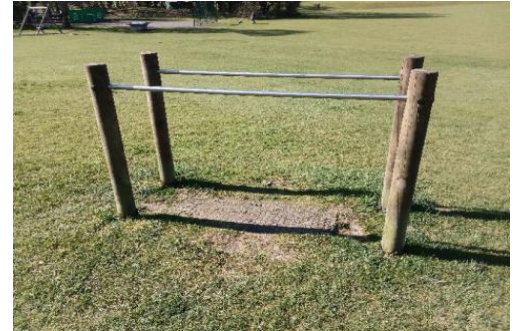
Item: Parallel Bars
Manufacturer: Not Identified
Surface Type: Grass Matrix Tiles
Item Quantity: 1
Equipment Compliance: Yes
Surface Area Compliance: Yes

The handrails are loose - Secure

The timber has a number of splits/shakes or air cracks and this may affect the stability or allow water ingress which will accelerate the rotting process - Monitor to ensure the splits do not cross through fixing points of the structure and/or cause any instability

There is some evidence of rot in the posts - Monitor for any further deterioration and replace as required

The surface is lifting at the edges and creating trip points - Repair perimeter of surfacing to remove trip points

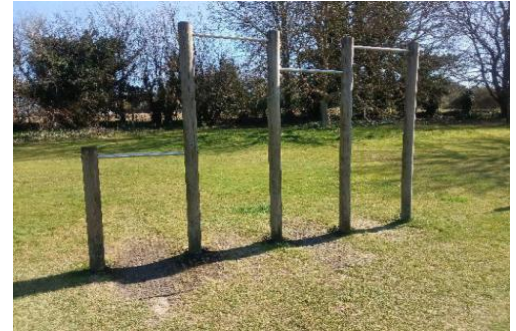
Item: Pull Up Station
Manufacturer: Not Identified
Surface Type: Grass Matrix Tiles
Item Quantity: 1
Equipment Compliance: Yes
Surface Area Compliance: Yes

The surface is lifting at the edges and creating trip points - Repair perimeter of surfacing to remove trip points

The handrails are working loose - Secure

There is some strimmer / machinery damage apparent on the posts, this can penetrate the preservative applied to the timber and accelerate the rotting process - Monitor for any deterioration (rot) and replace as required

The timber has a number of splits/shakes or air cracks and this may affect the stability or allow water ingress which will accelerate the rotting process - Monitor to ensure the splits do not cross through fixing points of the structure and/or cause any instability

There is some evidence of rot in the posts - Monitor for any further deterioration and replace as required

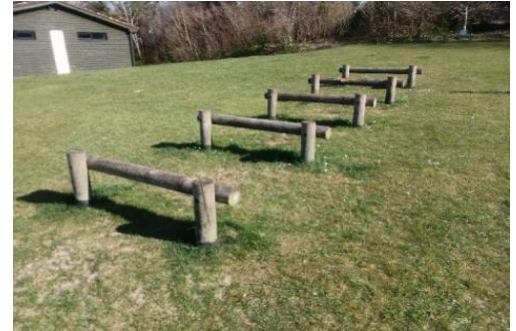
Item: Hurdles
Manufacturer: Not Identified
Surface Type: Grass
Item Quantity: 1
Equipment Compliance: Yes
Surface Area Compliance: Yes

There is/are bolt cap covers missing or damaged on the item - Replace missing or damaged bolt cap covers

The timber has a number of splits/shakes or air cracks and this may affect the stability or allow water ingress which will accelerate the rotting process - Monitor to ensure the splits do not cross through fixing points of the structure and/or cause any instability

There is some strimmer / machinery damage apparent on the posts, this can penetrate the preservative applied to the timber and accelerate the rotting process - Monitor for any deterioration (rot) and replace as required

There are areas or parts of the timber on the structure that have rotted - Replace all affected timbers

There is some evidence of rot in the timber - Monitor for any further deterioration and replace as required

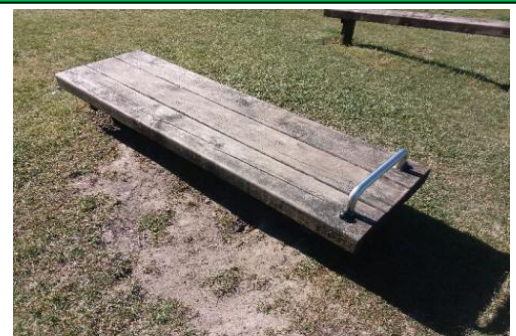
Item: Ability Bench
Manufacturer: Not Identified
Surface Type: Mixed Surface
Item Quantity: 1
Equipment Compliance: Yes
Surface Area Compliance: Yes

The surface has eroded in some areas and may be slippery in wet conditions - Reinstate the surface

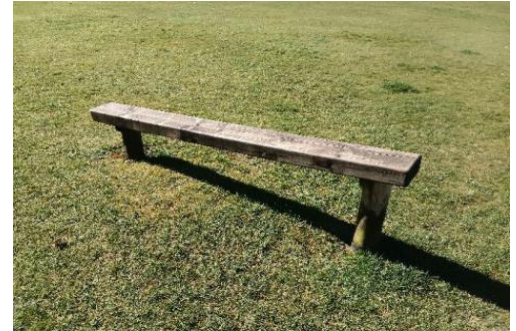
Item: Sit Up Station
Manufacturer: Not Identified
Surface Type: Grass
Item Quantity: 1
Equipment Compliance: Yes
Surface Area Compliance: Yes

There is some strimmer / machinery damage apparent on the posts, this can penetrate the preservative applied to the timber and accelerate the rotting process - Monitor for any deterioration (rot) and replace as required

There is some evidence of rot in the timber - Monitor for any further deterioration and replace as required

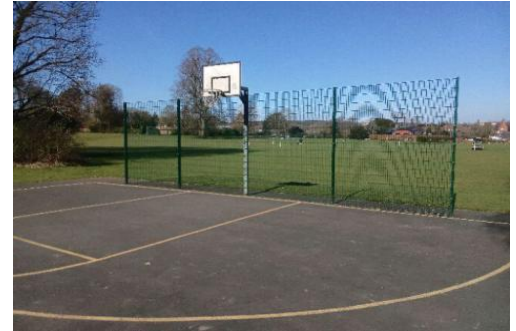
Item: Multi Use Games Area (MUGA)
Manufacturer: Not Identified
Surface Type: Bitmac
Item Quantity: 1
Equipment Compliance: No
Surface Area Compliance: N/A

A clearly visible facility sign should be provided in a prominent position with the wording as detailed BS EN 15312- the equipment is not intended for children less than 3 years old- the warning - Do not climb on the framework or nets- the warning - Do not hang on the ring (if provided)- the warning - Do not wear rings or other jewellery- name and telephone number of the administrator- number to call in case of accident - Provide signage to BS EN 15312

There is/are finger entrapments in the framework and the item fails to meet the requirements of BS EN 15312 Clause 4.4.2.2 Entrapment of fingers - Monitor - No action given the risk assessment

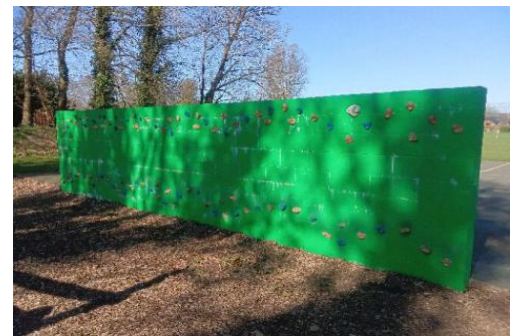
Item: Traverse Wall
Manufacturer: Not Identified
Surface Type: Woodchip
Item Quantity: 1
Equipment Compliance: Yes
Surface Area Compliance: Yes

The safety surface is low and the membrane is exposed creating trip points - Remove or resecure the exposed membrane and top up the surface to the correct level

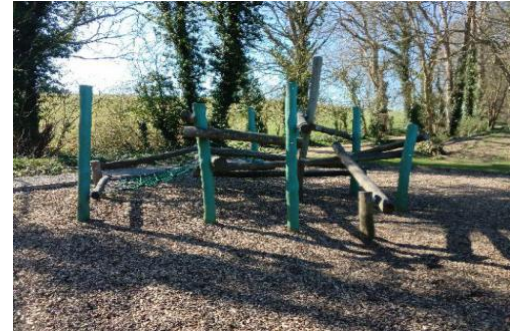
Item: Log Climber
Manufacturer: Dylan Group Ltd
Surface Type: Woodchip
Item Quantity: 1
Equipment Compliance: No
Surface Area Compliance: No

The depth of the loose fill surfacing is lower than the recommended depth specified in BS EN 1176; the free height of fall of the equipment is less than 2.0m and a minimum of 300mm depth should be provided (including an extra 100mm to allow for compaction and displacement as per BS EN 1176 Part 1 - Table 4) - Top up loose fill surfacing to recommended levels

There are falls in excess of 600mm between adjacent components on the structure, in contravention of the recommendations set out in BS EN 1176 Part 1; 4.2.8.4 - Monitor - No action given the risk assessment

There is some evidence of rot in the timber - Monitor for any further deterioration and replace as required

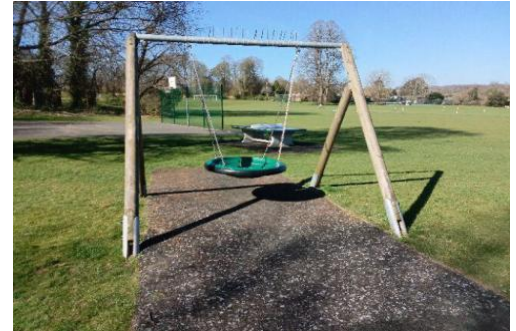
Item: Basket Swing - Type 1
Manufacturer: Playdale Playgrounds Ltd
Surface Type: Bonded Rubber Mulch
Item Quantity: 1
Equipment Compliance: Yes
Surface Area Compliance: Yes

Swings of this design should have a secondary safety mechanism fitted to prevent collapse of the seat in the event of a joint failure to comply with BS EN 1176 Part 2, however this swing was installed prior to the standards being updated in 2018 and the manufacturer has confirmed that the joint was independently cycle tested by BSi - Monitor use and check the joint and fixing security regularly

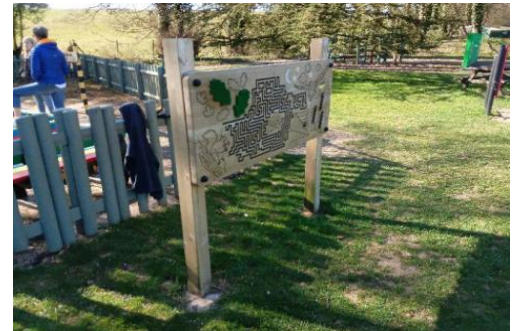
Item: Play Panel
Manufacturer: Hand Made Places
Surface Type: Grass
Item Quantity: 1
Equipment Compliance: Yes
Surface Area Compliance: N/A

The surface has eroded and the foundations are exposed - Reinstate surrounding surfaces to cover the foundations

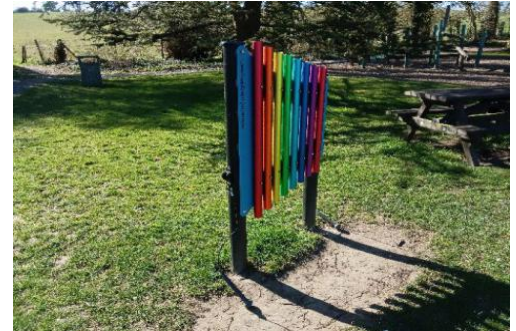
Item: Musical Instrument
Manufacturer: Inclusive Play
Surface Type: Grass
Item Quantity: 1
Equipment Compliance: N/A
Surface Area Compliance: N/A

The surface has eroded in some areas and may be slippery in wet conditions - Reinstate the surface

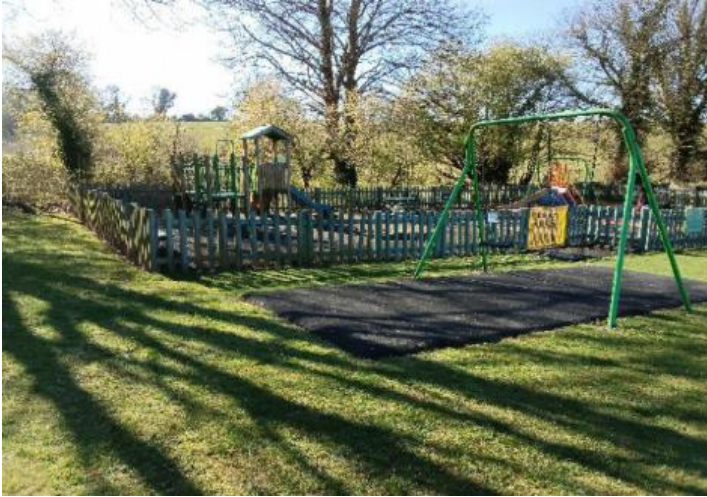
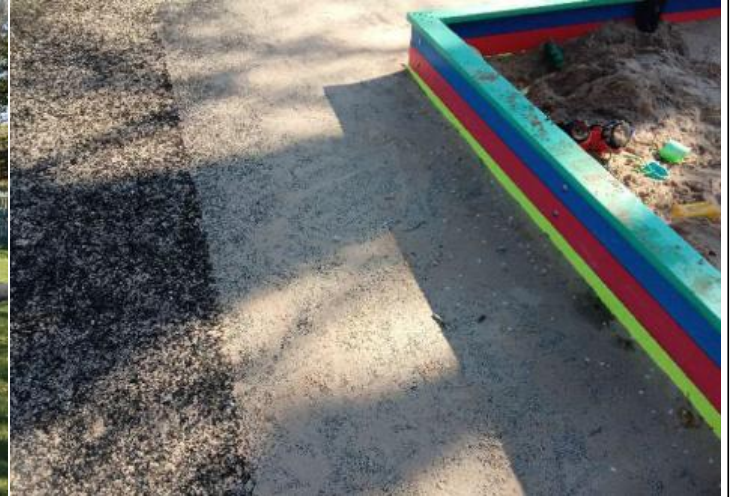
Item: Ancillary Items - Site General
Manufacturer: Owner/Operator

Risk Level: L - Low Risk
Surface: N/A

Finding: Sand is migrating into the surrounding play area

Action: Clean and maintain area

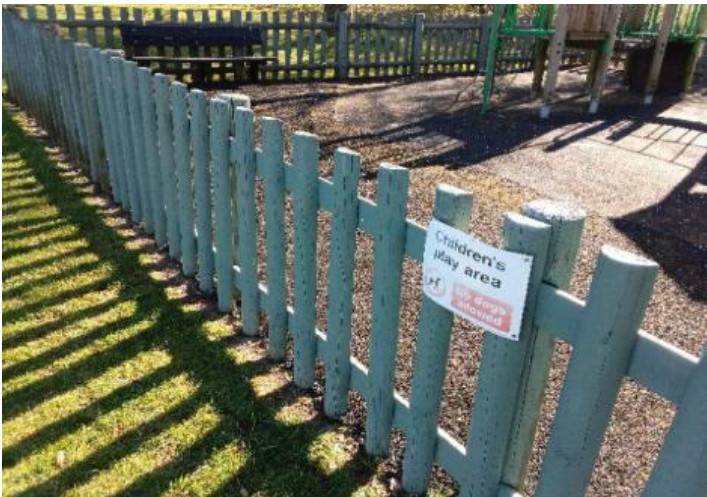
Item: Fences - Fencing - Timber
Manufacturer: Not Identified

Risk Level: L - Low Risk
Surface: Bonded Rubber Mulch

Finding: There is some evidence of rot in the timber

Action: Monitor for any further deterioration and replace as required

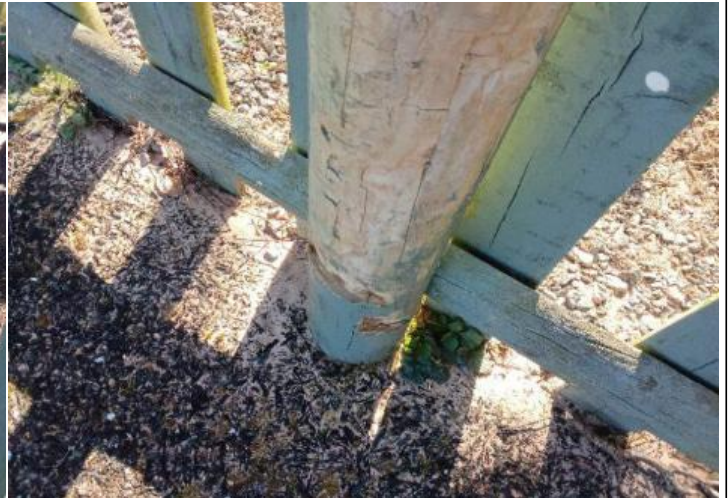
Item: Fences - Fencing - Timber
Manufacturer: Not Identified

Risk Level: L - Low Risk
Surface: Bonded Rubber Mulch

Finding: Parts of the timber are rough or splintered

Action: Remove all rough or sharp edges

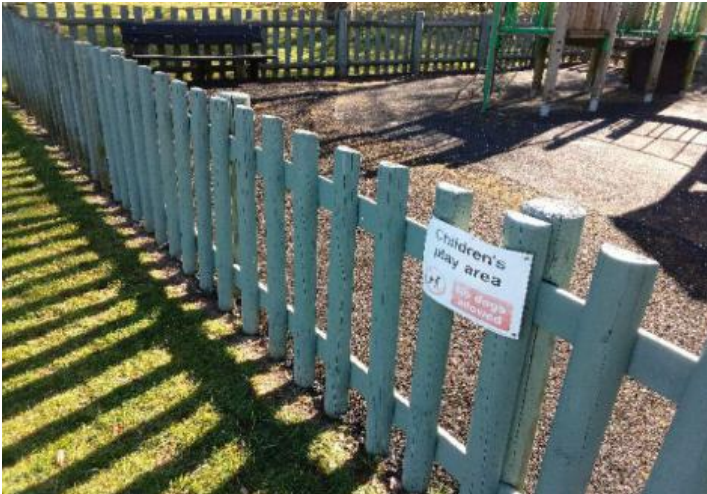
Item: Fences - Fencing - Timber
Manufacturer: Not Identified

Risk Level: L - Low Risk
Surface: Bonded Rubber Mulch

Finding: There are areas or parts of the timber on the structure that have rotted

Action: Replace all affected timbers

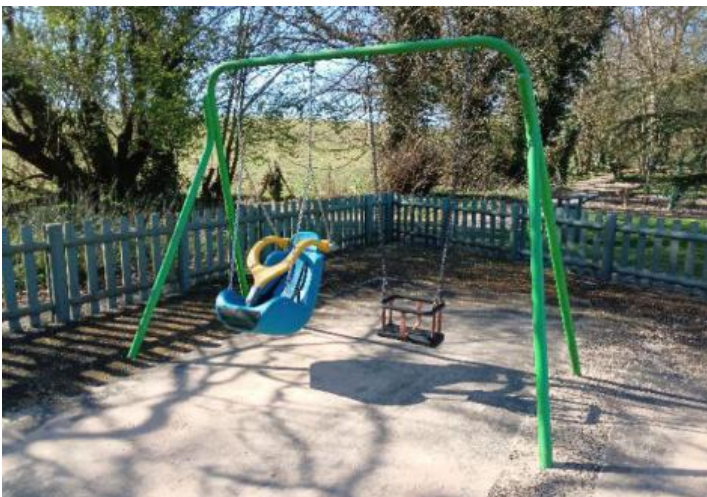
Item: Swings - 1 Bay 2 Seat Swing
Manufacturer: Not Identified

Risk Level: V - Very Low Risk
Surface: Bonded Rubber Mulch

Finding: The connecting links are in excess of 8.6mm and less than 12mm and fail the requirements of BS EN 1176 Part 1; clause 4.2.13, Chains

Action: Monitor - No action given the risk assessment

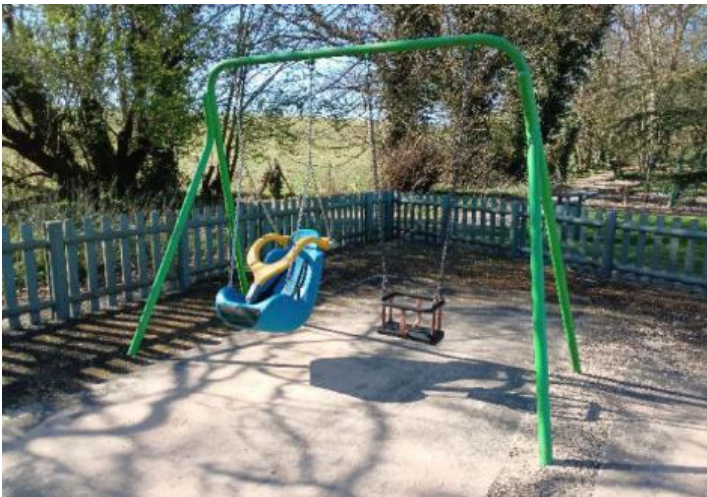
Item: Swings - 1 Bay 2 Seat Swing
Manufacturer: Not Identified

Risk Level: L - Low Risk
Surface: Bonded Rubber Mulch

Finding: The seat clearance from finished surface level to the underside of the seat is too low and does not meet the requirements of BS EN 1176 Part 2 (350mm minimum clearance required)

Action: Adjust seat height/s (400mm-500mm is recommended)

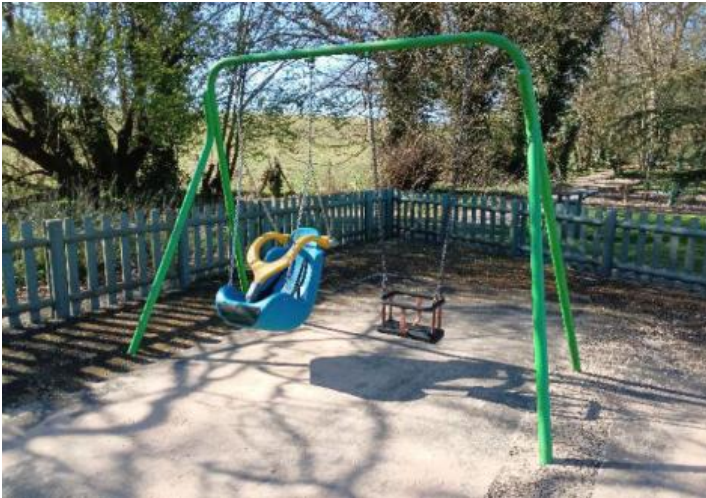
Item: Swings - 1 Bay 2 Seat Swing
Manufacturer: Not Identified

Finding: The seat has minor damage or wear

Action: Monitor for any further deterioration and replace as required

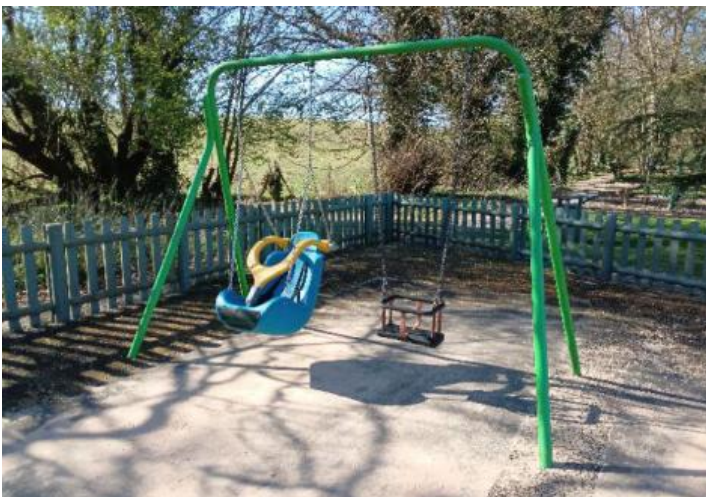
Item: Swings - 1 Bay 2 Seat Swing
Manufacturer: Not Identified

Finding: There is some notable evidence of chain wear

Action: Monitor for any further deterioration and replace when 40% worn

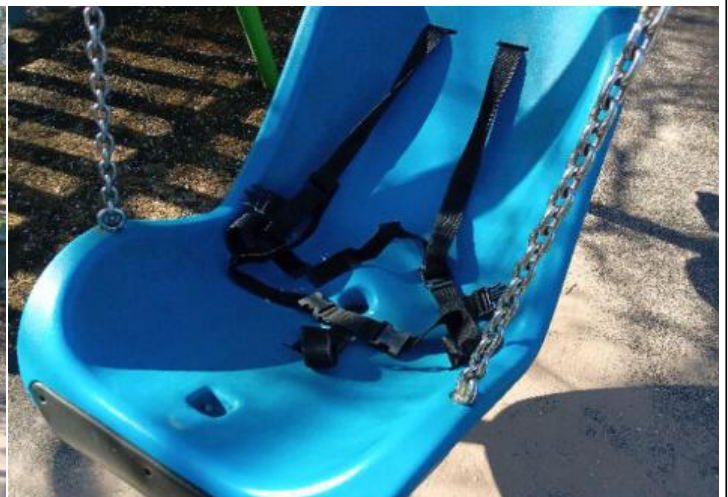
Item: Swings - 1 Bay 2 Seat Swing
Manufacturer: Not Identified

Finding: The safety harness is not designed to be left on the seat as it presents a strangulation risk if not used as intended. The manufacturer advises that the harness is an accessory that comes to the play area with the supervisor and leaves with the supervisor. The harness is not to be left attached to the seat when not in use.

Action: Remove harness

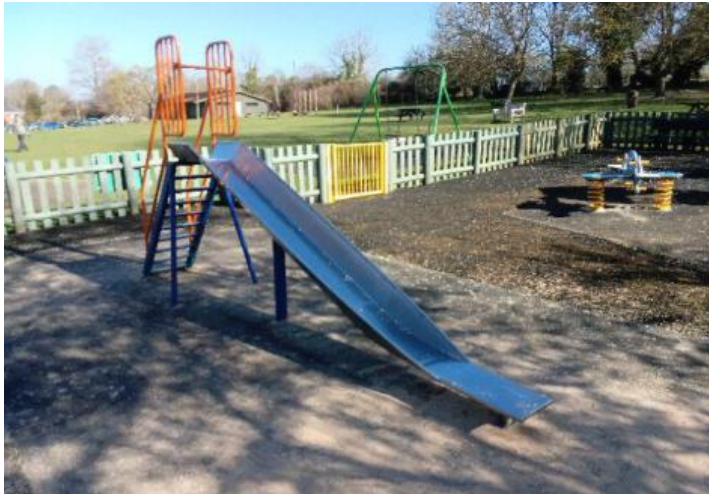
Item: Other - Free Standing Slide
Manufacturer: Not Identified

Finding: There is/are bolt cap covers missing or damaged on the item

Action: Replace missing or damaged bolt cap covers

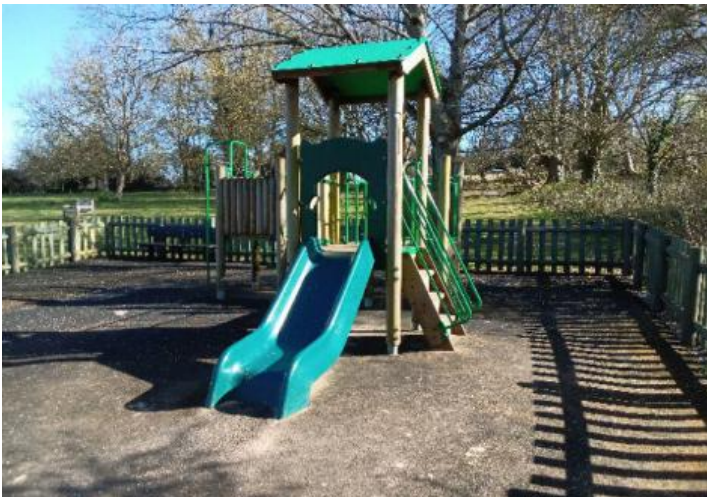
Item: Activity Equipment - Multi Play (Junior)
Manufacturer: A.E.Evans

Finding: The bush / bushes is / are worn or missing

Action: Replace worn or missing bushes

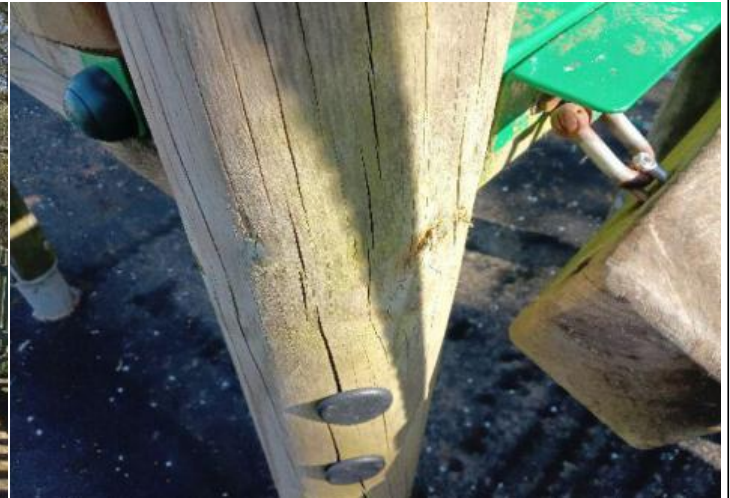
Item: Activity Equipment - Multi Play (Junior)
Manufacturer: A.E.Evans

Finding: Parts of the timber are rough or splintered

Action: Remove all rough or sharp edges

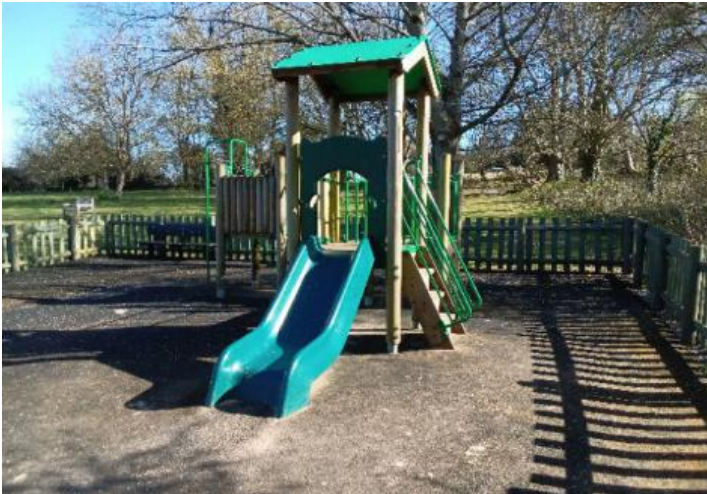
Item: Activity Equipment - Multi Play (Junior)
Manufacturer: A.E.Evans

Finding: The timber has a number of splits/shakes or air cracks and this may affect the stability or allow water ingress which will accelerate the rotting process

Action: Monitor to ensure the splits do not cross through fixing points of the structure and/or cause any instability

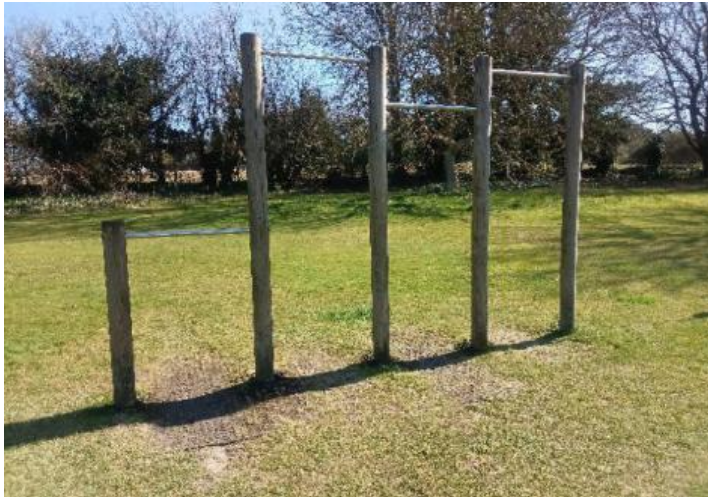
Item: Outdoor Fitness Equipment - Pull Up Station
Manufacturer: Not Identified

Finding: The surface is lifting at the edges and creating trip points

Action: Repair perimeter of surfacing to remove trip points

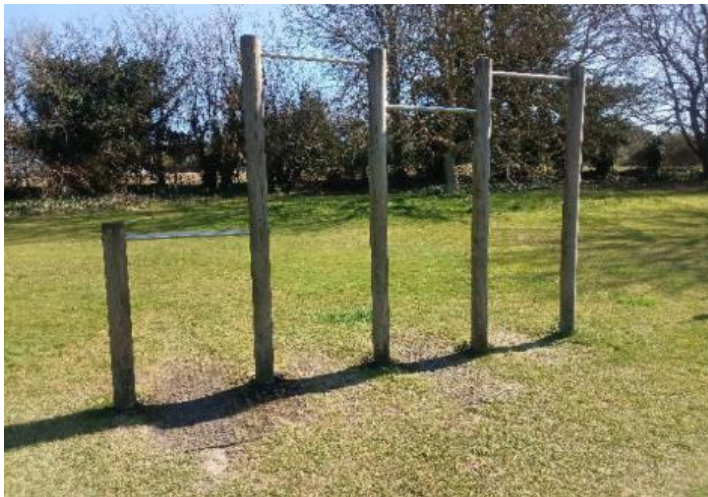
Item: Outdoor Fitness Equipment - Pull Up Station
Manufacturer: Not Identified

Finding: The timber has a number of splits/shakes or air cracks and this may affect the stability or allow water ingress which will accelerate the rotting process

Action: Monitor to ensure the splits do not cross through fixing points of the structure and/or cause any instability

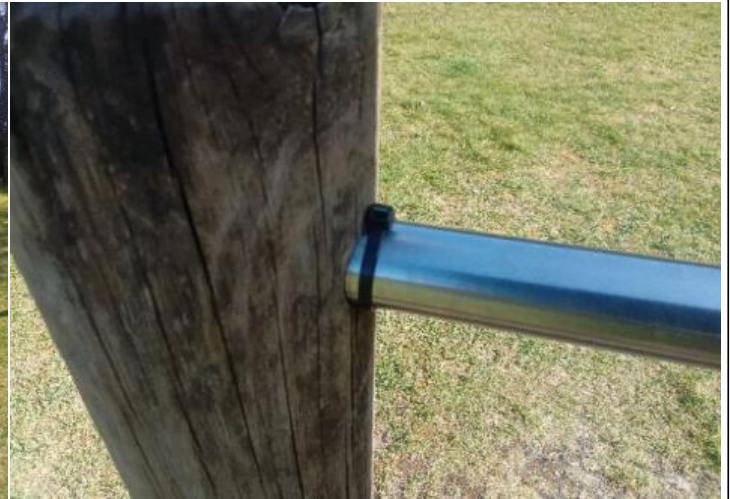
Item: Outdoor Fitness Equipment - Pull Up Station
Manufacturer: Not Identified

Finding: Cable ties are present and there are sharp projecting ends

Action: Remove

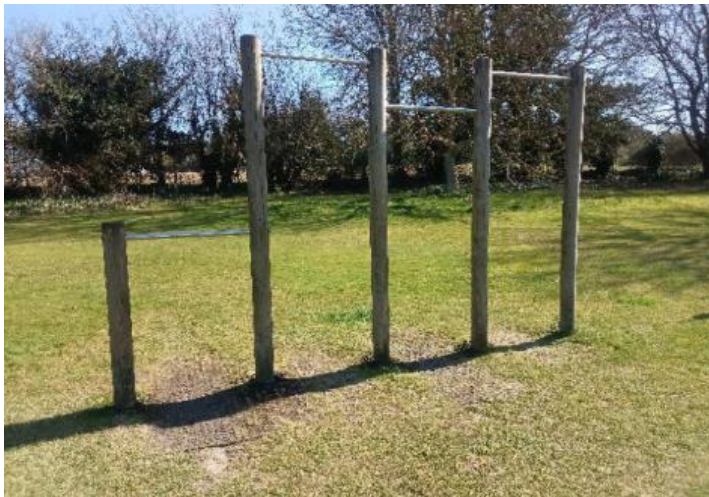
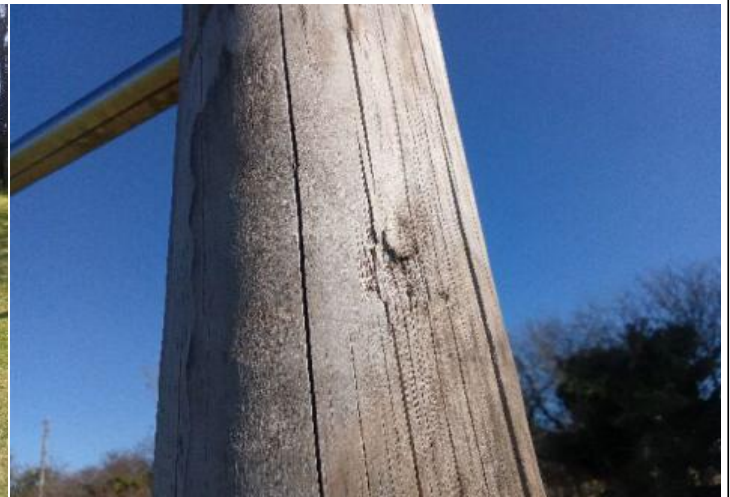
Finding: Parts of the timber are rough or splintered

Action: Remove all rough or sharp edges

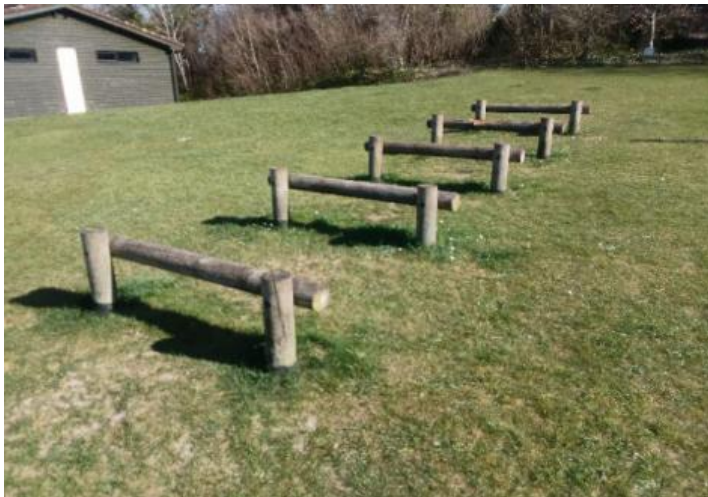
Item: Outdoor Fitness Equipment - Hurdles
Manufacturer: Not Identified

Finding: There is/are bolt cap covers missing or damaged on the item

Action: Replace missing or damaged bolt cap covers

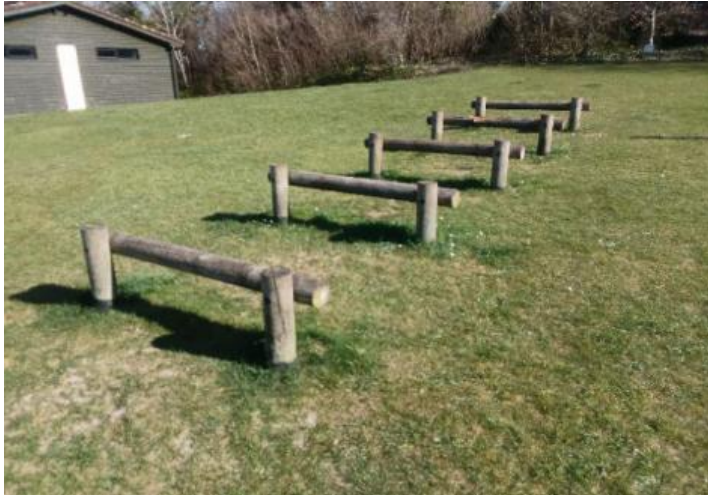
Item: Outdoor Fitness Equipment - Hurdles
Manufacturer: Not Identified

Finding: There are areas or parts of the timber on the structure that have rotted

Action: Replace all affected timbers

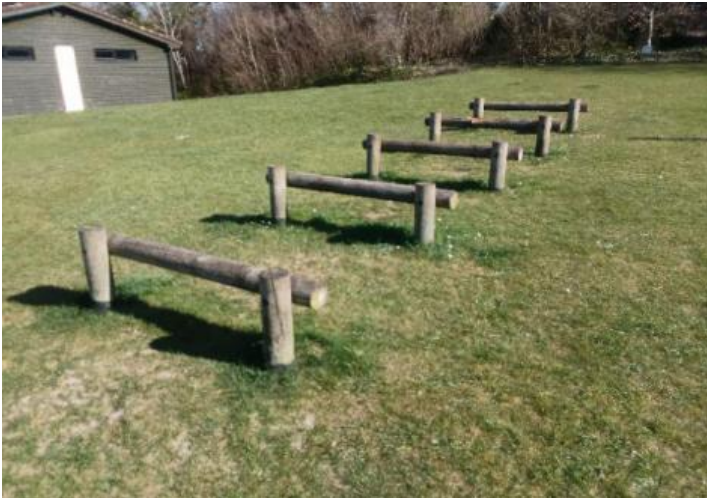
Item: Outdoor Fitness Equipment - Hurdles
Manufacturer: Not Identified

Finding: The timber has a number of splits/shakes or air cracks and this may affect the stability or allow water ingress which will accelerate the rotting process

Action: Monitor to ensure the splits do not cross through fixing points of the structure and/or cause any instability

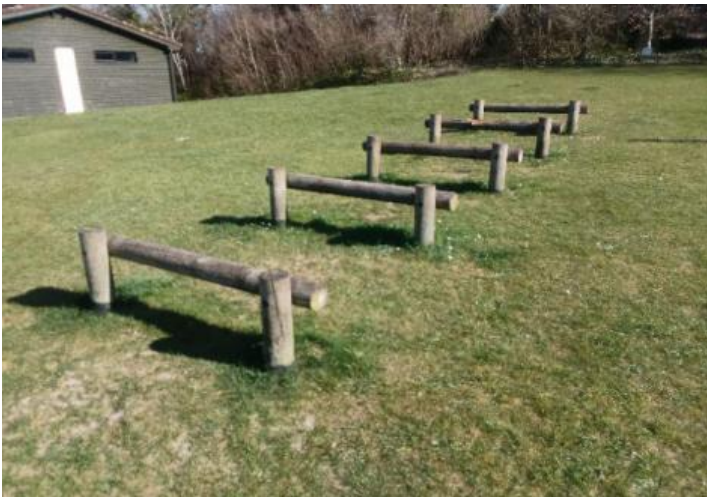
Item: Outdoor Fitness Equipment - Hurdles
Manufacturer: Not Identified

Finding: There is some evidence of rot in the timber

Action: Monitor for any further deterioration and replace as required

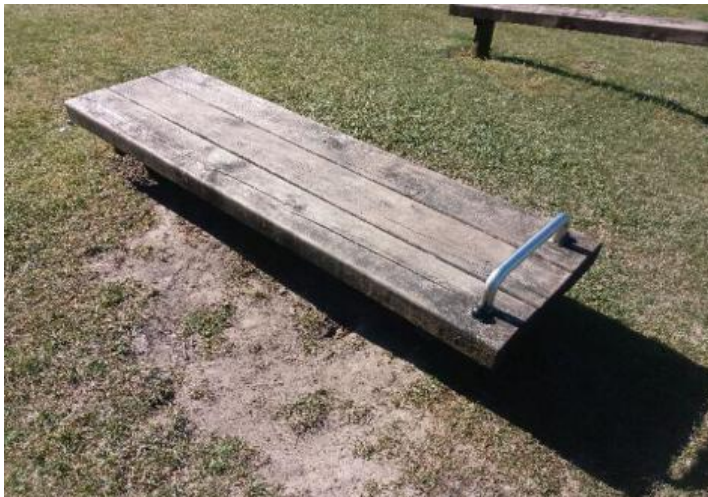
Item: Outdoor Fitness Equipment - Ability Bench
Manufacturer: Not Identified

Finding: The surface has eroded in some areas and may be slippery in wet conditions

Action: Reinstate the surface

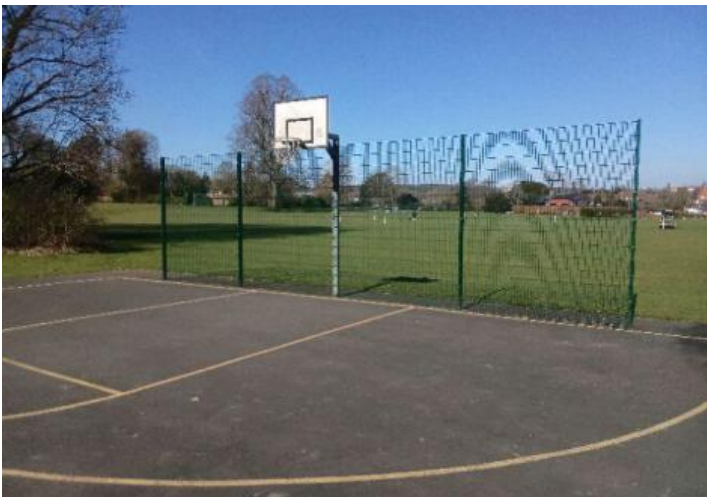
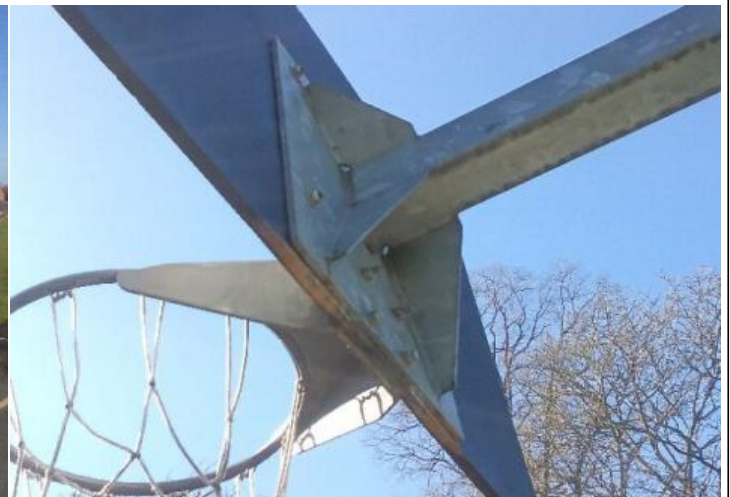
Item: Multi Use Games Area - Multi Use Games Area (MUGA)
Manufacturer: Not Identified

Finding: There are projecting bolt thread(s) present

Action: Remove excess thread length and deburr or provide cap

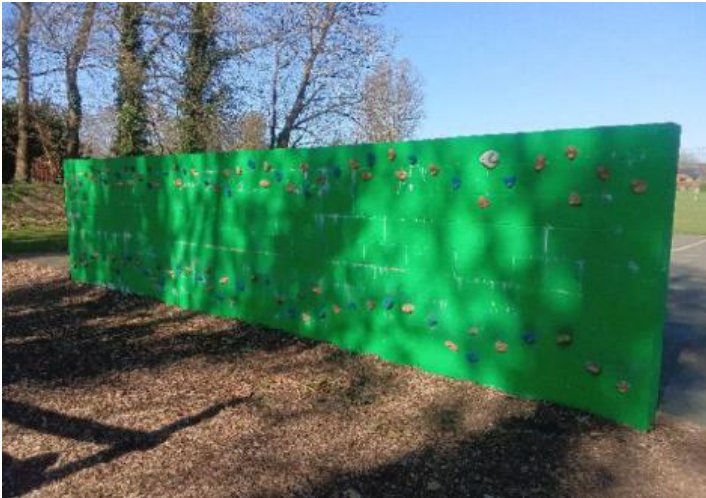
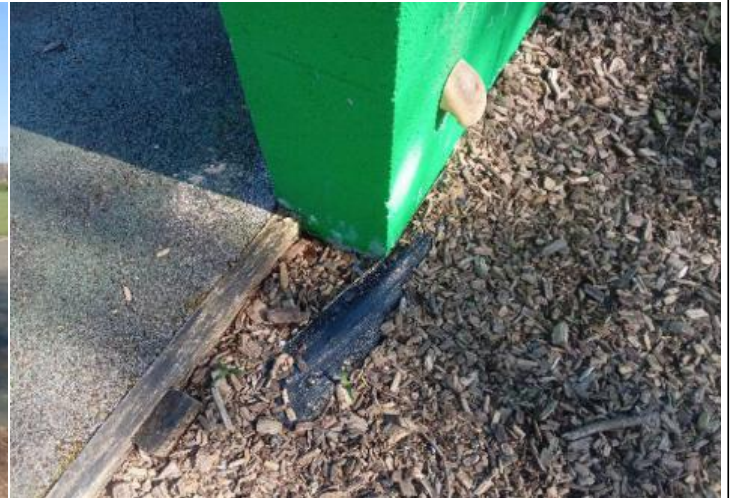
Item: Activity Equipment - Traverse Wall
Manufacturer: Not Identified

Finding: The safety surface is low and the membrane is exposed creating trip points

Action: Remove or resecure the exposed membrane and top up the surface to the correct level

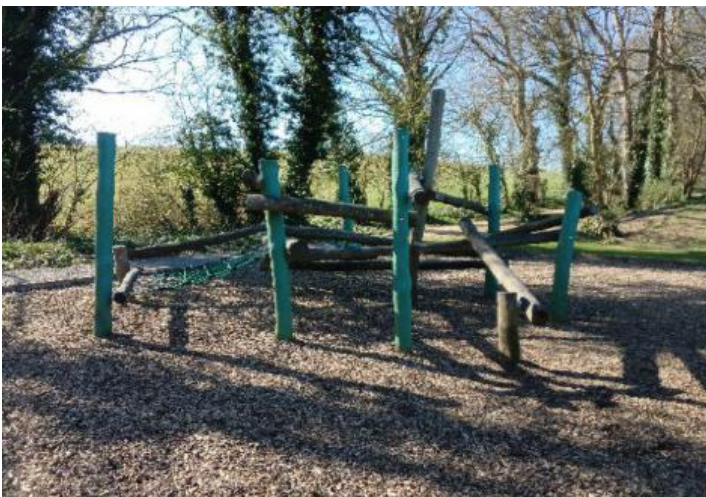
Item: Activity Equipment - Log Climber
Manufacturer: Dylan Group Ltd

Finding: The depth of the loose fill surfacing is lower than the recommended depth specified in BS EN 1176; the free height of fall of the equipment is less than 2.0m and a minimum of 300mm depth should be provided (including an extra 100mm to allow for compaction and displacement as per BS EN 1176 Part 1 - Table 4)

Action: Top up loose fill surfacing to recommended levels

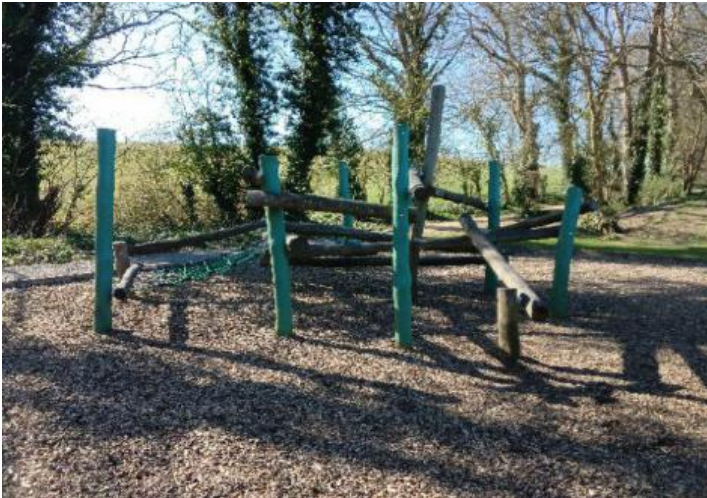
Item: Activity Equipment - Log Climber
Manufacturer: Dylan Group Ltd

Finding: There are falls in excess of 600mm between adjacent components on the structure, in contravention of the recommendations set out in BS EN 1176 Part 1; 4.2.8.4

Action: Monitor - No action given the risk assessment

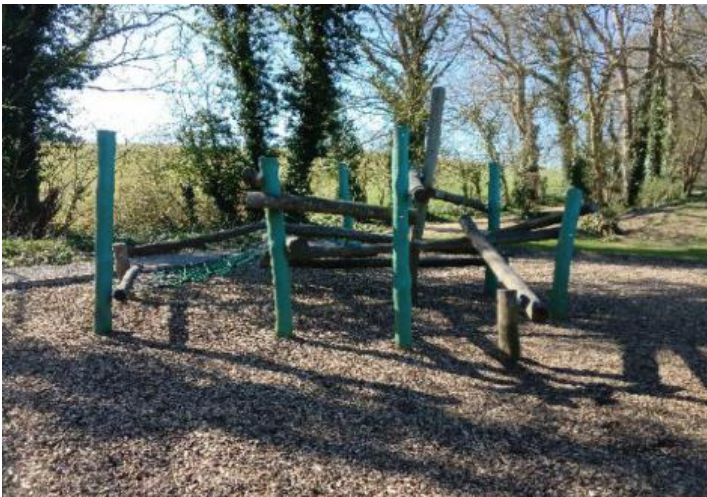
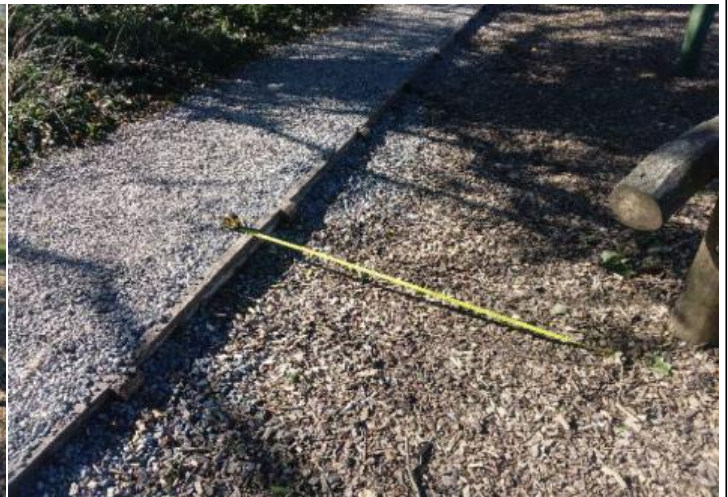
Item: Activity Equipment - Log Climber
Manufacturer: Dylan Group Ltd

Finding: The timber edging forms a hard object within the falling space of the equipment and there is also insufficient surfacing provided in contravention of BS EN 1176 Part 1

Action: Monitor - No action given the risk assessment

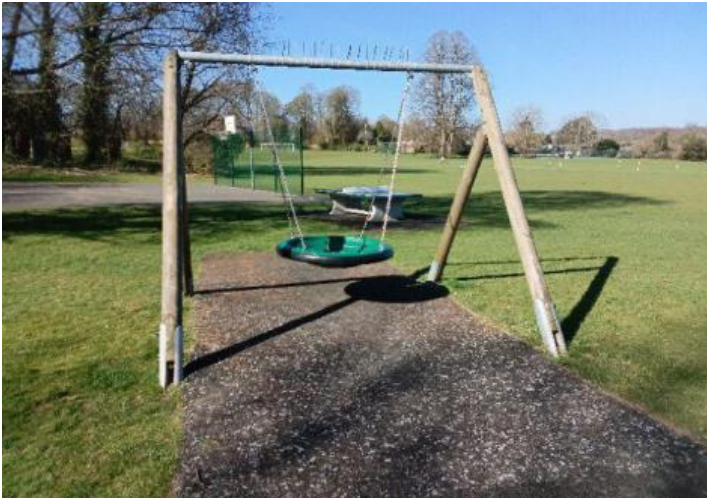
Item: Swings - Basket Swing - Type 1
Manufacturer: Playdale Playgrounds Ltd

Finding: There is some notable evidence of chain wear

Action: Monitor for any further deterioration and replace when 40% worn

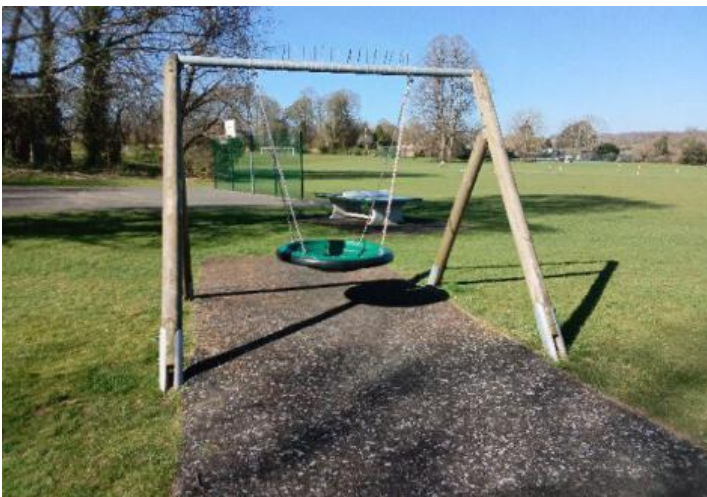
Item: Swings - Basket Swing - Type 1
Manufacturer: Playdale Playgrounds Ltd

Finding: The bush / bushes is / are showing signs of wear

Action: Monitor for any further deterioration and replace as required

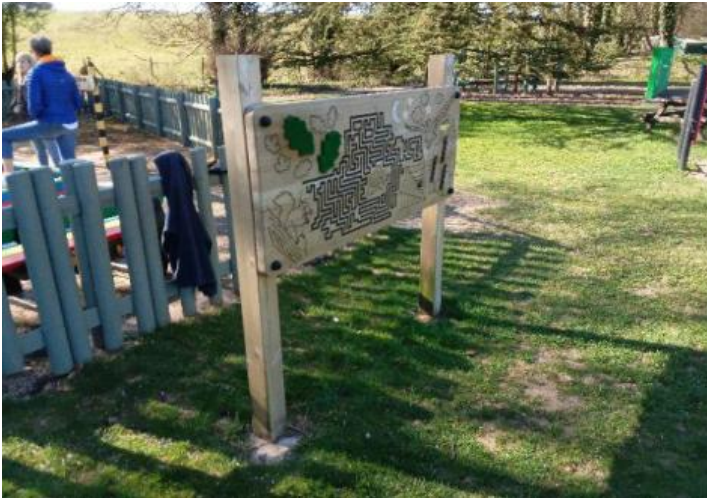
Item: Activity Equipment - Play Panel
Manufacturer: Hand Made Places

Finding: The surface has eroded and the foundations are exposed

Action: Reinstate surrounding surfaces to cover the foundations

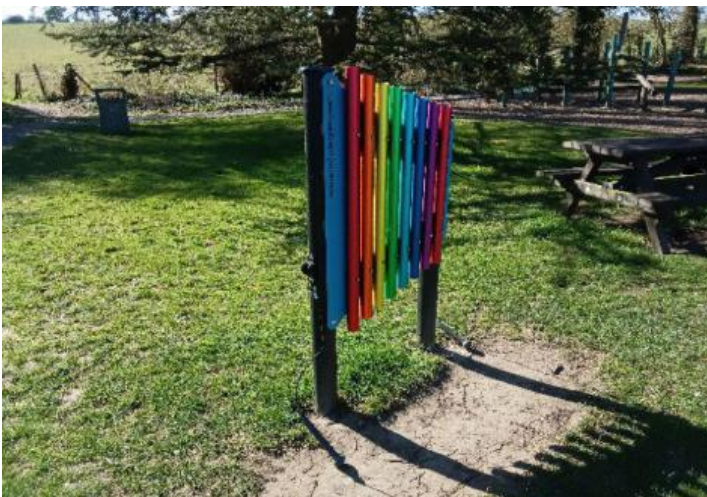
Item: Other - Musical Instrument
Manufacturer: Inclusive Play

Finding: The surface has eroded in some areas and may be slippery in wet conditions

Action: Reinstate the surface

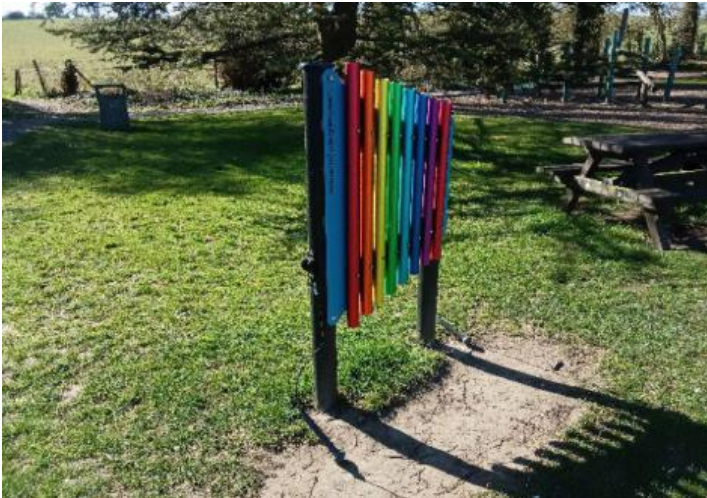
Item: Other - Musical Instrument
Manufacturer: Inclusive Play

Finding: The surface has eroded and the foundations are exposed

Action: Reinststate surrounding surfaces to cover the foundations
