I hereby summon you to attend a meeting of the **RECREATION COMMITTEE** on Thursday 10th September 2026 at 7:30 PM, to be held at The Pavilion, Hunter Park, SO21 1QS

**To Receive** the Visual Tree Assessment conducted in May 2026 and **consider** the recommendations.

The Visual Tree Assessment (VTA) was carried out in July 2026 to assess the condition and safety of trees at Northfields and Hunter Park.

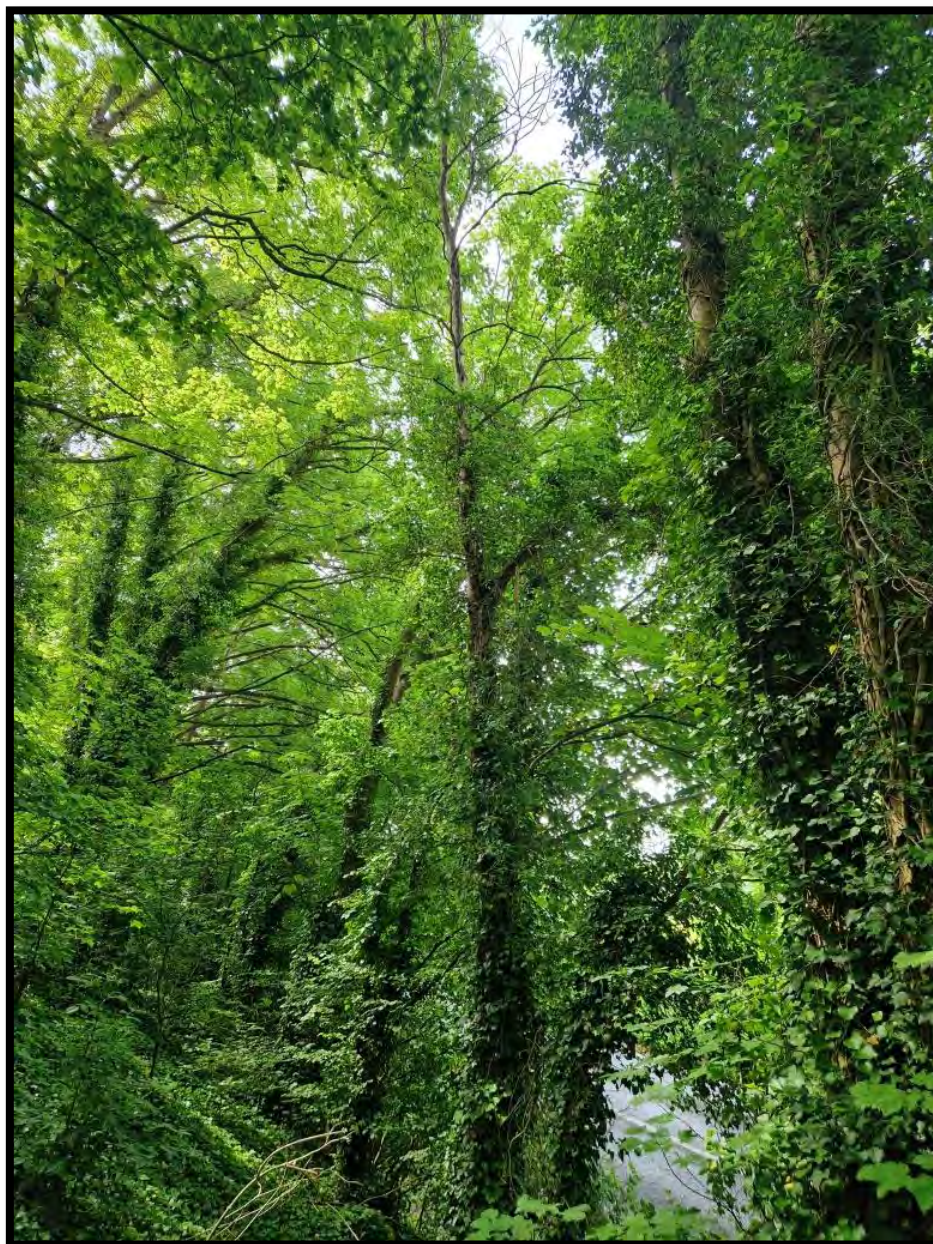
Trees at Northfields were partially inaccessible due to the steep embankment and the eroded land.

**Plate 1: Inaccessible trees due to dense understorey and a steep, eroding embankment.  
(Northfields)**

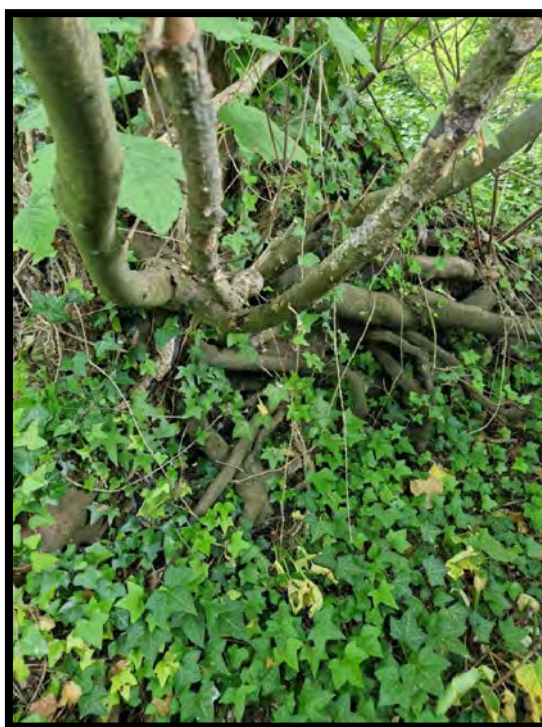
Where this waste has been left within watercourses, then the levels of the water has risen and is now undermining the banks where trees are growing. It is assumed that the recent collapse of a veteran and ancient boundary bank Ash tree occurred was due to these raised levels as it can be seen the soil has eroded beneath the trees' roots which were supporting it.

**Plate 4: Soil erosion at Northfields Park.**

A revetment, or terracing should be engineered to prevent trees collapsing down the bank. Water diversion gullies could also assist with reducing erosion.

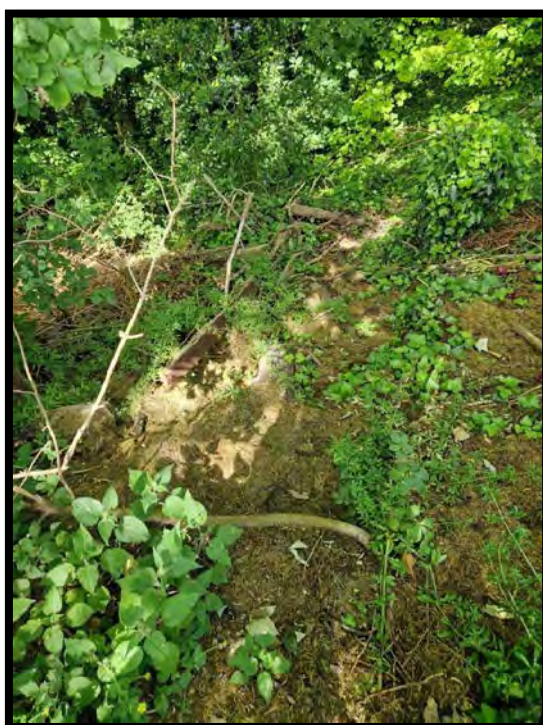
**Plate 5: Fly-tipped garden waste and building materials at Northfields Park.**

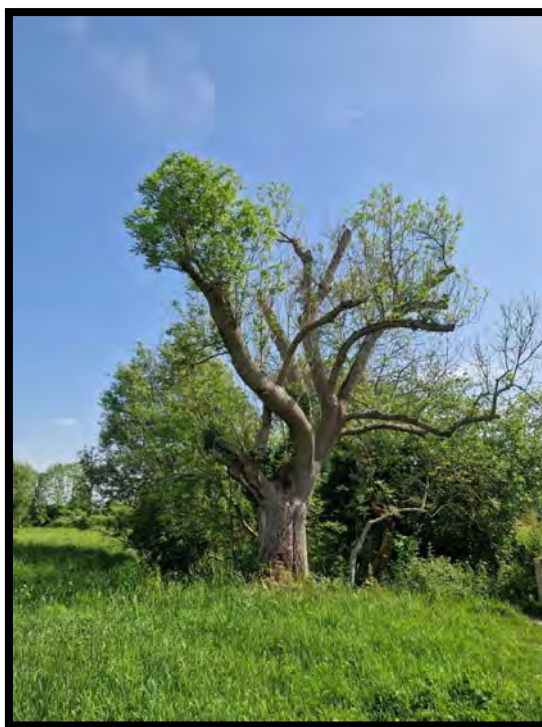
**There are also a number of veteran Ash trees and these should be retained and managed as veteran trees as they have important ecological benefits. The Ash tree at the cattle bridge within Berry Meadows is a veteran Ash tree.**

**Plate 8: Veteran Ash tree.**

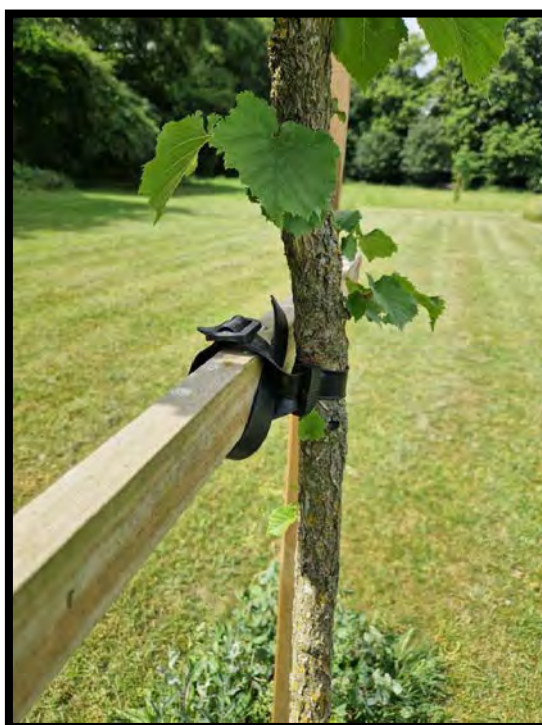
Newly planted trees across the sites were recorded to be staked with a crossbar and tie. The ties on a number of trees were strangulating the tree. These should be checked regularly and released once the trees are established. The crossbars are lacking any protection for the stem of the tree. The abrasions will prevent the vascular system (just below the bark) from operating or even die.

**Plate 10: Strangled tree (Hunter Park).**

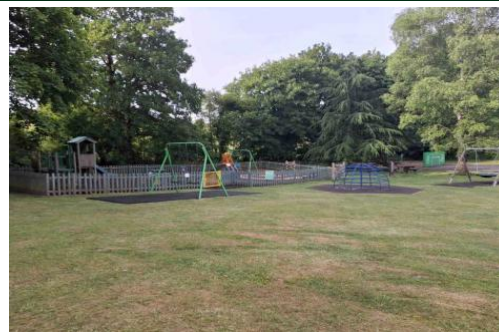
**Finding 1**

There is moderate damage to the surface - Repair the damaged areas of surfacing

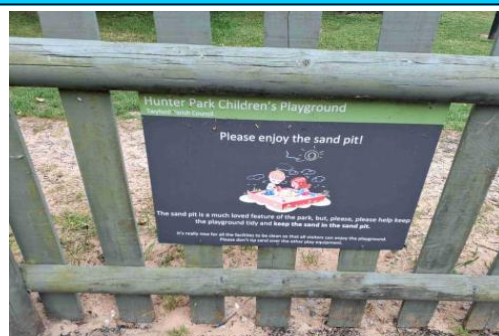
**Finding 1**

It is recommended that signage, with information including the site address, contact information for maintenance issues and emergency contact details are provided for the facility - Provide in accordance with the recommendations

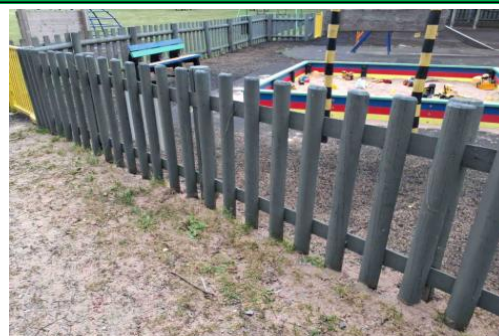
**Finding 1**

There is some evidence of rot in the timber - Monitor for any further deterioration and replace as required

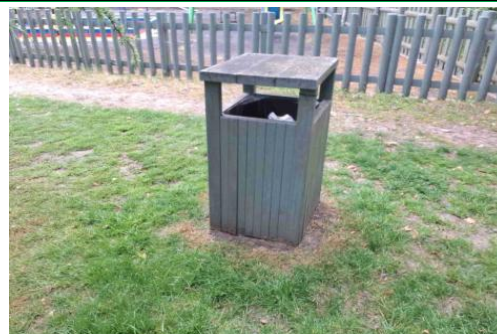
**Finding 1**

The lid or door of the litter bin is not secured - Ensure the lid or door is kept locked

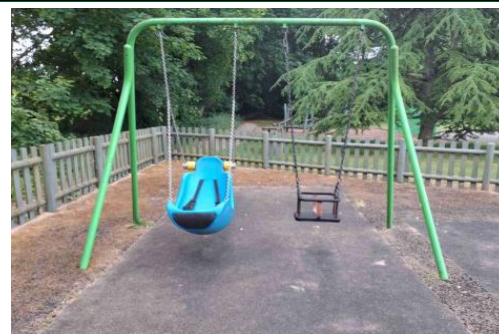
**Finding 1**

The safety harness is not designed to be left on the seat as it presents a strangulation risk if not used as intended. The manufacturer advises that the harness is an accessory that comes to the play area with the supervisor and leaves with the supervisor. The harness is not to be left attached to the seat when not in use. - Remove harness

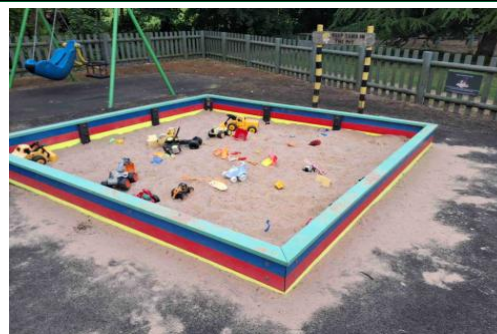
**Finding 1**

Sand is migrating on to the surrounding surface which may become slippery - Clean and maintain

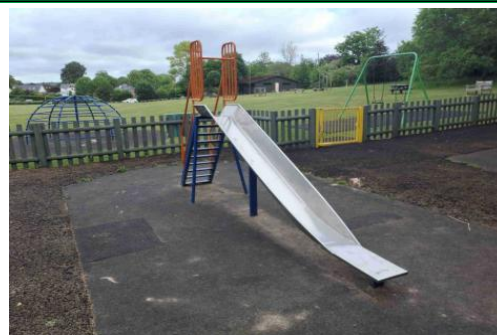
**Finding 1**

The fixings have corroded excessively - Replace all corroded fixings

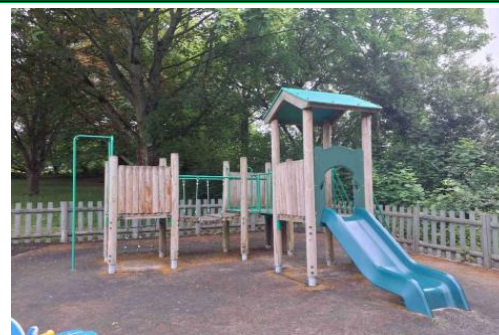
**Finding 1**

There is/are finger entrapment/s in the slide starting section and the item fails to meet the requirements of BS EN 1176 Part 1 4.2.7.6 Entrapment of fingers - Remove the entrapments

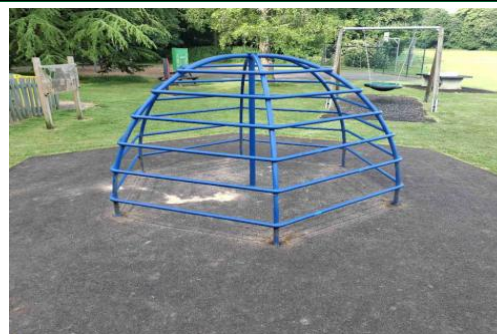
**Item:** Climbing Frame  
**Manufacturer:** Not Identified  
**Surface Type:** Wet Pour  
**Item Quantity:** 1  
**Equipment Compliance:** Yes  
**Surface Area Compliance:** Yes  
**Life Expectancy:** >10 Years  
**Total Findings:** 1

There is some minor damage to the surface - Monitor for any further deterioration and repair as required

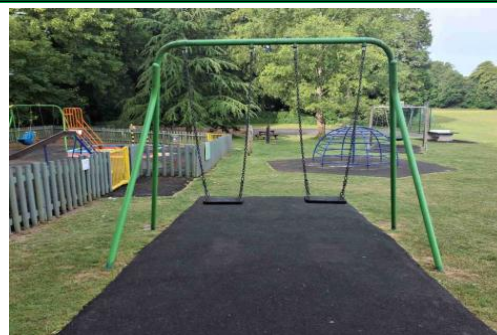
**Item:** 1 Bay 2 Seat (Flat)  
**Manufacturer:** Not Identified  
**Surface Type:** Wet Pour  
**Item Quantity:** 1  
**Equipment Compliance:** No  
**Surface Area Compliance:** Yes  
**Life Expectancy:** >10 Years  
**Total Findings:** 3

The chain openings are in excess of the 8.6mm as recommended by BS EN 1176 - Monitor - No action given the risk assessment

There is some notable evidence of chain wear - Monitor for any further deterioration and replace when 40% worn

The surface is lifting at the edges and creating trip points - Repair perimeter of surfacing to remove trip points

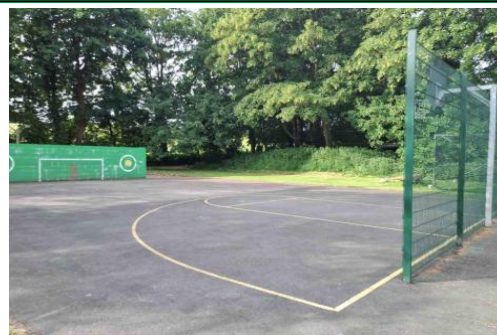
**Item:** Multi Use Games Area (MUGA)  
**Manufacturer:** Not Identified  
**Surface Type:** Bitmac  
**Item Quantity:** 1  
**Equipment Compliance:** No  
**Surface Area Compliance:** N/A  
**Life Expectancy:** >10 Years  
**Total Findings:** 3

A clearly visible facility sign should be provided in a prominent position with the wording as detailed BS EN 15312 - the equipment is not intended for children less than 3 years old - the warning - Do not climb on the framework or nets - the warning - Do not hang on the ring (if provided) - the warning - Do not wear rings or other jewellery - name and telephone number of the administrator - number to call in case of accident - Provide signage to BS EN 15312

There is/are finger entrapments in the mesh and the item fails to meet the requirements of BS EN 15312 Clause 4.4.2.2 Entrapment of fingers - Monitor - No action given the risk assessment

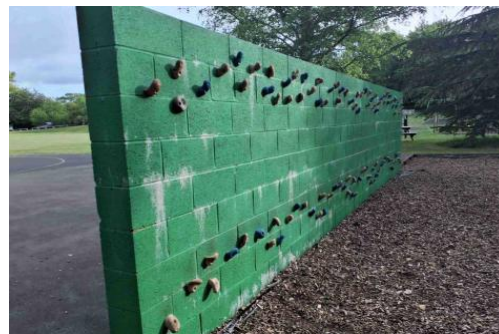
**Item:** Traverse Wall  
**Manufacturer:** Not Identified  
**Surface Type:** Woodchip  
**Item Quantity:** 1  
**Equipment Compliance:** Yes  
**Surface Area Compliance:** Yes  
**Life Expectancy:** >10 Years  
**Total Findings:** 2

The safety surface is low and the membrane is exposed creating trip points - Remove or resecure the exposed membrane and top up the surface to the correct level

The surface has eroded and the foundations are exposed - Reinstate surrounding surfaces to cover the foundations

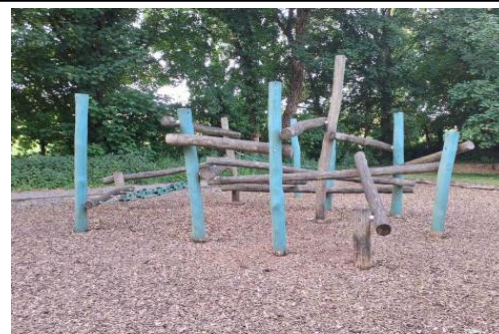
**Item:** Log Climber  
**Manufacturer:** Dylan Group Ltd  
**Surface Type:** Woodchip  
**Item Quantity:** 1  
**Equipment Compliance:** No  
**Surface Area Compliance:** No  
**Life Expectancy:** >10 Years  
**Total Findings:** 6

The depth of the loose fill surfacing is lower than the recommended depth specified in BS EN 1176; the free height of fall of the equipment is less than 2.0m and a minimum of 300mm depth should be provided (including an extra 100mm to allow for compaction and displacement as per BS EN 1176 Part 1 - Table 4) - Top up loose fill surfacing to recommended levels

The timber edging forms a projecting obstacle / hard object within the falling space of the equipment, in contravention of the requirements of BS EN 1176 Part 1 - Top up loose fill to level with the edging

A number of fixing(s) have worked loose - Secure all loose fixings

There are falls in excess of 600mm between adjacent components on the structure, in contravention of the recommendations set out in BS EN 1176 Part 1; 4.2.8.4 - Monitor - No action given the risk assessment

There is some evidence of rot in the timber - Monitor for any further deterioration and replace as required

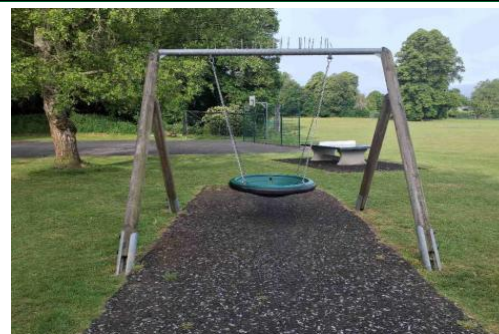
**Item:** Basket Swing - Type 1  
**Manufacturer:** Playdale Playgrounds Ltd  
**Surface Type:** Bonded Rubber Mulch  
**Item Quantity:** 1  
**Equipment Compliance:** Yes  
**Surface Area Compliance:** Yes  
**Life Expectancy:** 5 -10 Years  
**Total Findings:** 3

Swings of this design should have a secondary safety mechanism fitted to prevent collapse of the seat in the event of a joint failure to comply with BS EN 1176 Part 2, however this swing was installed prior to the standards being updated in 2018 and the manufacturer has confirmed that the joint was independently cycle tested by BSi - Monitor use and check the joint and fixing security regularly

There is some notable evidence of chain wear - Monitor for any further deterioration and replace when 40% worn

Bolt cap cover/s missing or damaged - Replace

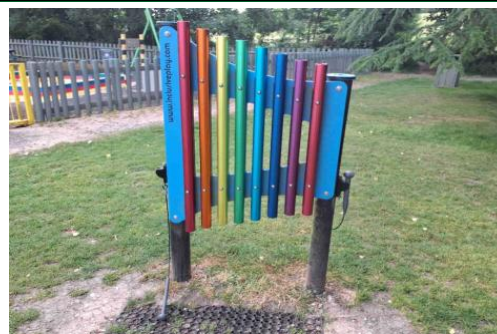
**Item:** Musical Instrument  
**Manufacturer:** Inclusive Play  
**Surface Type:** Grass  
**Item Quantity:** 1  
**Equipment Compliance:** Yes  
**Surface Area Compliance:** N/A  
**Life Expectancy:** 5 -10 Years  
**Total Findings:** 1

The area around the item has eroded and may become slippery - Reinstate eroded area

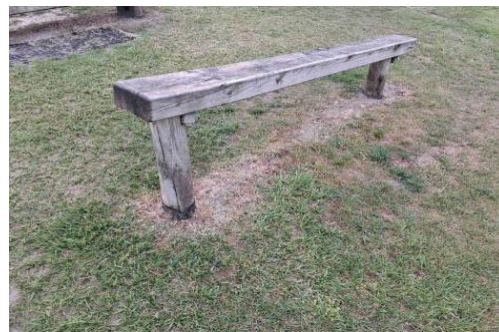
**Item:** Sit Up Station  
**Manufacturer:** Not Identified  
**Surface Type:** Grass  
**Item Quantity:** 1  
**Equipment Compliance:** Yes  
**Surface Area Compliance:** Yes  
**Life Expectancy:** 5 -10 Years  
**Total Findings:** 2

There are post protectors around the timber posts that are preventing the inspector from thoroughly testing for signs of decay and we are unable to verify the condition of the posts in these locations. NOTE - timber rot / decay is possible even with the post protectors in place - Refer to manufacturer inspection / maintenance recommendations

The item is slightly loose in its foundations - Monitor for any further deterioration and repair as required

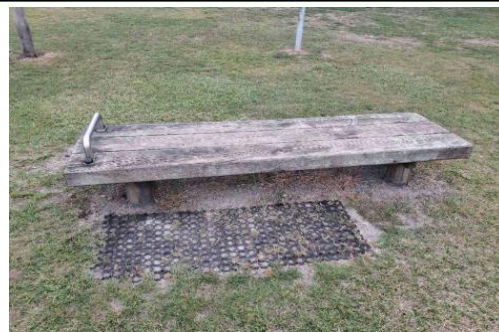
**Item:** Ability Bench  
**Manufacturer:** Not Identified  
**Surface Type:** Mixed Surface  
**Item Quantity:** 1  
**Equipment Compliance:** Yes  
**Surface Area Compliance:** Yes  
**Life Expectancy:** 3 - 5 Years  
**Total Findings:** 2

The edges of the grass mat surface are raised / lifting above the surrounding surface - Secure edges of grass mats as per the API Code of Practice to remove trip hazards

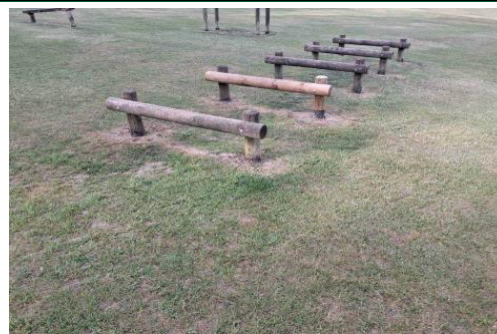
**Item:** Hurdles  
**Manufacturer:** Not Identified  
**Surface Type:** Grass  
**Item Quantity:** 1  
**Equipment Compliance:** Yes  
**Surface Area Compliance:** Yes  
**Life Expectancy:** 3 - 5 Years  
**Total Findings:** 2

There are post protectors around the timber posts that are preventing the inspector from thoroughly testing for signs of decay and we are unable to verify the condition of the posts in these locations. NOTE - timber rot / decay is possible even with the post protectors in place - Refer to manufacturer inspection / maintenance recommendations

A number of fixing(s) have worked loose - Secure all loose fixings

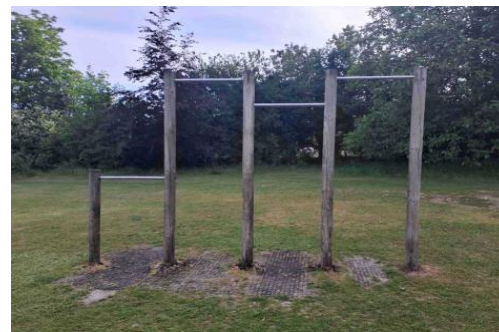
**Item:** Pull Up Station  
**Manufacturer:** Not Identified  
**Surface Type:** Grass Matrix Tiles  
**Item Quantity:** 1  
**Equipment Compliance:** Yes  
**Surface Area Compliance:** Yes  
**Life Expectancy:** 3 - 5 Years  
**Total Findings:** 5

The grass mats are silted up, the soil is compacted and the area will become very slippery when the soil is wet. - Reinstate as required

There are post protectors around the timber posts that are preventing the inspector from thoroughly testing for signs of decay and we are unable to verify the condition of the posts in these locations. NOTE - timber rot / decay is possible even with the post protectors in place - Refer to manufacturer inspection / maintenance recommendations

The timber has a number of splits/shakes or air cracks and this may affect the stability or allow water ingress which will accelerate the rotting process. Timber splits may also create rough / splintering edges. - Monitor, sand down any rough edges and ensure the splits do not cross through fixing points of the structure and/or cause any instability

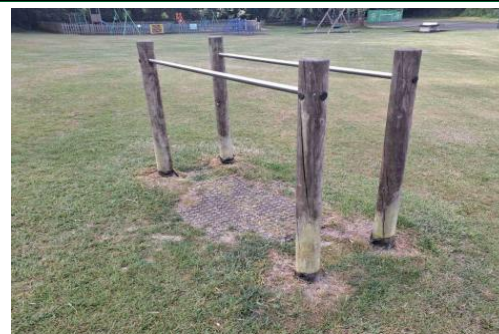
**Item:** Parallel Bars  
**Manufacturer:** Not Identified  
**Surface Type:** Grass Matrix Tiles  
**Item Quantity:** 1  
**Equipment Compliance:** Yes  
**Surface Area Compliance:** Yes  
**Life Expectancy:** 3 - 5 Years  
**Total Findings:** 3

The grass mats are silted up, the soil is compacted and the area will become very slippery when the soil is wet. - Reinstate as required

There are post protectors around the timber posts that are preventing the inspector from thoroughly testing for signs of decay and we are unable to verify the condition of the posts in these locations. NOTE - timber rot / decay is possible even with the post protectors in place - Refer to manufacturer inspection / maintenance recommendations

There is some strimmer / machinery damage apparent on the posts, this can penetrate the preservative applied to the timber and accelerate the rotting process - Monitor for any deterioration (rot) and replace as required

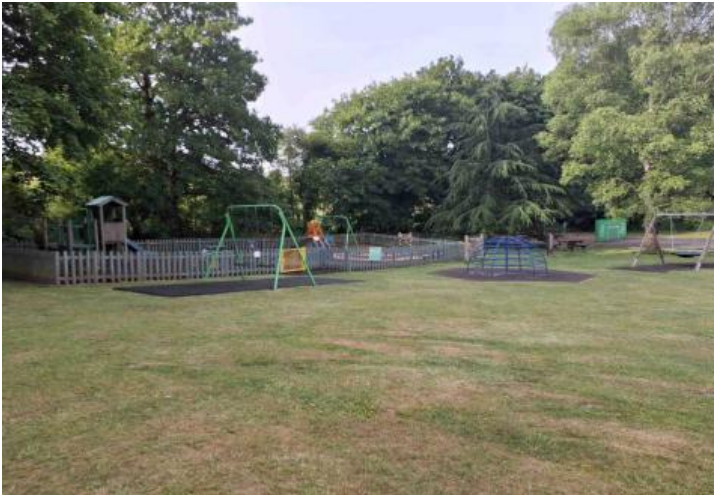
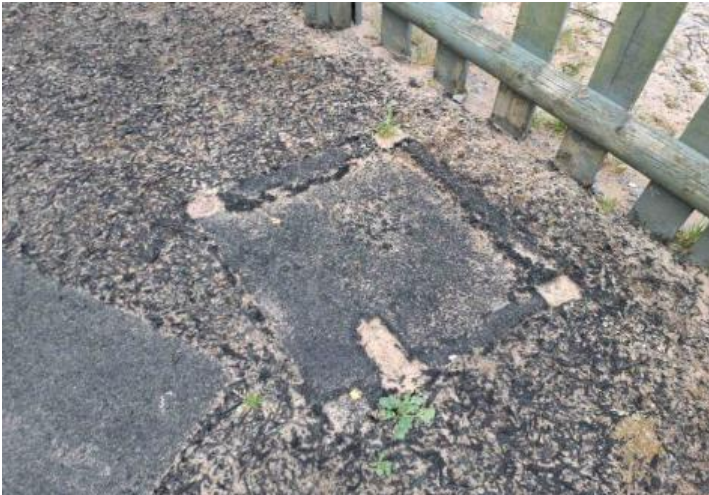
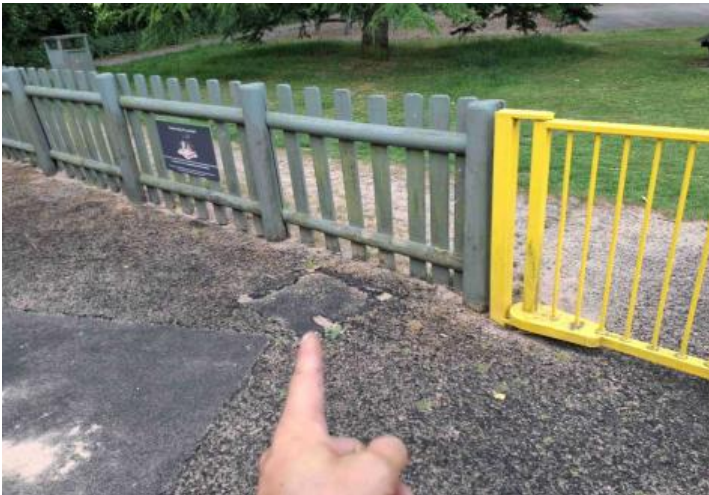
| 8 - Low Risk (Finding 1) | | | |
|---|---|---|---|
| <b>Finding:</b> There is moderate damage to the surface | | <b>Action:</b> Repair the damaged areas of surfacing | |

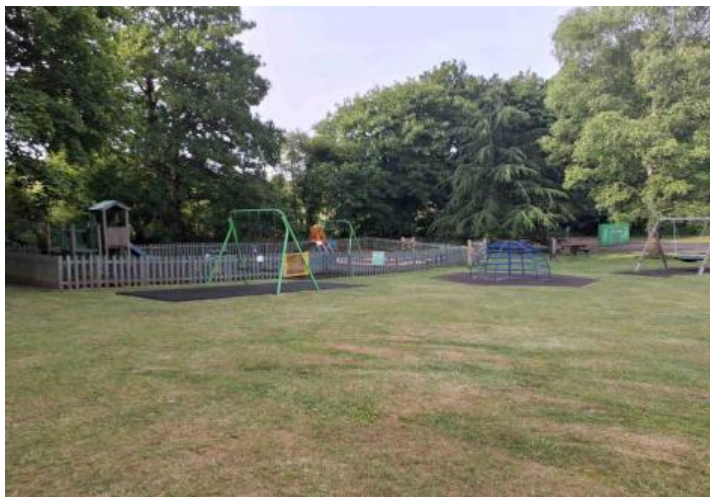
**Finding:** There is algae, silt or moss growth on the surface resulting in slippery conditions

**Action:** Clean and treat appropriately

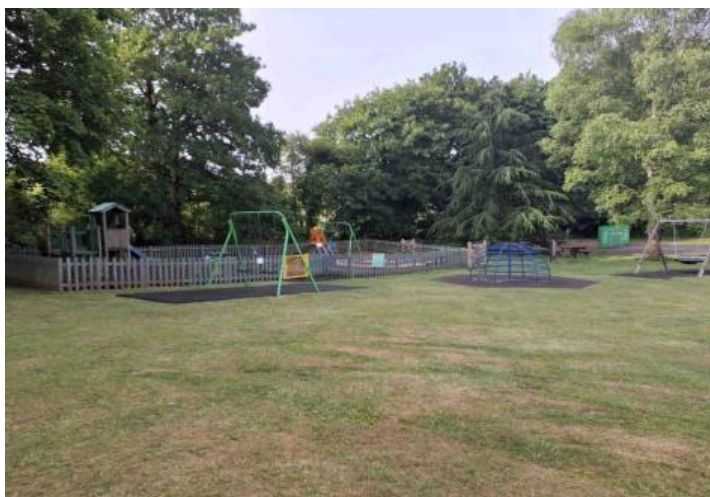
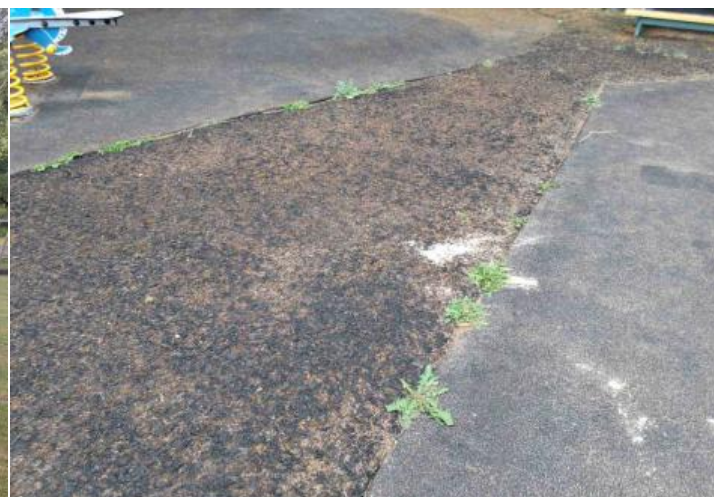
**Finding:** There is weed / vegetation growth within the surface

**Action:** Remove weed / vegetation growth

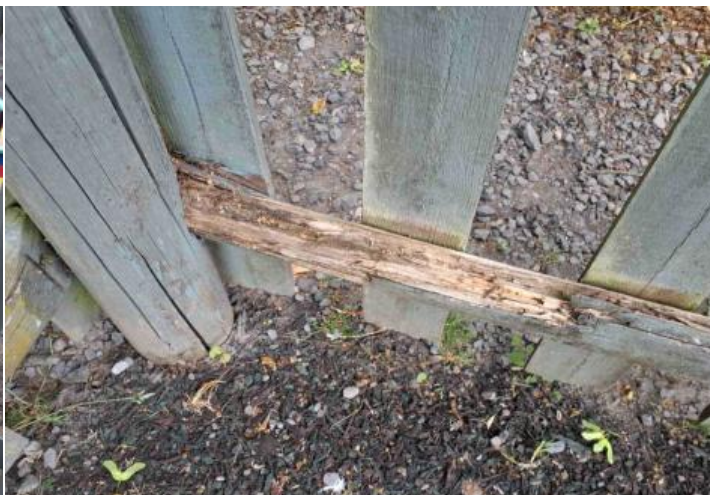
**Finding:** There is some evidence of rot in the timber

**Action:** Monitor for any further deterioration and replace as required

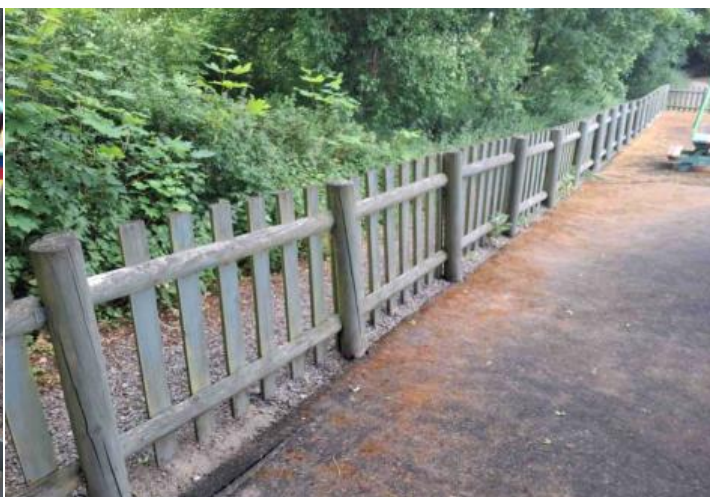
**Finding:** There are areas or parts of the timber on the structure that have rotted

**Action:** Replace all affected timbers

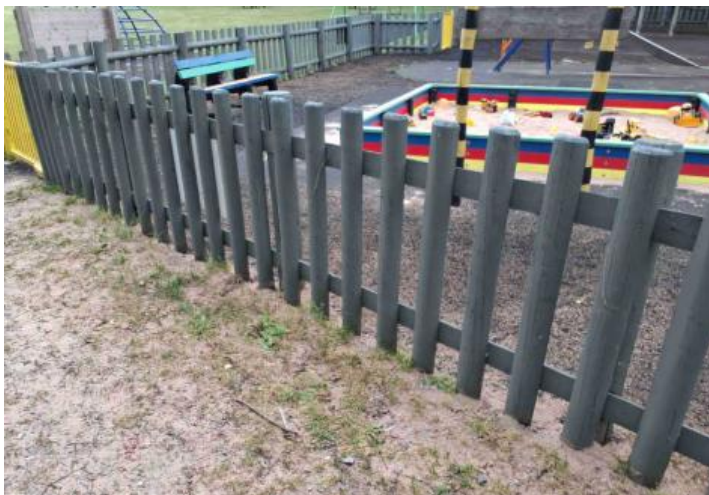
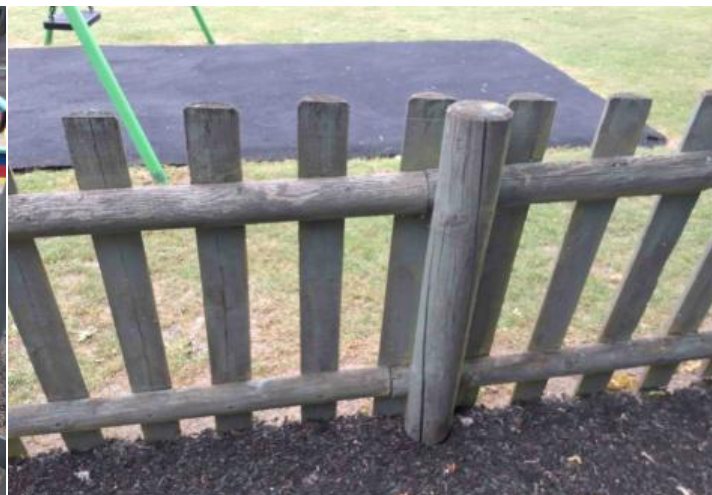
**Finding:** There are a number of loose posts around the fence

**Action:** Monitor for any further deterioration and reset as required

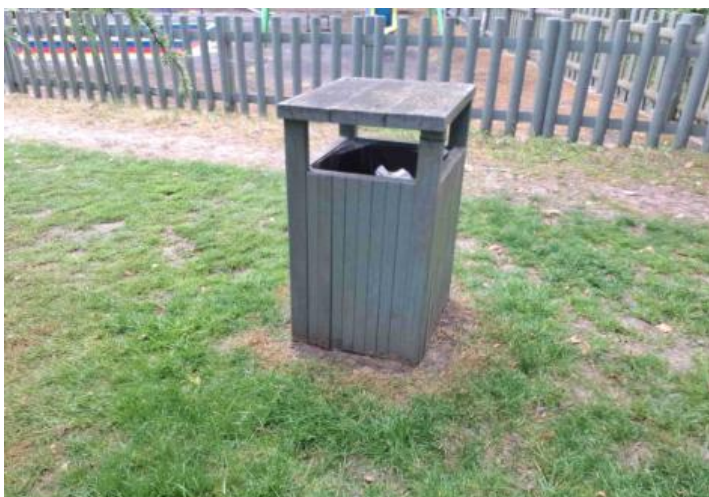
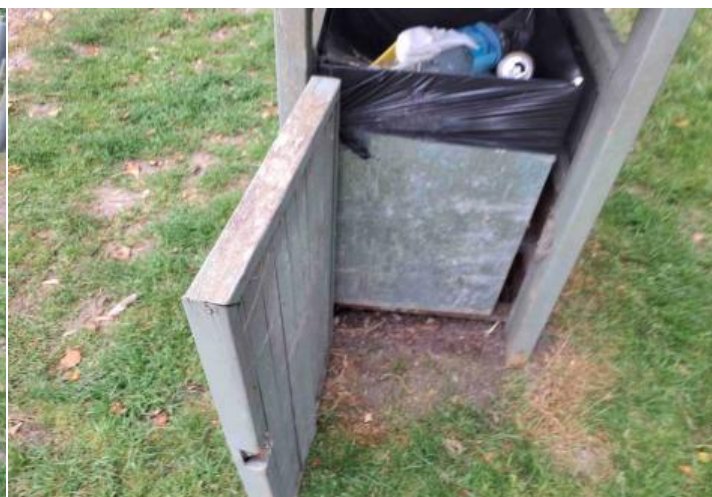
**Finding:** The lid or door of the litter bin is not secured

**Action:** Ensure the lid or door is kept locked

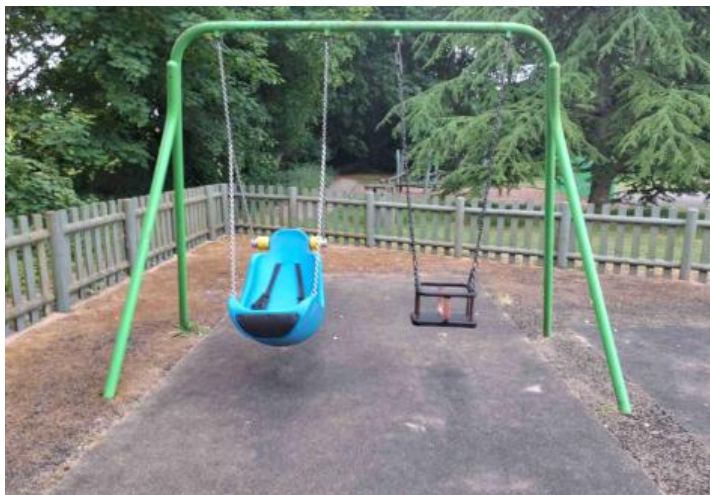
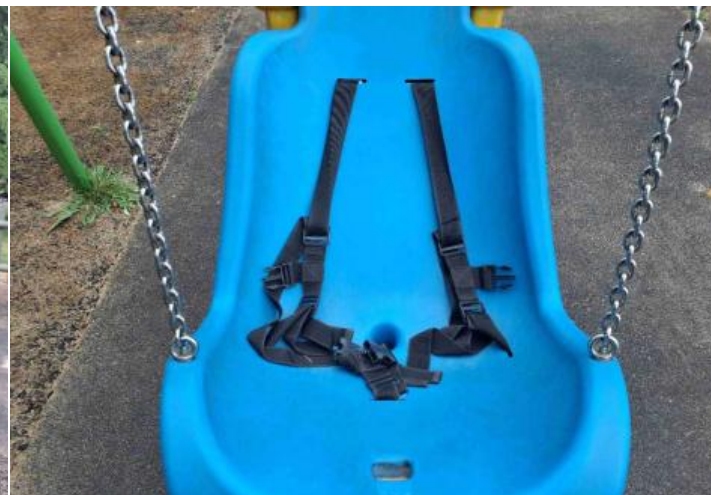
**Finding:** The safety harness is not designed to be left on the seat as it presents a strangulation risk if not used as intended. The manufacturer advises that the harness is an accessory that comes to the play area with the supervisor and leaves with the supervisor. The harness is not to be left attached to the seat when not in use.

**Action:** Remove harness

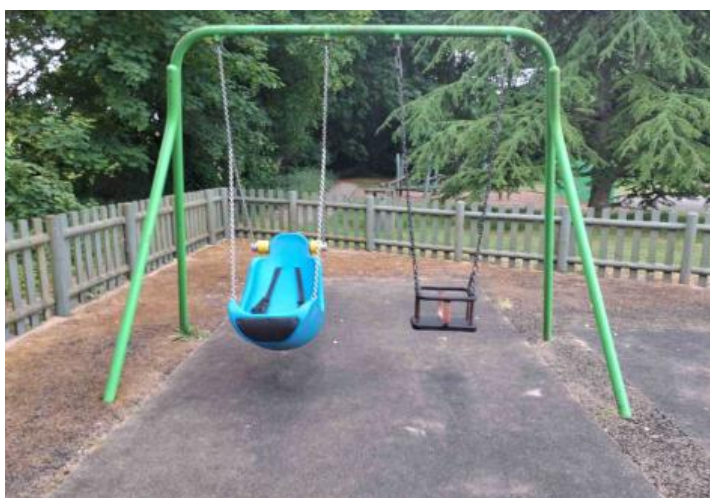
**Finding:** The chain openings are in excess of the 8.6mm as recommended by BS EN 1176

**Action:** Monitor - No action given the risk assessment

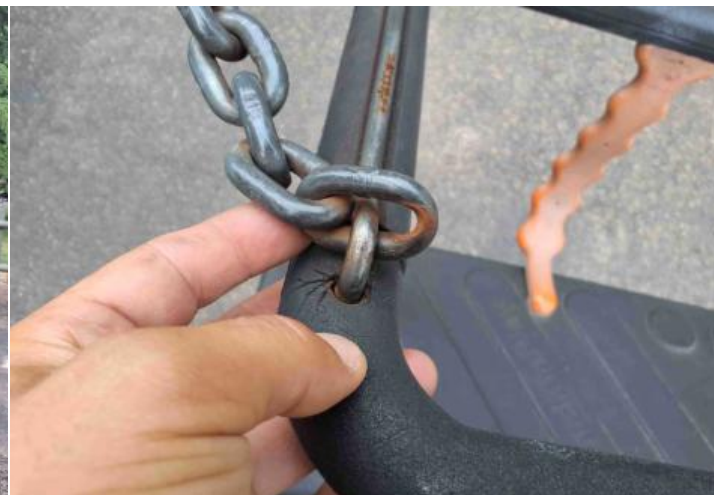
**Finding:** There is some notable evidence of chain wear

**Action:** Monitor for any further deterioration and replace when 40% worn

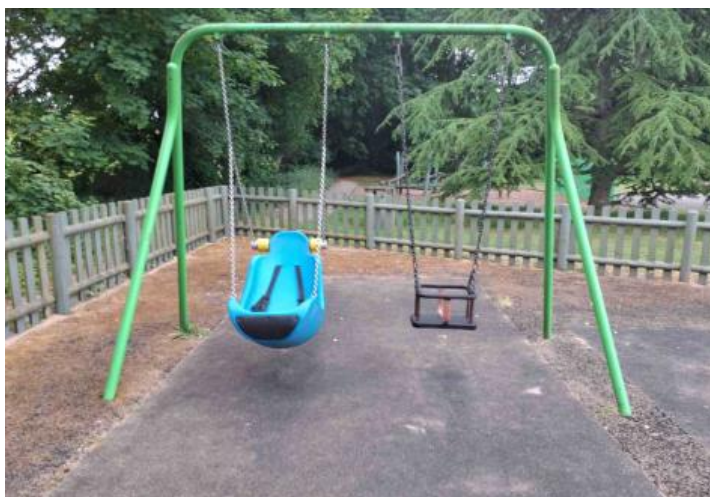
**Finding:** The seats are too close to each other as defined in BS EN 1176 Part 2; this is a low risk failure and no remedial action is required

**Action:** Monitor - No action given the risk assessment

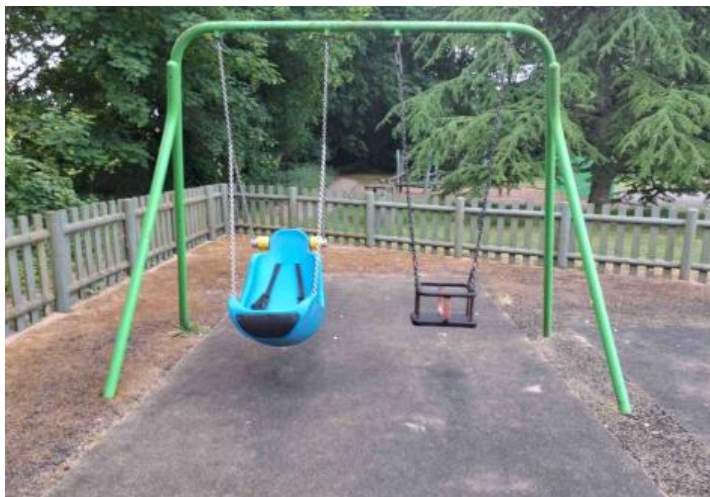
**Finding:** The seat clearance from finished surface level to the underside of the seat is too low and does not meet the requirements of BS EN 1176 Part 2 (350mm minimum clearance required)

**Action:** Adjust seat height/s (400mm-500mm is recommended)

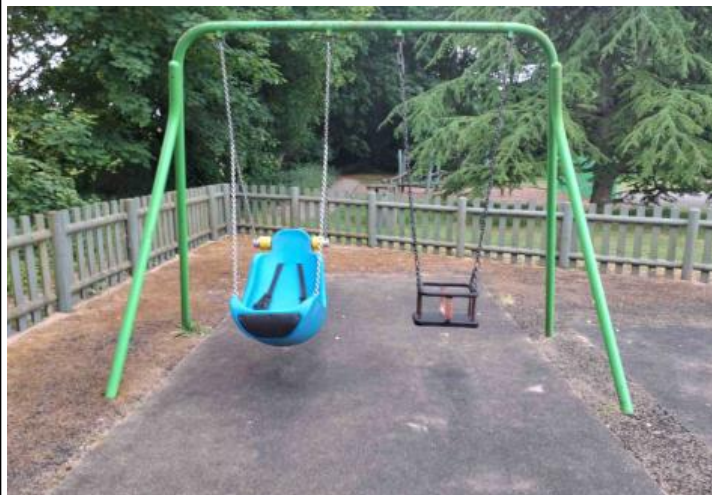
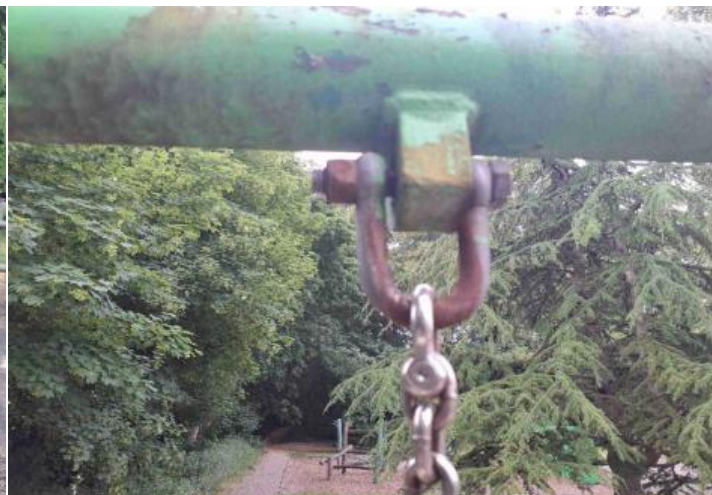
**Finding:** There is some wear to the shackles.

**Action:** Monitor for any further deterioration and replace when 40% worn

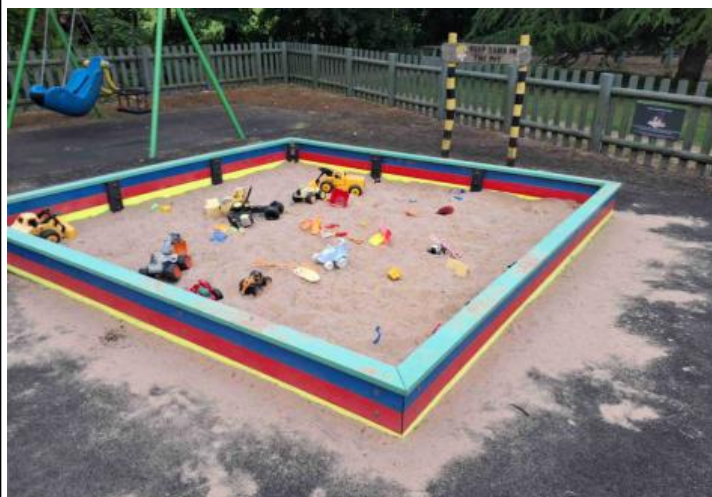
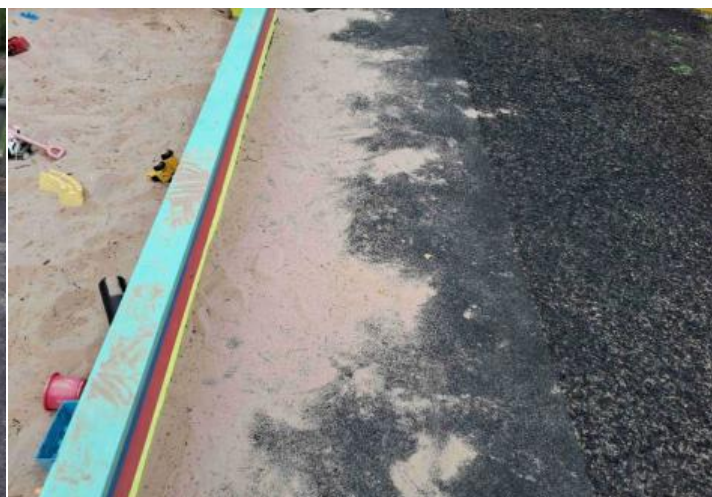
**Finding:** Sand is migrating on to the surrounding surface which may become slippery

**Action:** Clean and maintain

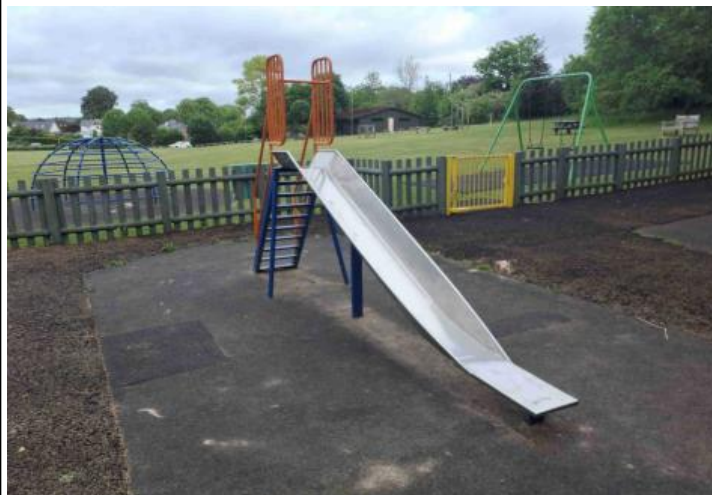
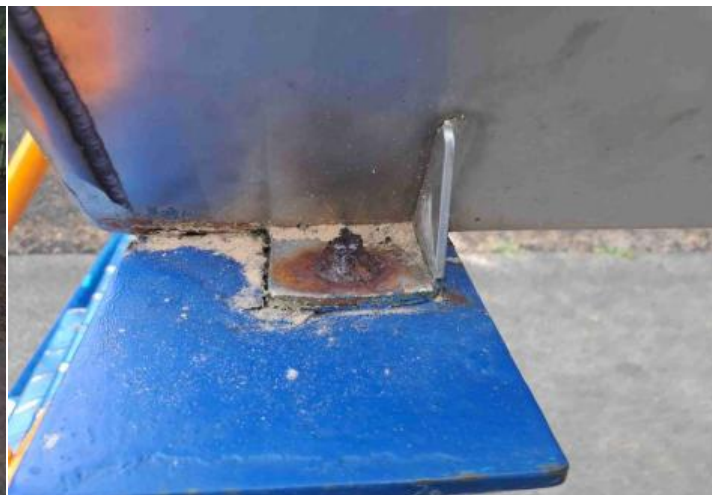
**Finding:** The fixings have corroded excessively

**Action:** Replace all corroded fixings

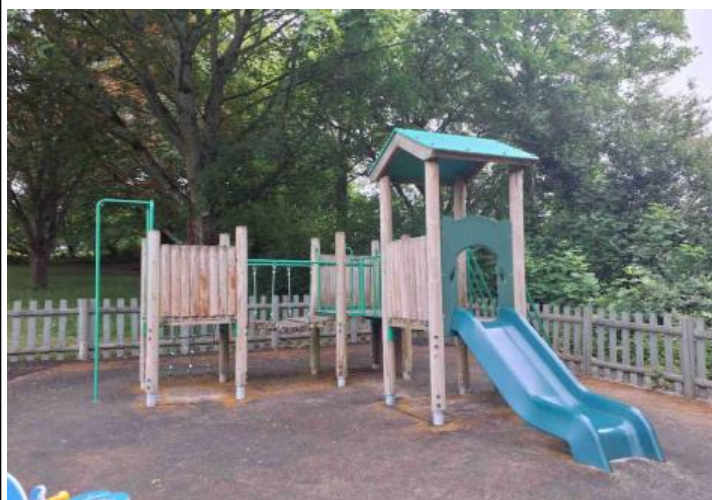
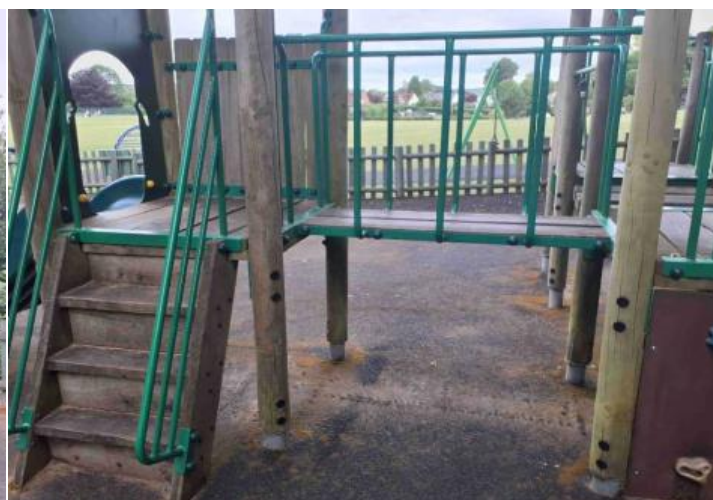
**Item:** Activity Equipment - Multi Play (Junior)  
**Manufacturer:** A.E.Evans

**Finding:** The unit is easily accessible and should have the appropriate barriers installed to meet the requirements of BS EN 1176 Part 1 as the height of the unit exceeds 600mm

**Action:** Monitor - No action given the risk assessment

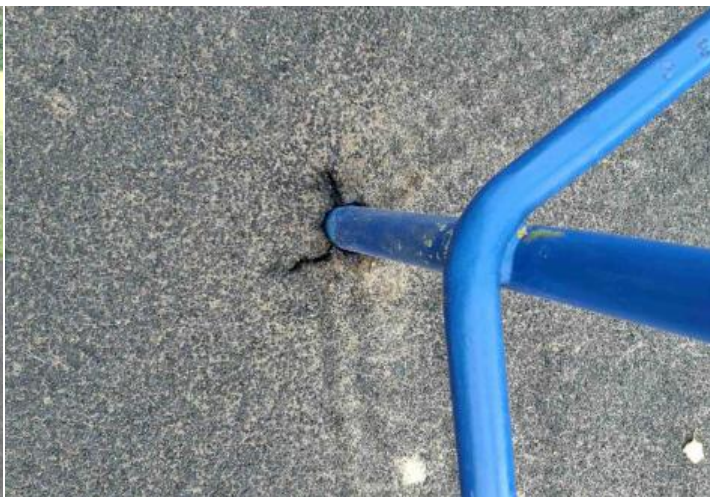
**Item:** Activity Equipment - Climbing Frame  
**Manufacturer:** Not Identified

**Finding:** There is some minor damage to the surface

**Action:** Monitor for any further deterioration and repair as required

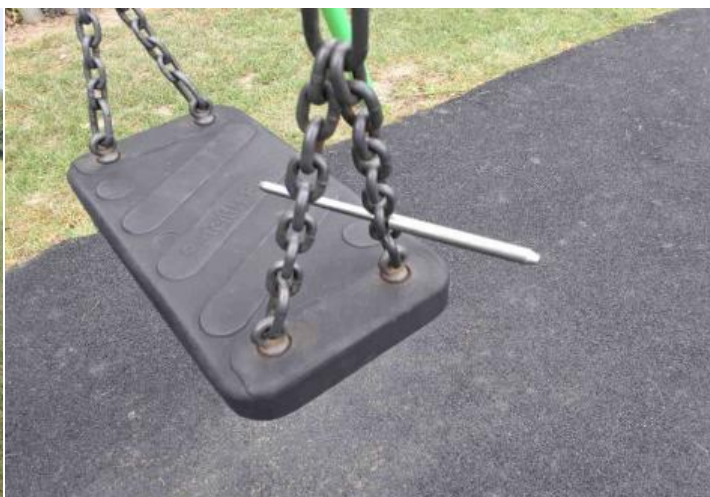
**Item:** Swings - 1 Bay 2 Seat (Flat)  
**Manufacturer:** Not Identified

**Finding:** The chain openings are in excess of the 8.6mm as recommended by BS EN 1176

**Action:** Monitor - No action given the risk assessment

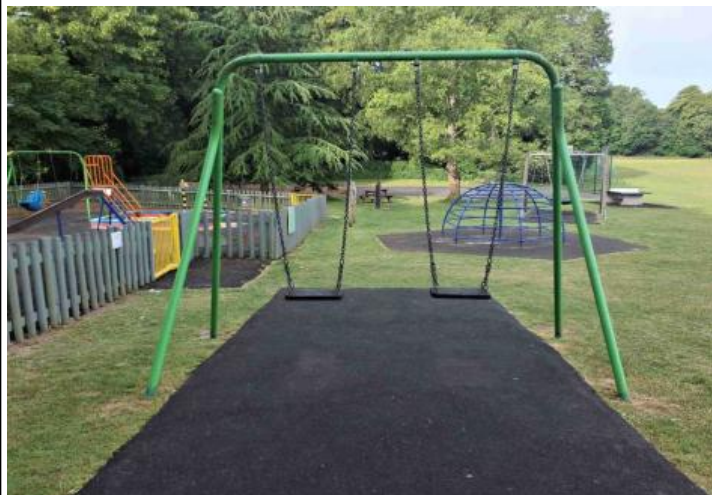
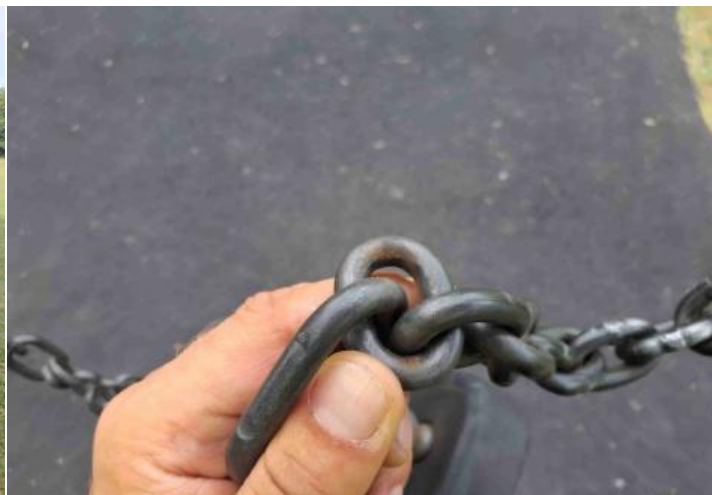
**Item:** Swings - 1 Bay 2 Seat (Flat)  
**Manufacturer:** Not Identified

**Finding:** There is some notable evidence of chain wear

**Action:** Monitor for any further deterioration and replace when 40% worn

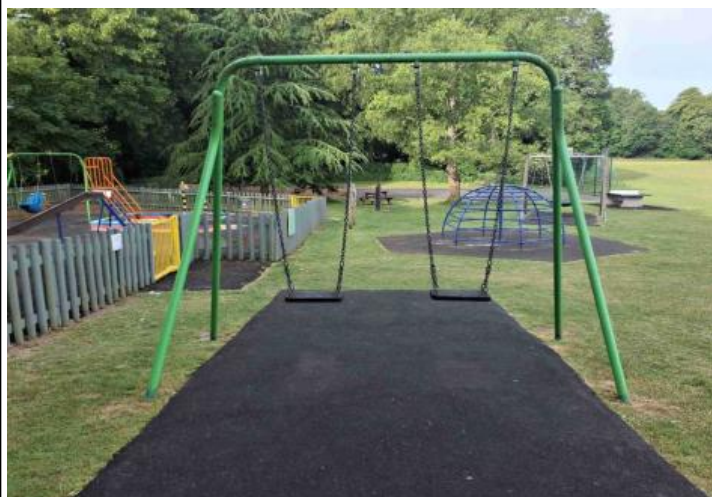
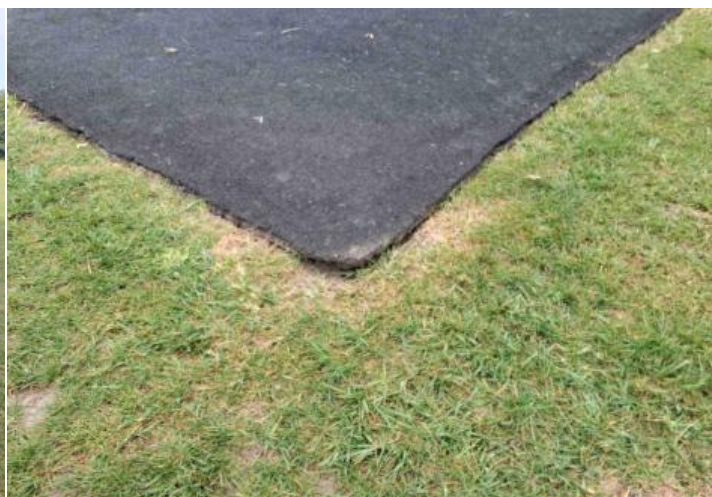
**Item:** Swings - 1 Bay 2 Seat (Flat)  
**Manufacturer:** Not Identified

**Finding:** The surface is lifting at the edges and creating trip points

**Action:** Repair perimeter of surfacing to remove trip points

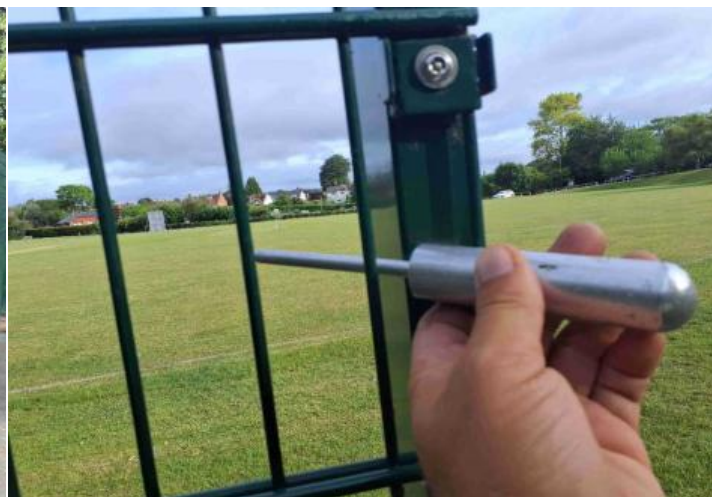
**Finding:** There is/are finger entrapments in the mesh and the item fails to meet the requirements of BS EN 15312 Clause 4.4.2.2 Entrapment of fingers

**Action:** Monitor - No action given the risk assessment

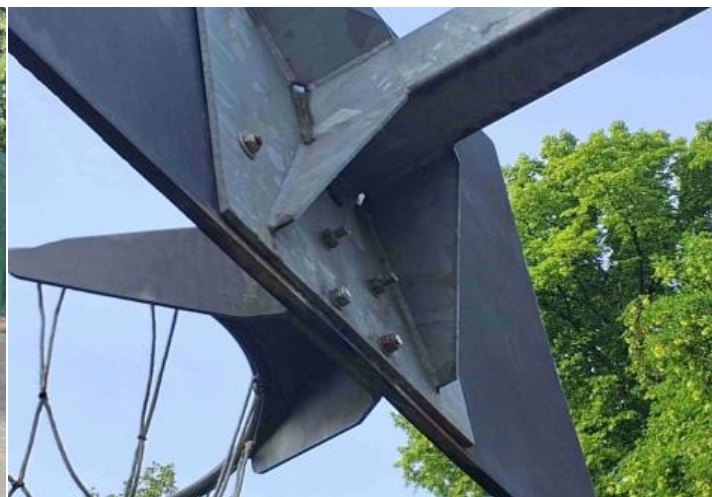
**Finding:** There are projecting bolt thread(s) present

**Action:** Remove excess thread length and deburr or provide cap
