I hereby summon you to attend a meeting of the **RECREATION COMMITTEE** on Thursday 10th September 2026 at 7:30 PM, to be held at The Pavilion, Hunter Park, SO21 1QS

**To Receive** the Visual Tree Assessment conducted in May 2026 and **consider** the recommendations.

The Visual Tree Assessment (VTA) was carried out in July 2026 to assess the condition and safety of trees at Northfields and Hunter Park.

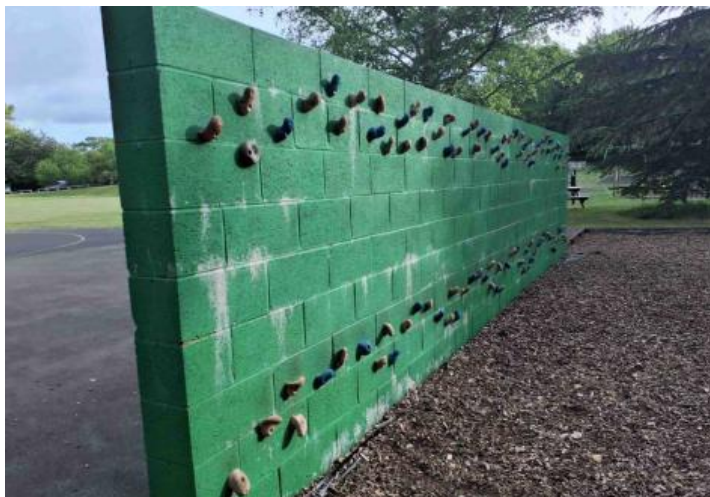
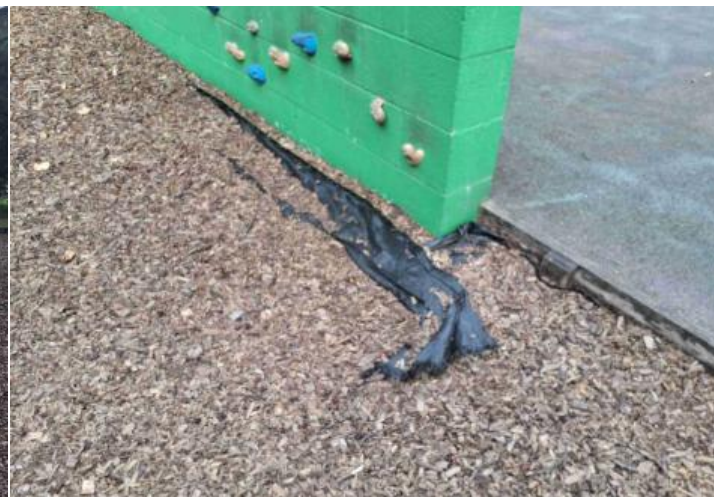
**Item:** Activity Equipment - Traverse Wall  
**Manufacturer:** Not Identified

**Finding:** The safety surface is low and the membrane is exposed creating trip points

**Action:** Remove or resecure the exposed membrane and top up the surface to the correct level

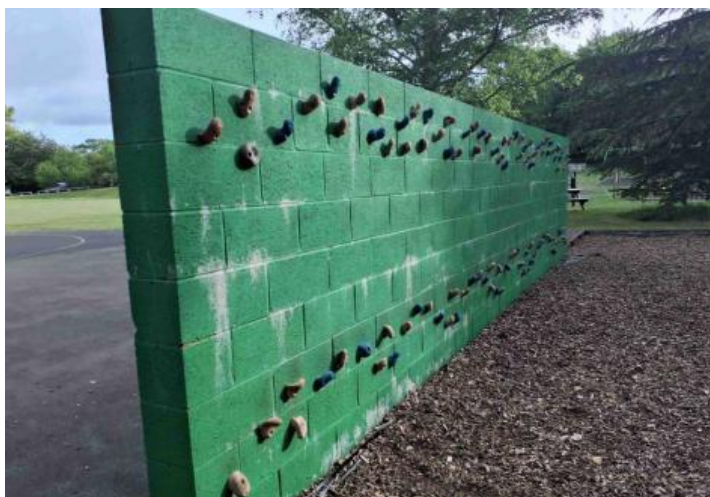
**Item:** Activity Equipment - Traverse Wall  
**Manufacturer:** Not Identified

**Finding:** The surface has eroded and the foundations are exposed

**Action:** Reinstate surrounding surfaces to cover the foundations

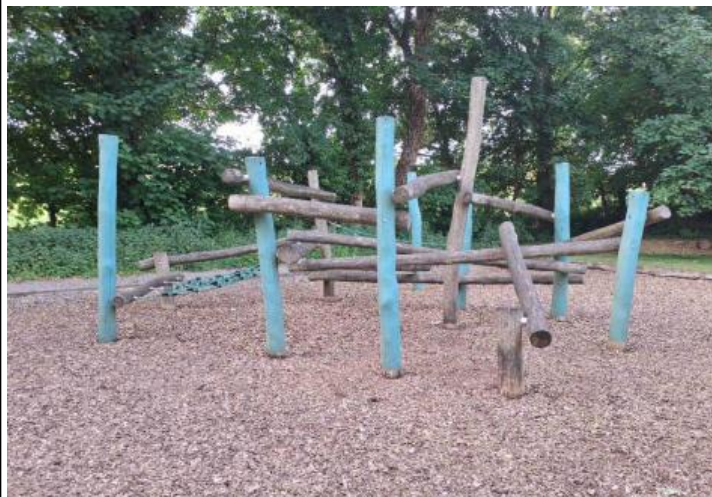
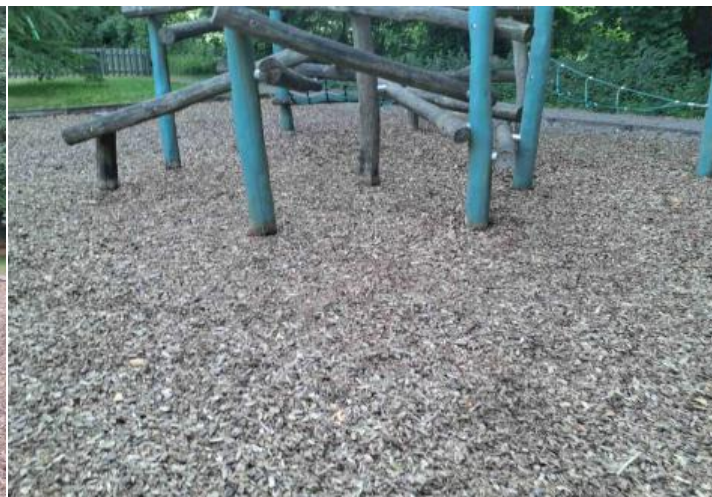
**Item:** Activity Equipment - Log Climber  
**Manufacturer:** Dylan Group Ltd

**Finding:** The depth of the loose fill surfacing is lower than the recommended depth specified in BS EN 1176; the free height of fall of the equipment is less than 2.0m and a minimum of 300mm depth should be provided (including an extra 100mm to allow for compaction and displacement as per BS EN 1176 Part 1 - Table 4)

**Action:** Top up loose fill surfacing to recommended levels

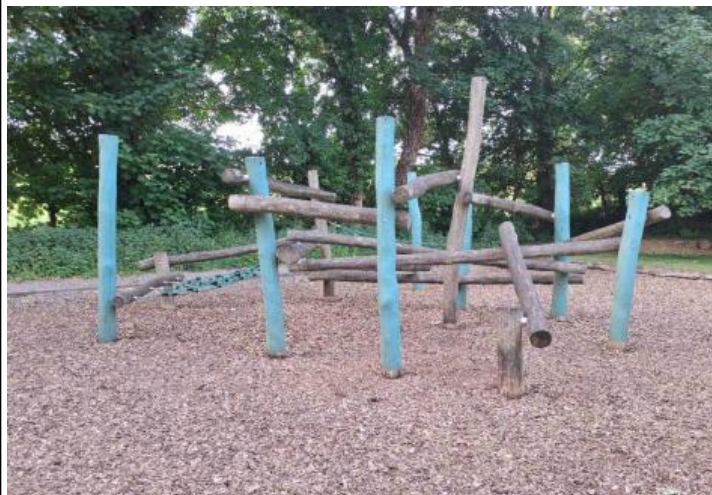
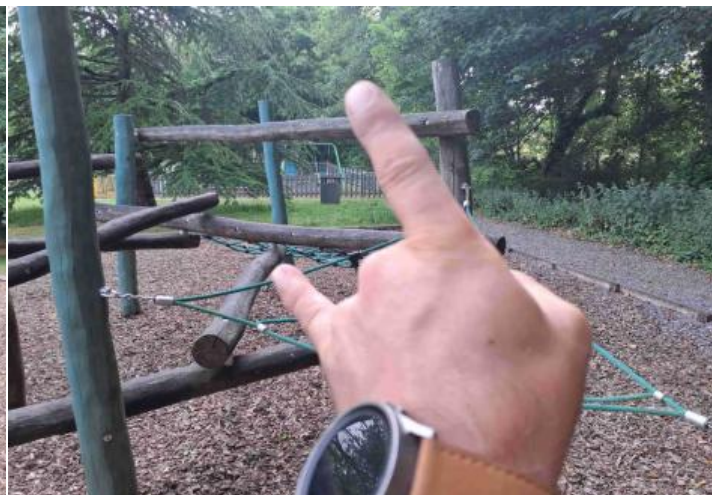
**Item:** Activity Equipment - Log Climber  
**Manufacturer:** Dylan Group Ltd

**Finding:** There are falls in excess of 600mm between adjacent components on the structure, in contravention of the recommendations set out in BS EN 1176 Part 1; 4.2.8.4

**Action:** Monitor - No action given the risk assessment

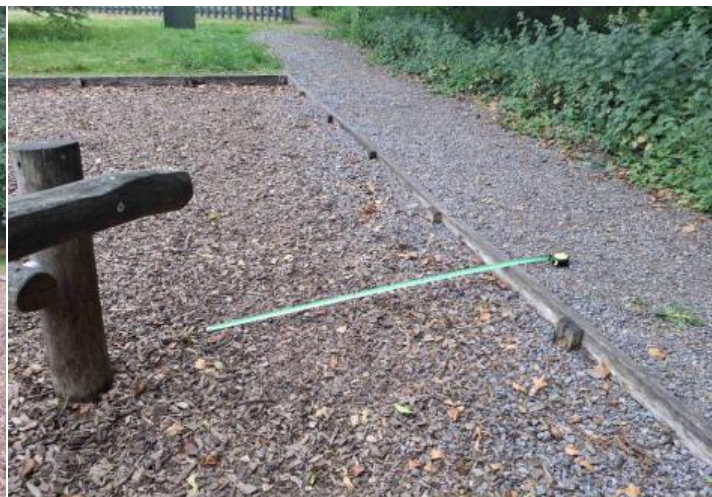
**Item:** Activity Equipment - Log Climber  
**Manufacturer:** Dylan Group Ltd

**Finding:** The timber edging forms a projecting obstacle / hard object within the falling space of the equipment, in contravention of the requirements of BS EN 1176 Part 1

**Action:** Top up loose fill to level with the edging

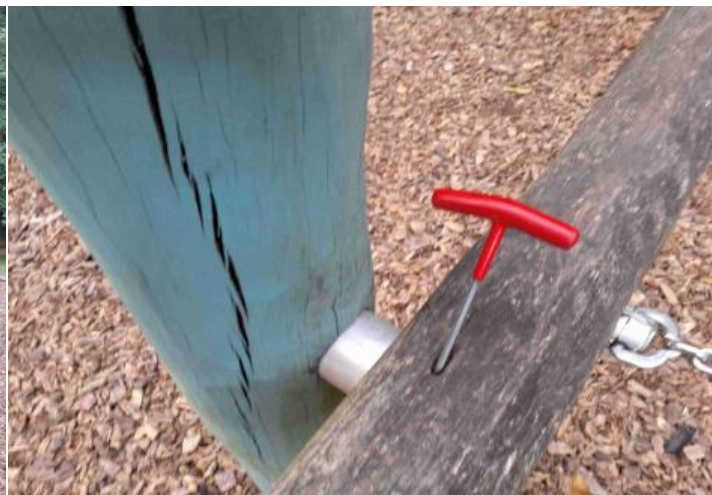
**Item:** Activity Equipment - Log Climber  
**Manufacturer:** Dylan Group Ltd

**Finding:** There is some evidence of rot in the timber

**Action:** Monitor for any further deterioration and replace as required

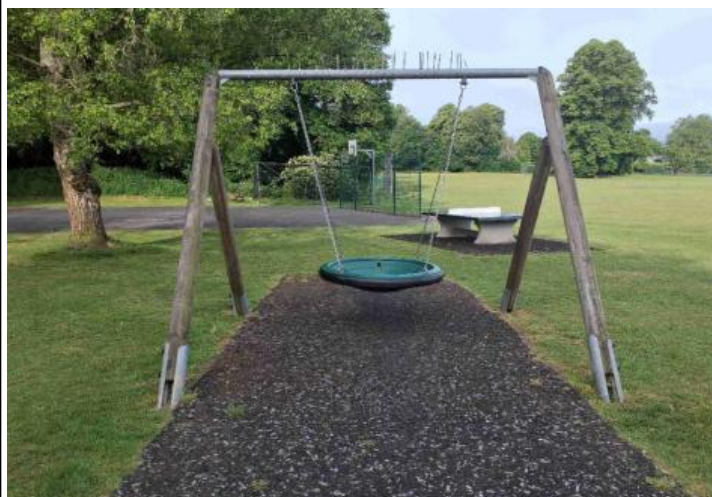
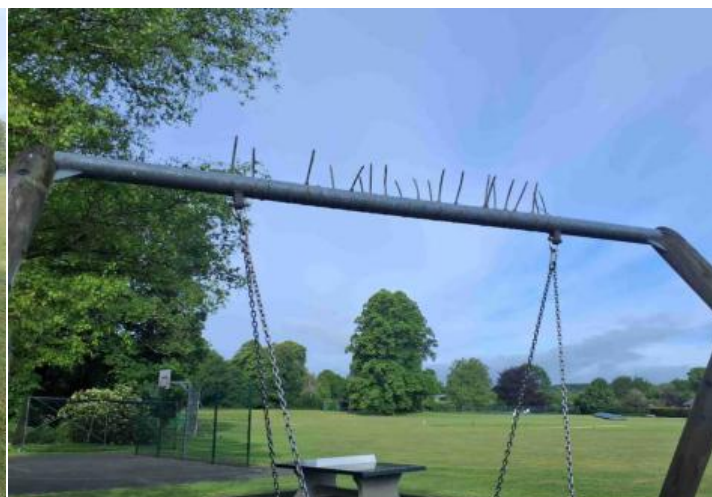
**Item:** Swings - Basket Swing - Type 1  
**Manufacturer:** Playdale Playgrounds Ltd

**Finding:** Swings of this design should have a secondary safety mechanism fitted to prevent collapse of the seat in the event of a joint failure to comply with BS EN 1176 Part 2, however this swing was installed prior to the standards being updated in 2018 and the manufacturer has confirmed that the joint was independently cycle tested by BSi

**Action:** Monitor use and check the joint and fixing security regularly

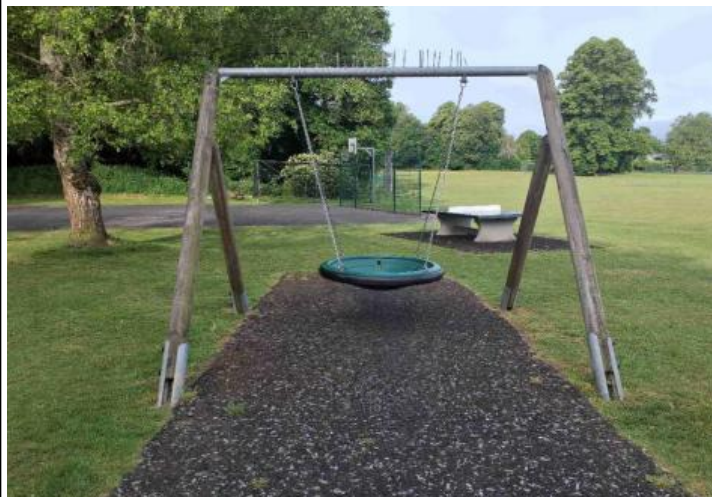
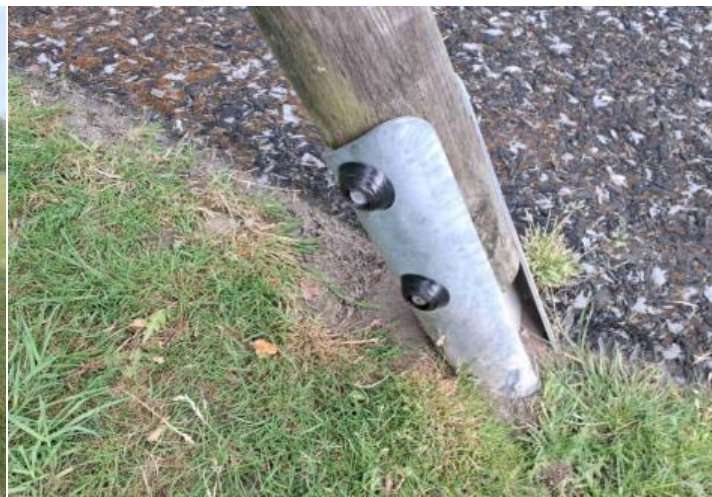
**Item:** Swings - Basket Swing - Type 1  
**Manufacturer:** Playdale Playgrounds Ltd

**Finding:** Bolt cap cover/s missing or damaged

**Action:** Replace

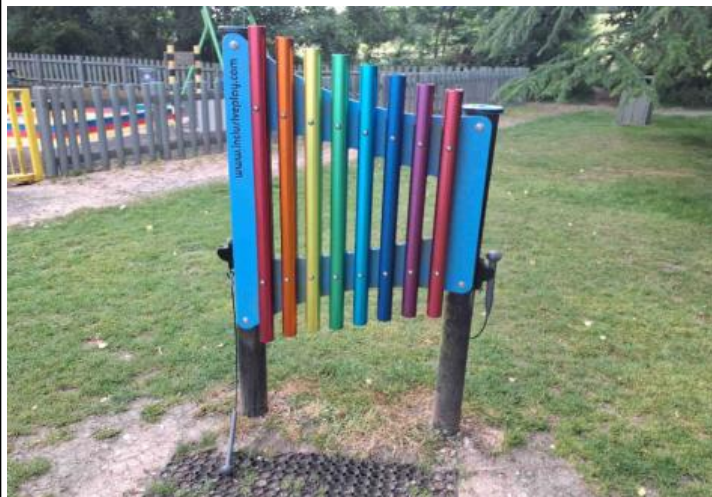
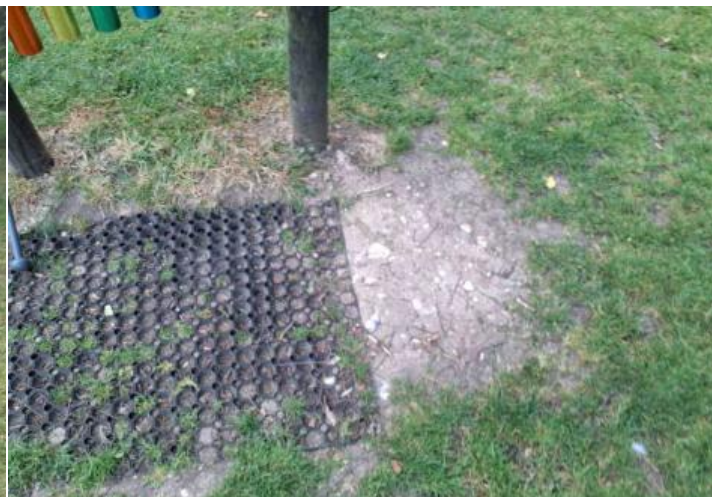
**Item:** Other - Musical Instrument  
**Manufacturer:** Inclusive Play

**Finding:** The area around the item has eroded and may become slippery

**Action:** Reinststate eroded area

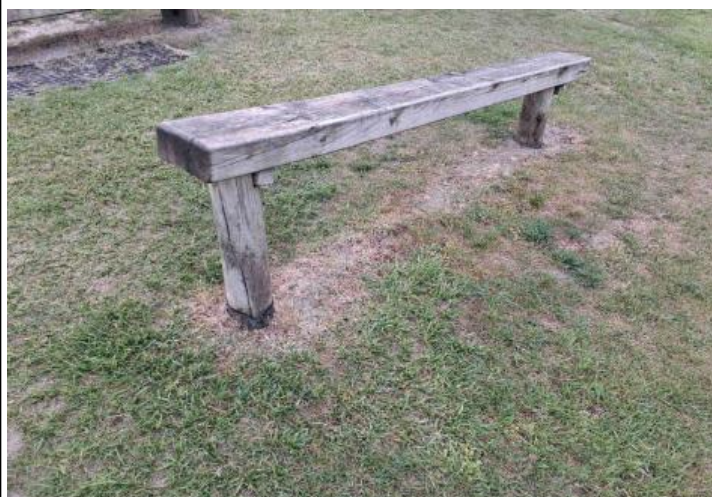
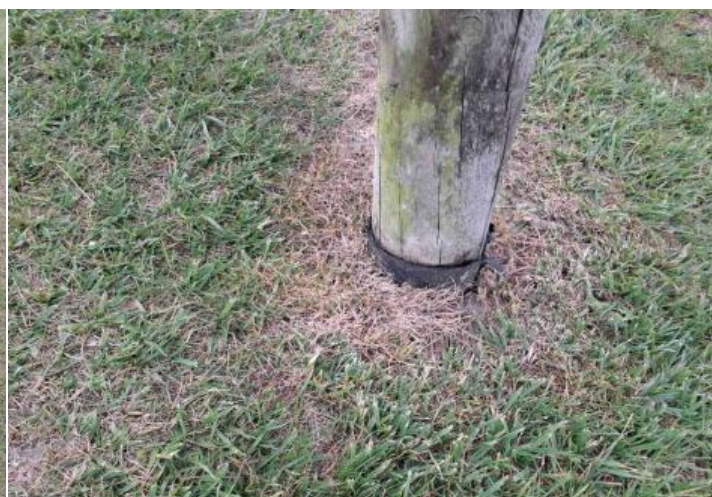
**Item:** Outdoor Fitness Equipment - Sit Up Station  
**Manufacturer:** Not Identified

**Finding:** There are post protectors around the timber posts that are preventing the inspector from thoroughly testing for signs of decay and we are unable to verify the condition of the posts in these locations. NOTE - timber rot / decay is possible even with the post protectors in place

**Action:** Refer to manufacturer inspection / maintenance recommendations

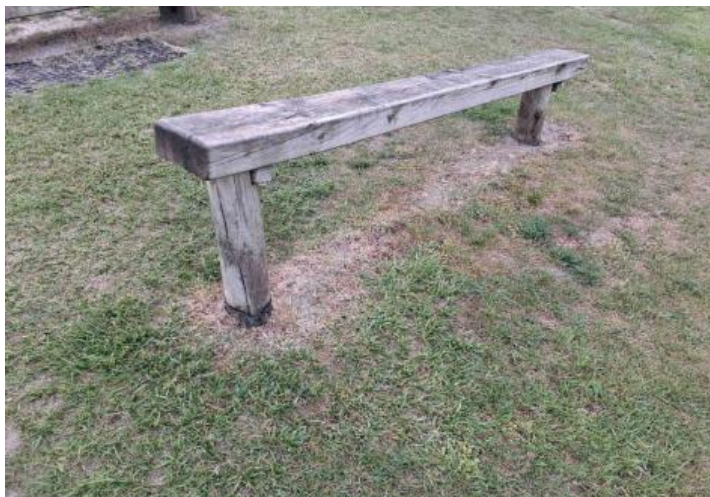
**Item:** Outdoor Fitness Equipment - Sit Up Station **Risk Level:** L - Low Risk  
**Manufacturer:** Not Identified **Surface:** Grass

**Finding:** The item is slightly loose in its foundations

**Action:** Monitor for any further deterioration and repair as required

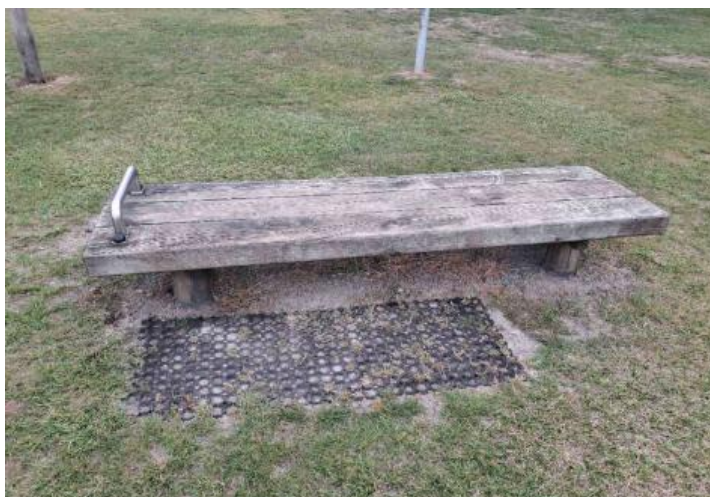
**Item:** Outdoor Fitness Equipment - Ability Bench **Risk Level:** L - Low Risk  
**Manufacturer:** Not Identified **Surface:** Mixed Surface

**Finding:** The edges of the grass mat surface are raised / lifting above the surrounding surface

**Action:** Secure edges of grass mats as per the API Code of Practice to remove trip hazards

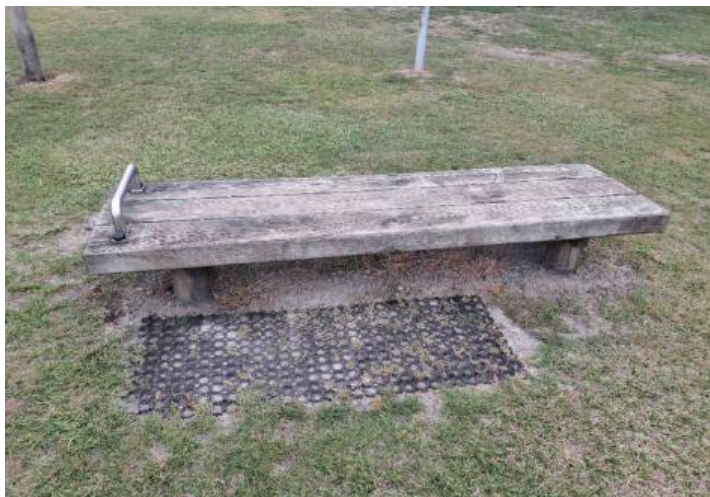
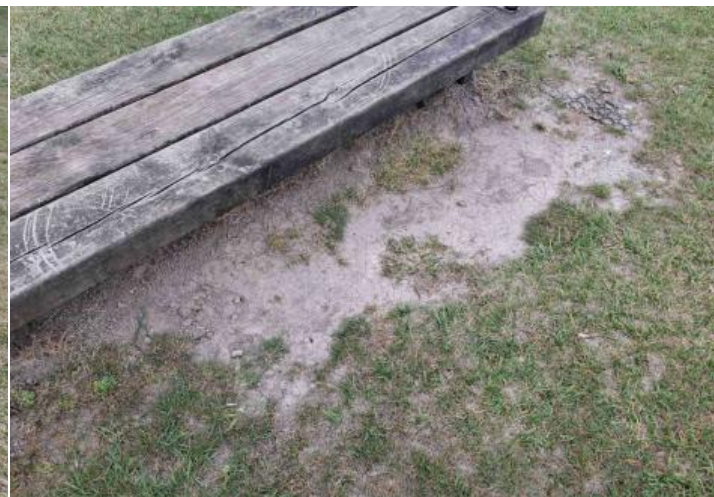
**Item:** Outdoor Fitness Equipment - Ability Bench  
**Manufacturer:** Not Identified  
**Risk Level:** L - Low Risk  
**Surface:** Mixed Surface

**Finding:** The area around the item has eroded and may become slippery

**Action:** Reinststate eroded area

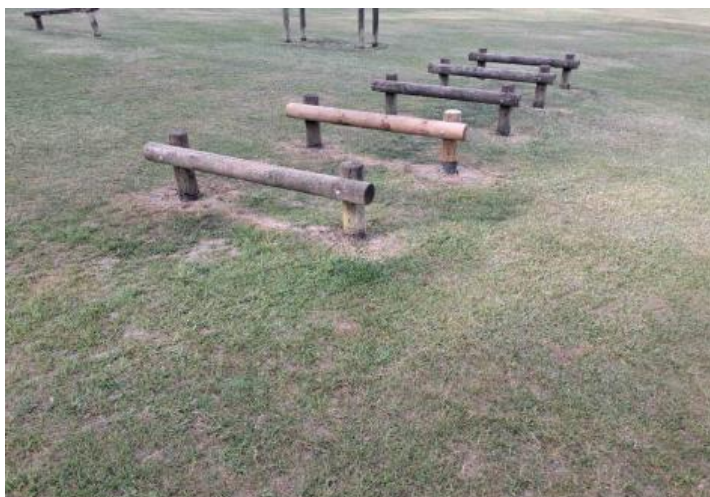
**Item:** Outdoor Fitness Equipment - Hurdles  
**Manufacturer:** Not Identified  
**Risk Level:** N - Risk Assessment not Undertaken  
**Surface:** Grass

**Finding:** There are post protectors around the timber posts that are preventing the inspector from thoroughly testing for signs of decay and we are unable to verify the condition of the posts in these locations. NOTE - timber rot / decay is possible even with the post protectors in place

**Action:** Refer to manufacturer inspection / maintenance recommendations

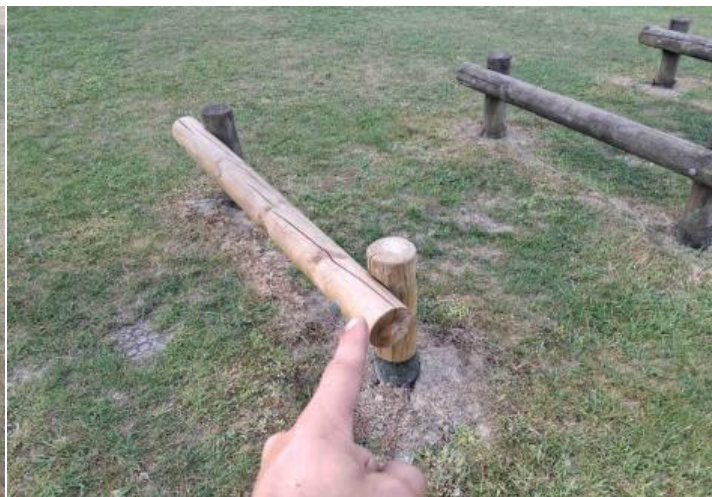
**Item:** Outdoor Fitness Equipment - Hurdles  
**Manufacturer:** Not Identified

**Finding:** A number of fixing(s) have worked loose

**Action:** Secure all loose fixings

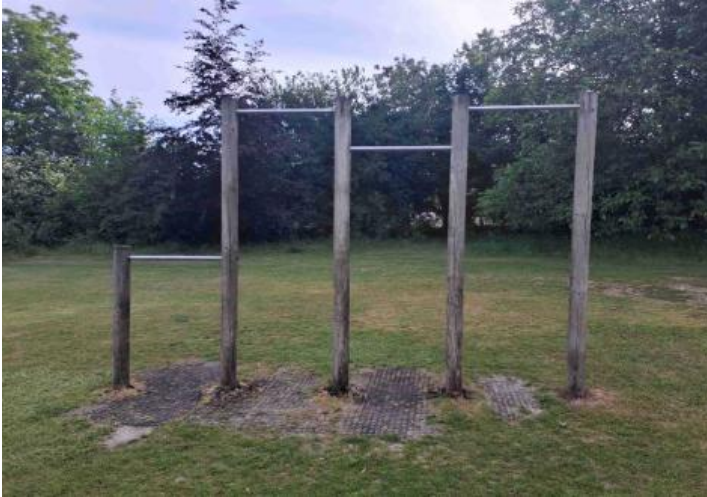
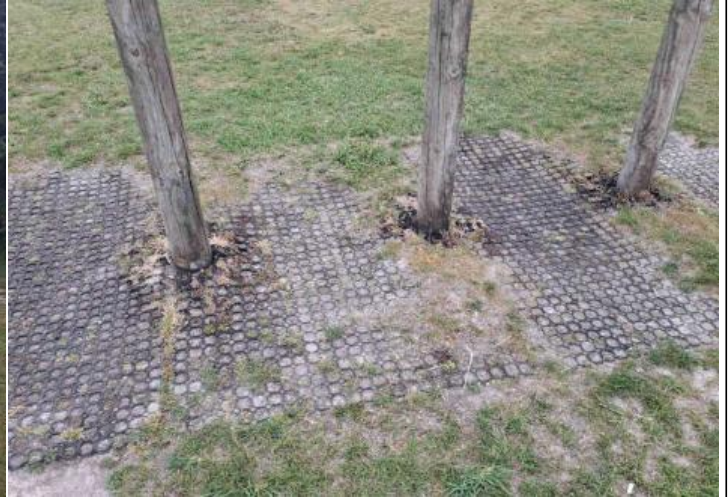
**Item:** Outdoor Fitness Equipment - Pull Up Station  
**Manufacturer:** Not Identified

**Finding:** The grass mats are silted up, the soil is compacted and the area will become very slippery when the soil is wet. **Action:** Reinstate as required

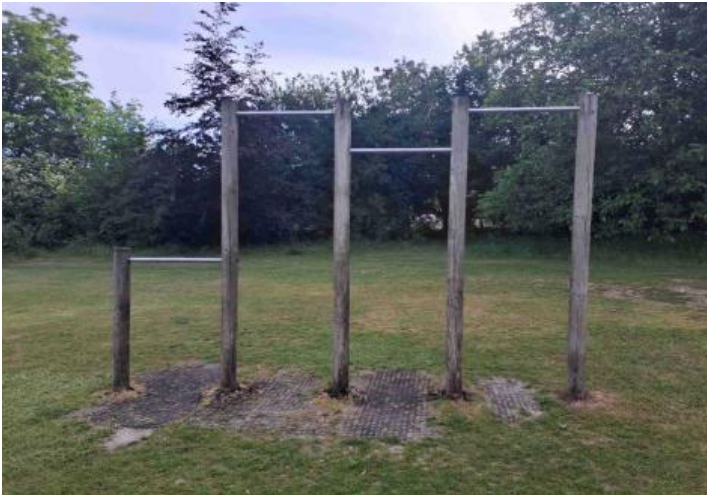
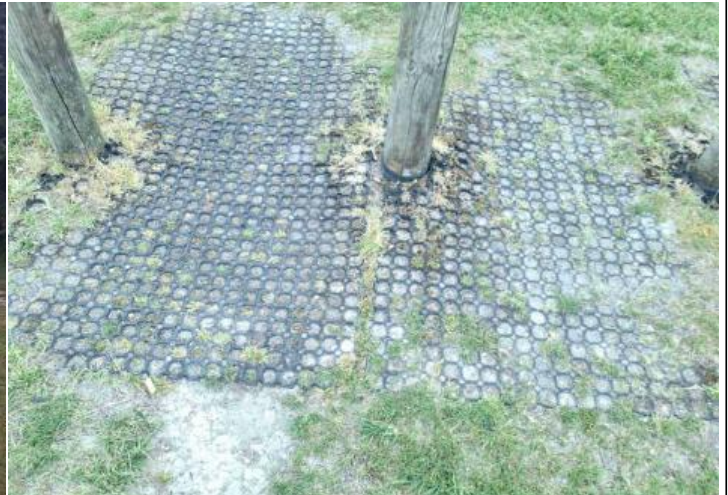
**Item:** Outdoor Fitness Equipment - Pull Up Station  
**Manufacturer:** Not Identified

**Finding:** There are gaps opening between the grass mat tiles **Action:** Provide additional ties or secure / reinstate surface

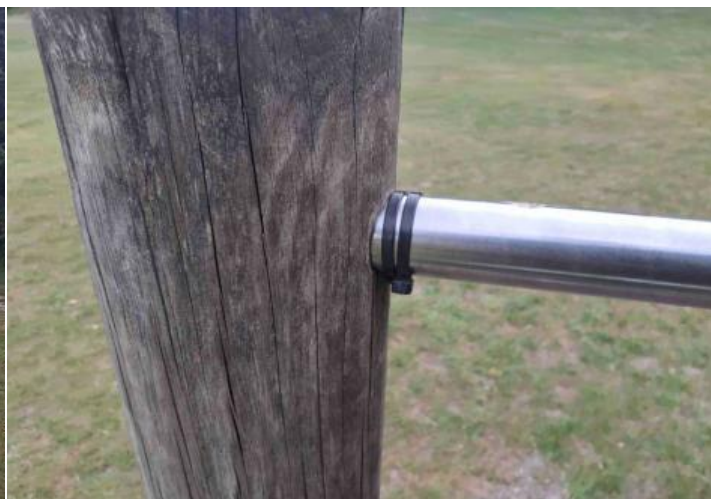
**Finding:** Cable ties are present and there are sharp projecting ends

**Action:** Remove

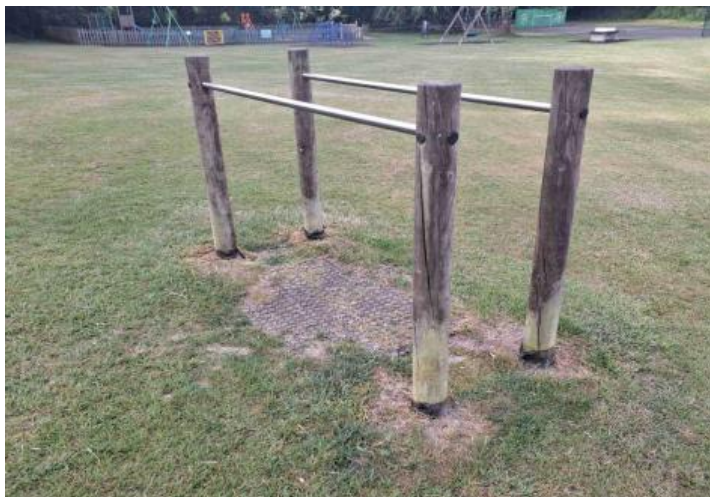
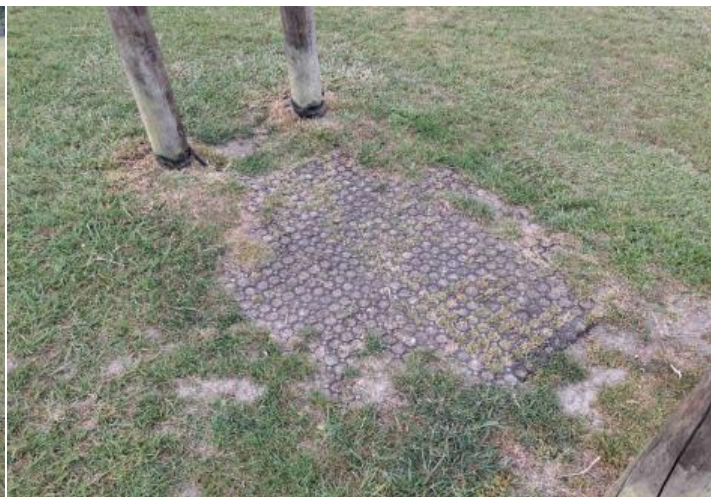
**Finding:** The grass mats are silted up, the soil is compacted and the area will become very slippery when the soil is wet.

**Action:** Reinstate as required

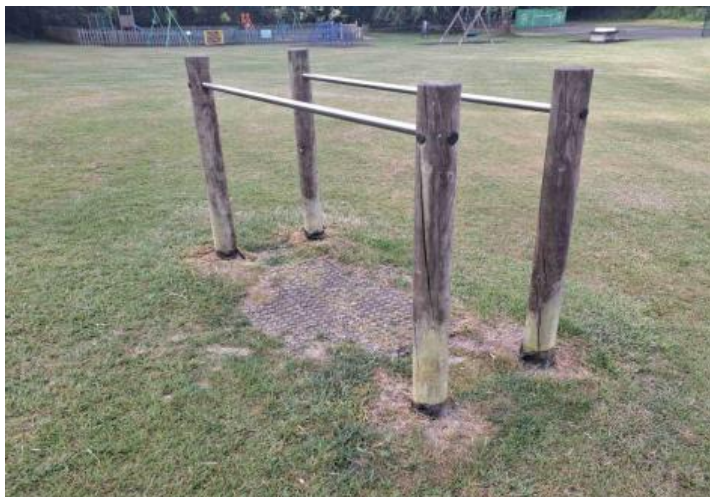
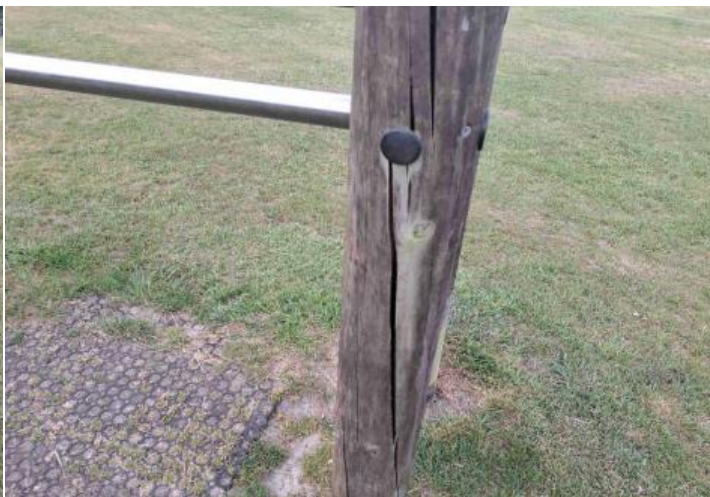
**Finding:** There is some strimmer / machinery damage apparent on the posts, this can penetrate the preservative applied to the timber and accelerate the rotting process

**Action:** Monitor for any deterioration (rot) and replace as required

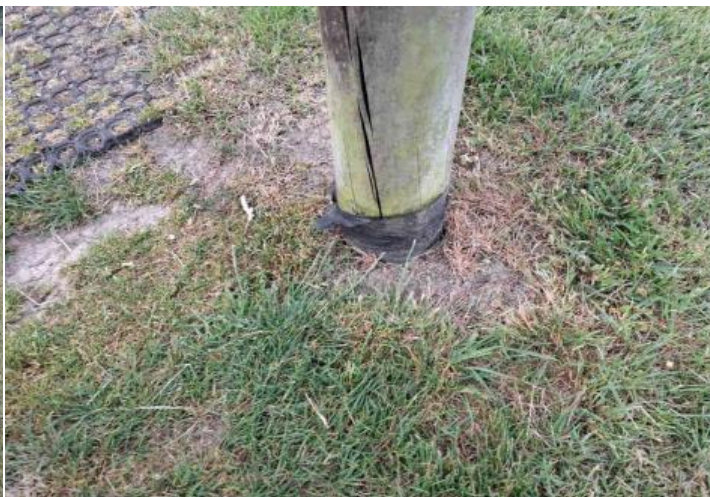
**Finding:** There are post protectors around the timber posts that are preventing the inspector from thoroughly testing for signs of decay and we are unable to verify the condition of the posts in these locations. NOTE - timber rot / decay is possible even with the post protectors in place

**Action:** Refer to manufacturer inspection / maintenance recommendations

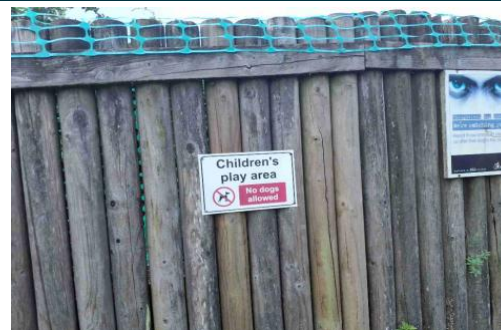
It is recommended that signage, with information including the site address, contact information for maintenance issues and emergency contact details are provided for the facility - Provide in accordance with the recommendations

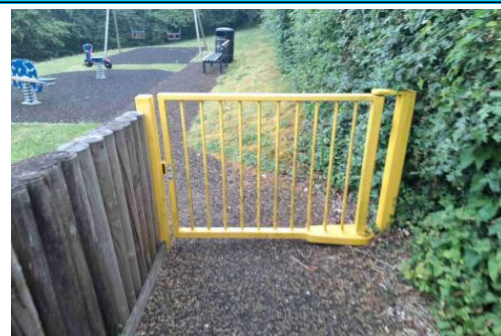
Insert/s missing or damaged - Replace

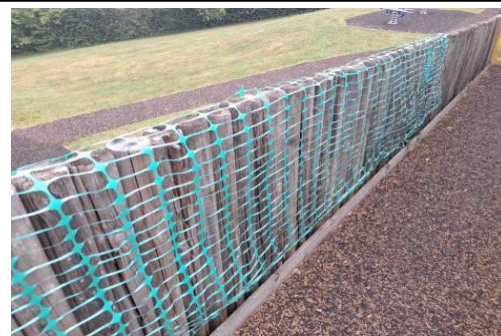
There are areas or parts of the timber on the structure that have rotted - Replace all affected timbers

There are a number of loose posts around the fence - Monitor for any further deterioration and reset as required

The fence is severely damaged in places - Repair or replace all affected sections

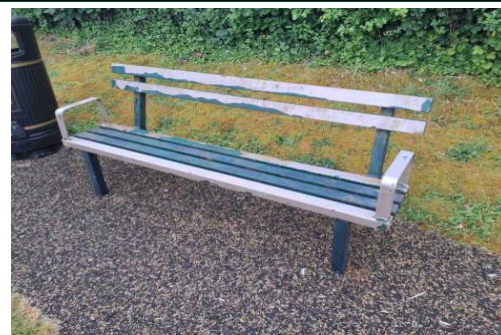
The paint is flaking off the metalwork - Rub down and re-paint

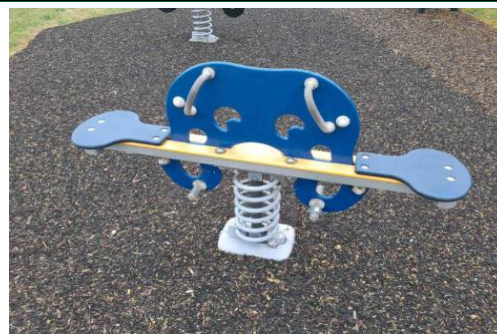
The end of handgrips and/or footrests have a cross section of less than 15cm<sup>2</sup> and fail to meet the requirements of BS EN 1176 Part 6 - Monitor - No action given the risk assessment

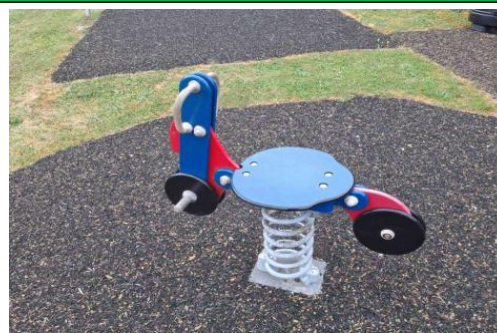
The paintwork on the spring has been damaged or worn exposing the metal underneath which is rusting - Treat any rusting components and repaint

Bolt cap cover/s missing or damaged - Replace

The end of handgrips and/or footrests have a cross section of less than 15cm<sup>2</sup> and fail to meet the requirements of BS EN 1176 Part 6 - Monitor - No action given the risk assessment

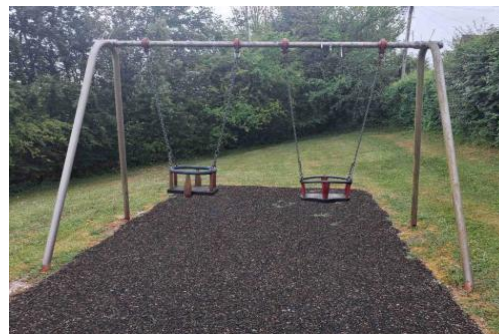
The split pins are missing from the shackles - Insert split pins to secure the shackles

The Anti Wrap bearings are dry and not moving freely - Lubricate bearings in accordance with the manufacturers recommendations

There is some notable evidence of chain wear - Monitor for any further deterioration and replace when 40% worn

The fixings have corroded excessively - Replace all corroded fixings

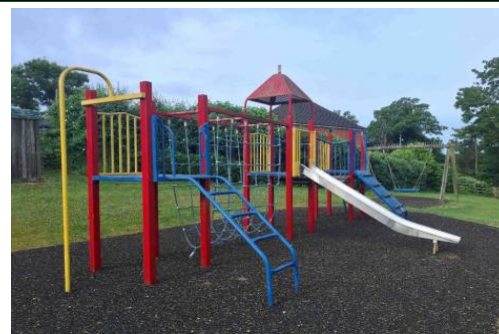
The item fails to meet the requirements of BS EN 1176 Part 1 4.2.7.2 for head and neck entrapment in the bridge - Remove entrapments

The paintwork on this item has been damaged or worn exposing the metal underneath which is rusting / corroding - Treat affected areas and repaint

There is some evidence of rot in the timber - Monitor for any further deterioration and replace as required

Insert/s missing or damaged - Replace

There is some wear to the shackles - Monitor for any further deterioration and replace when 40% worn

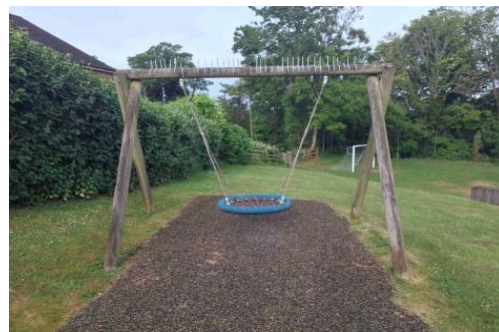
There is some evidence of rot in the timber - Monitor for any further deterioration and replace as required

The seat clearance from finished surface level to the underside of the seat is too low and does not meet the requirements of BS EN 1176 Part 2 (350mm minimum clearance required) - Adjust seat height/s (400mm-500mm is recommended)

There are areas or parts of the timber on the structure that have rotted - Replace all affected timbers

The connecting links are in excess of 8.6mm and less than 12mm and fail the requirements of BS EN 1176 Part 1; clause 4.2.13, Chains - Monitor - No action given the risk assessment

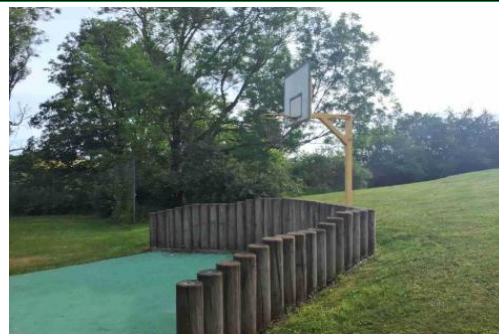
The free space between the backboard and the framework is less than 600mm and fails the requirements of BS EN15312:2007 +A1 2010 - Monitor - No action given the risk assessment

The item is slightly loose in its foundations - Monitor for any further deterioration and repair as required

The net has some minor damage - Monitor for any further deterioration and replace as required

The paintwork on this item has been damaged or worn exposing the metal underneath which is rusting / corroding - Treat affected areas and repaint

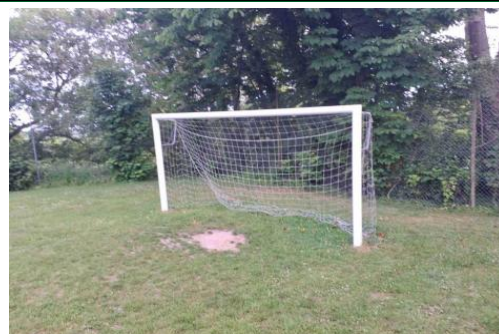
NB: We have undertaken a maintenance inspection only of the football goal(s); full load testing falls outside the scope of our inspection. - Implement load testing as required

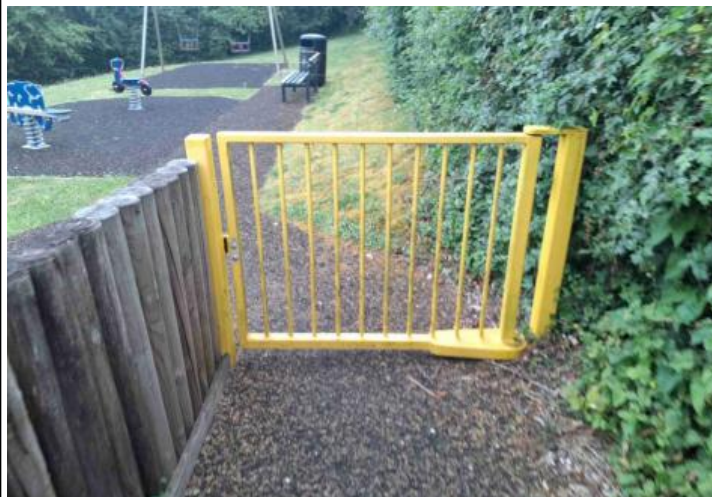
**Finding:** Insert/s missing or damaged

**Action:** Replace

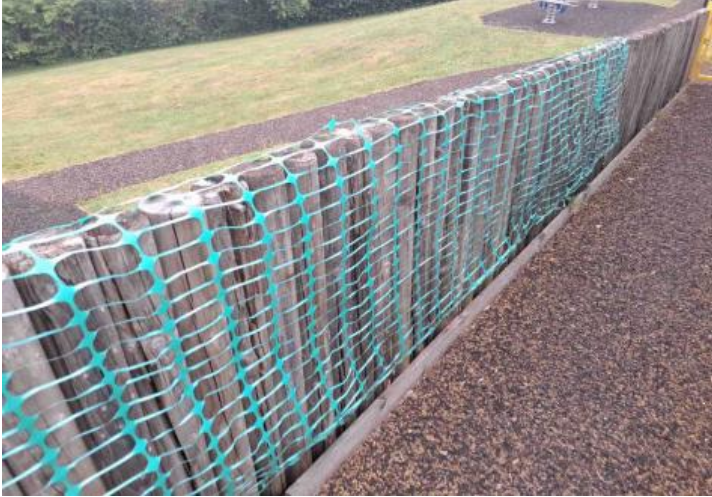
| <div> <div></div> <div>8 - Low Risk (Finding 1)</div> </div> | | | |
|---|--|---|--|
| <div> <div>Finding:</div> <div>There are areas or parts of the timber on the structure that have rotted</div> </div> | | <div> <div>Action:</div> <div>Replace all affected timbers</div> </div> | |

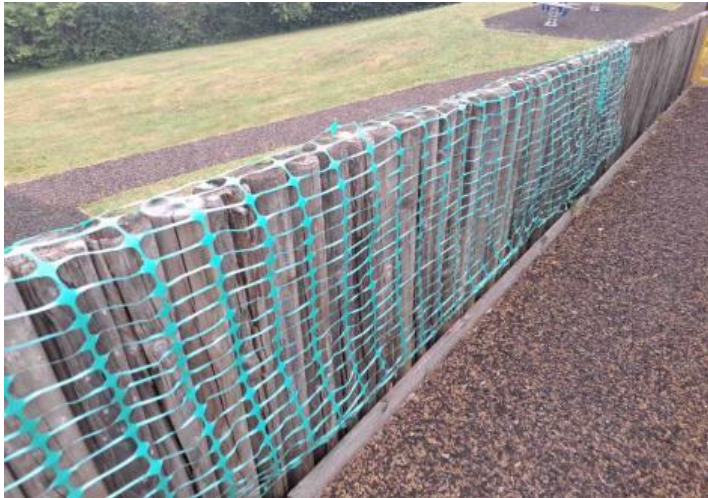
**Finding:** The fence is severely damaged in places

**Action:** Repair or replace all affected sections

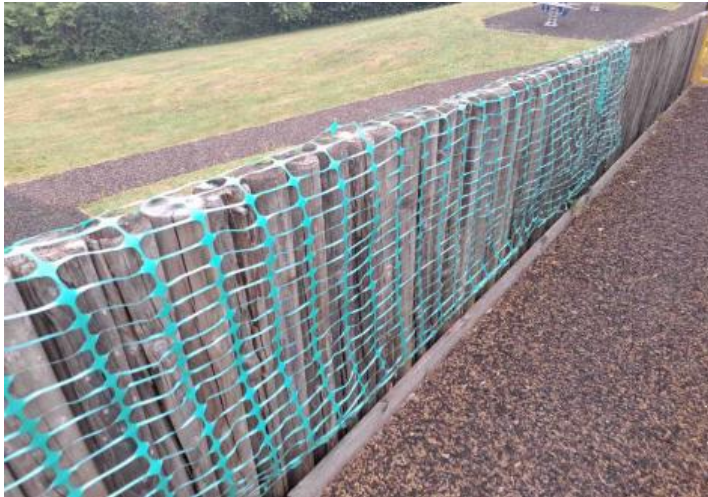
**Finding:** There are a number of loose posts around the fence

**Action:** Monitor for any further deterioration and reset as required

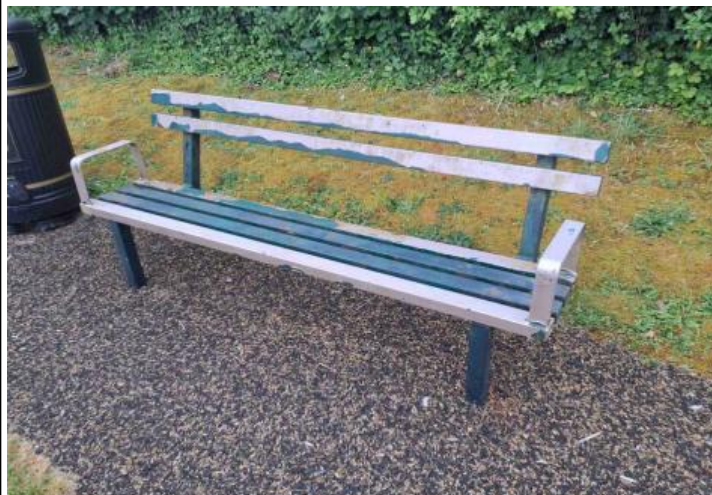
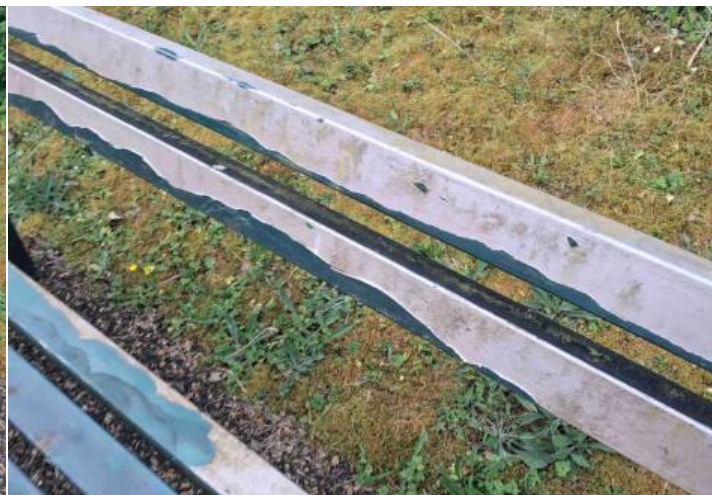
**Finding:** The paint is flaking off the metalwork

**Action:** Rub down and re-paint

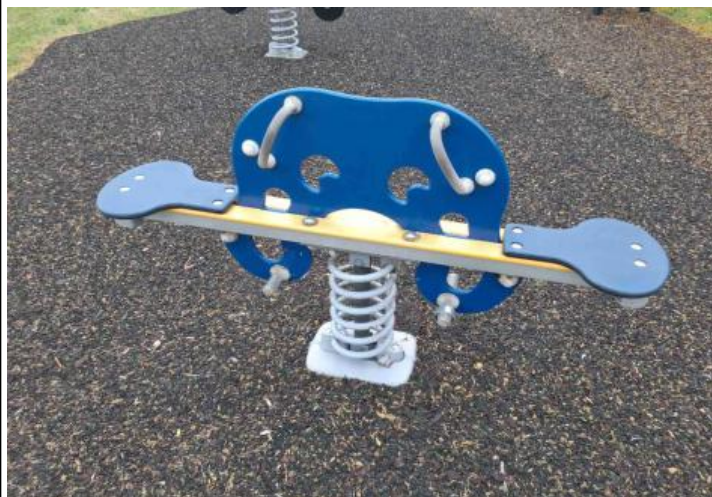
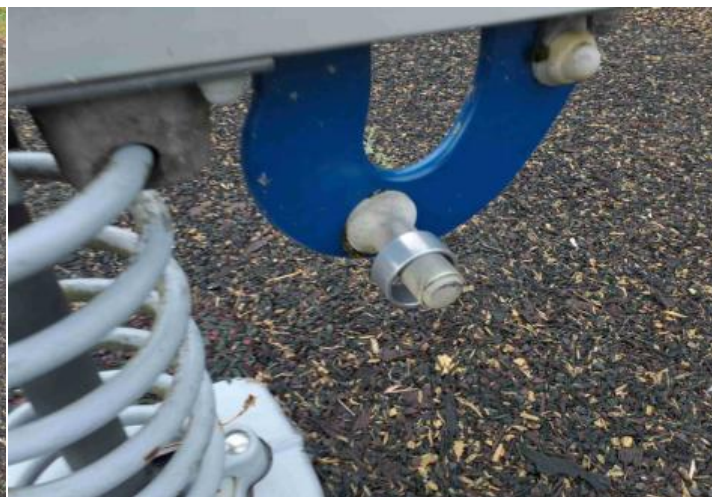
**Finding:** The end of handgrips and/or footrests have a cross section of less than 15cm<sup>2</sup> and fail to meet the requirements of BS EN 1176 Part 6

**Action:** Monitor - No action given the risk assessment

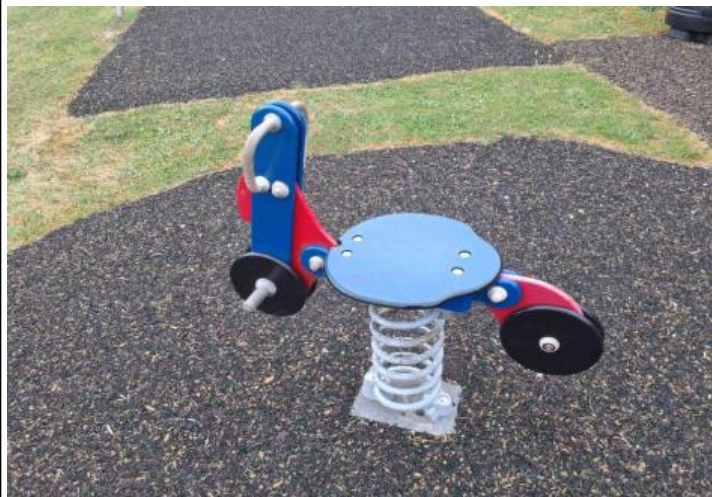
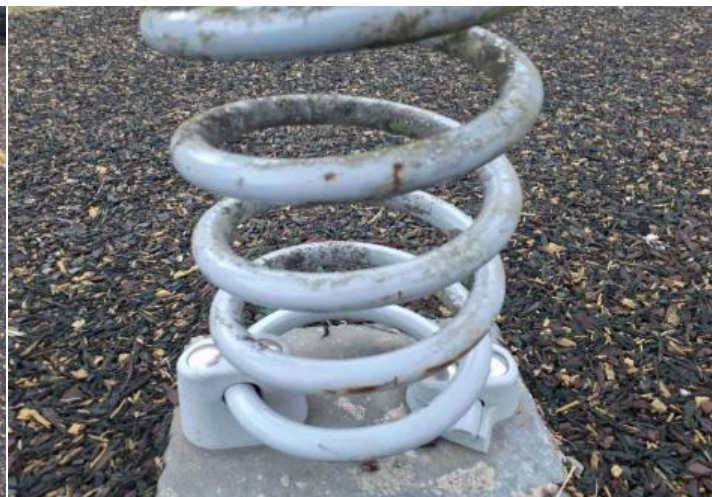
**Finding:** The paintwork on the spring has been damaged or worn exposing the metal underneath which is rusting  
**Action:** Treat any rusting components and repaint

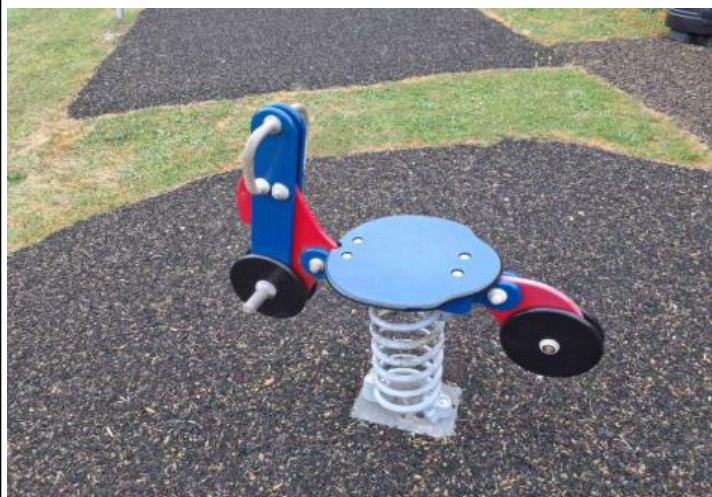
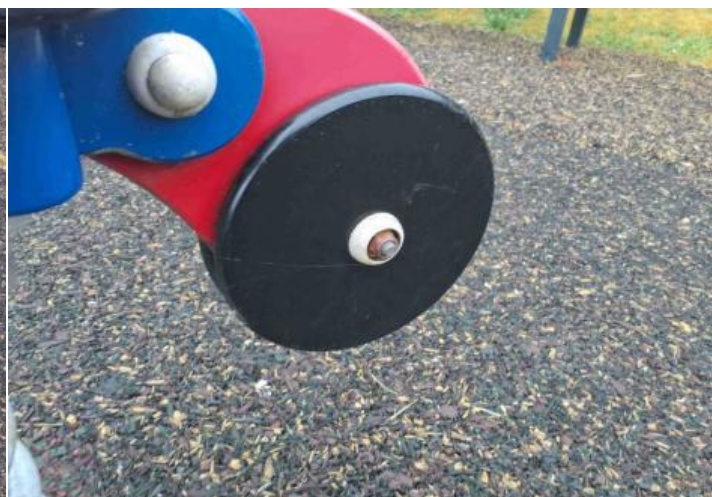
**Finding:** Bolt cap cover/s missing or damaged  
**Action:** Replace

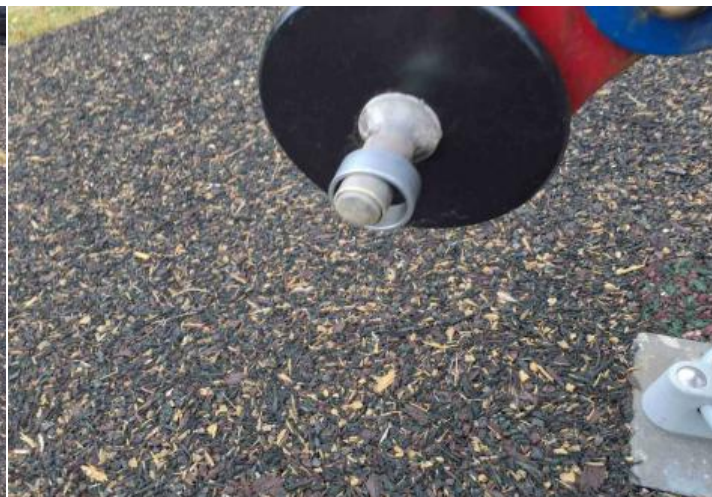
**Finding:** The end of handgrips and/or footrests have a cross section of less than 15cm<sup>2</sup> and fail to meet the requirements of BS EN 1176 Part 6  
**Action:** Monitor - No action given the risk assessment

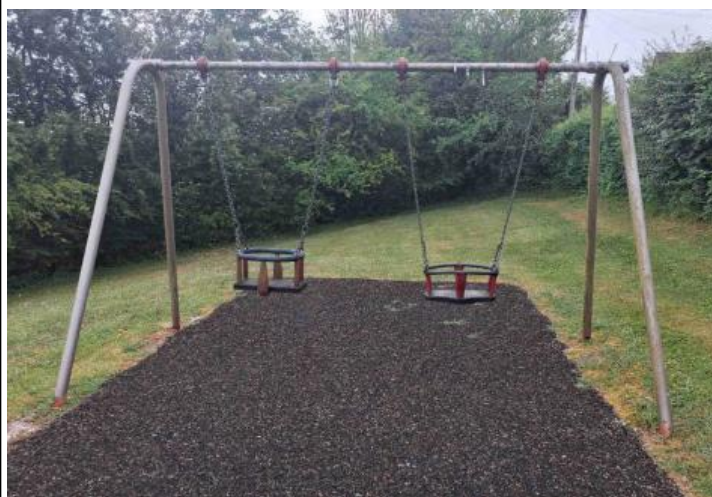
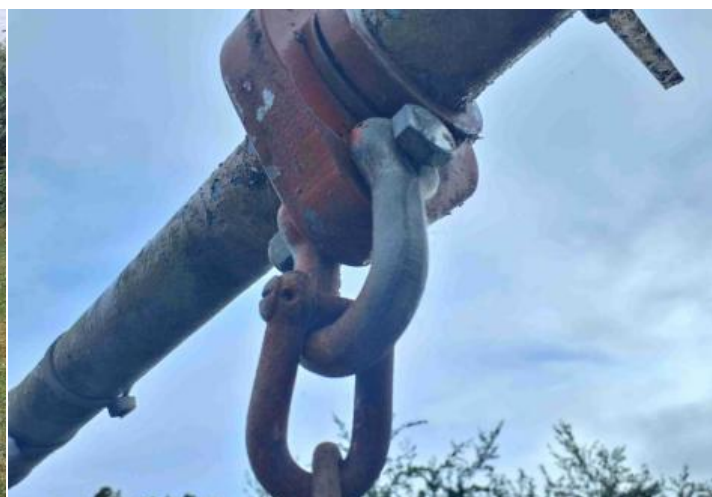
**Finding:** The split pins are missing from the shackles  
**Action:** Insert split pins to secure the shackles

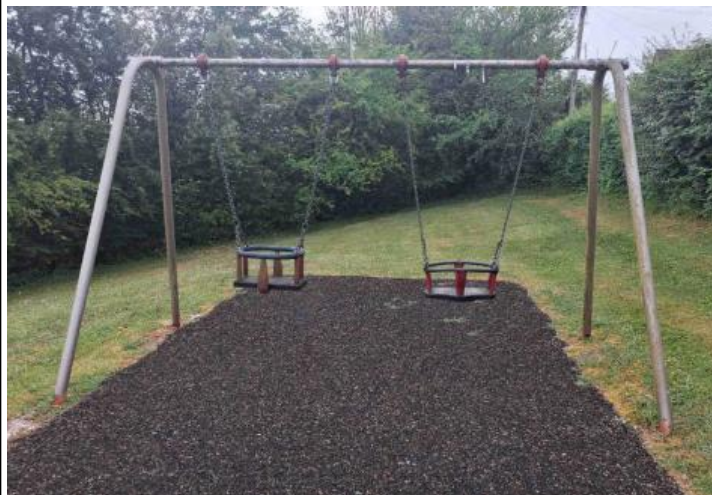
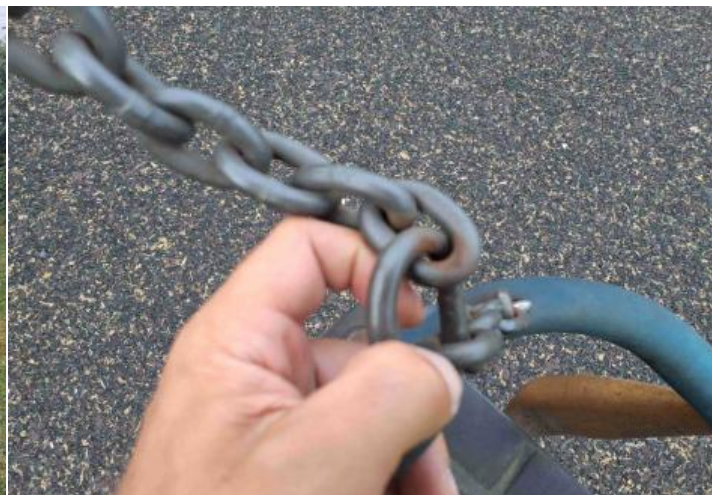
**Finding:** There is some notable evidence of chain wear

**Action:** Monitor for any further deterioration and replace when 40% worn
