I hereby summon you to attend a meeting of the **RECREATION COMMITTEE** on Thursday 10th September 2026 at 7:30 PM, to be held at The Pavilion, Hunter Park, SO21 1QS

**To Receive** the Visual Tree Assessment conducted in May 2026 and **consider** the recommendations.

The Visual Tree Assessment (VTA) was carried out in July 2026 to assess the condition and safety of trees at Northfields and Hunter Park.

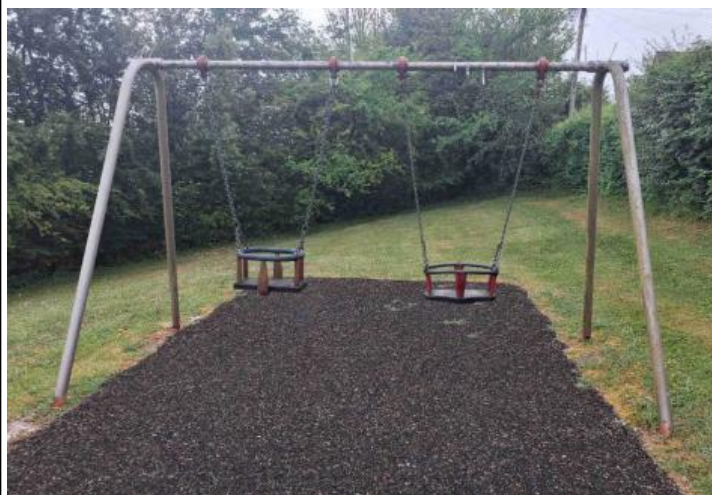
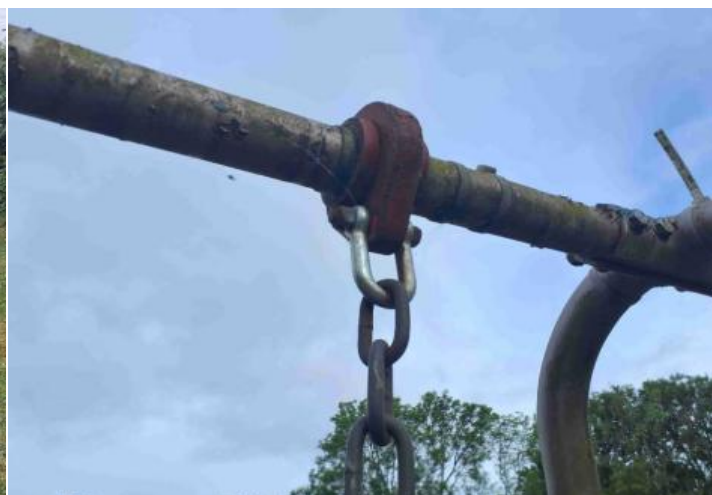
**Finding:** The Anti Wrap bearings are dry and not moving freely

**Action:** Lubricate bearings in accordance with the manufacturers recommendations

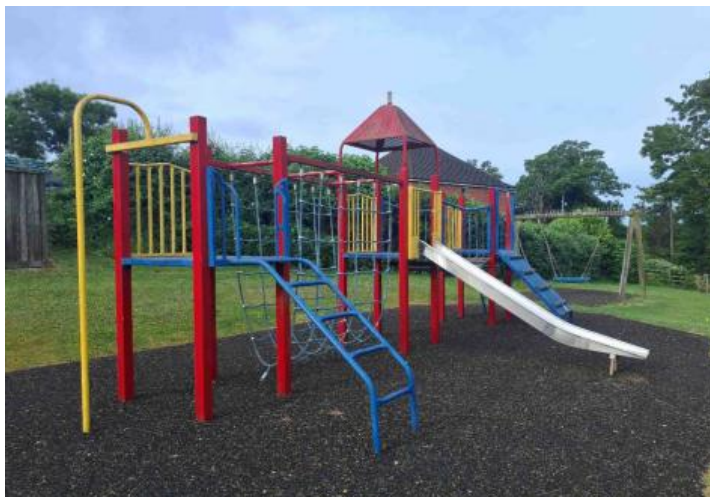
**Finding:** The item fails to meet the requirements of BS EN 1176 Part 1 4.2.7.2 for head and neck entrapment in the bridge

**Action:** Remove entrapments

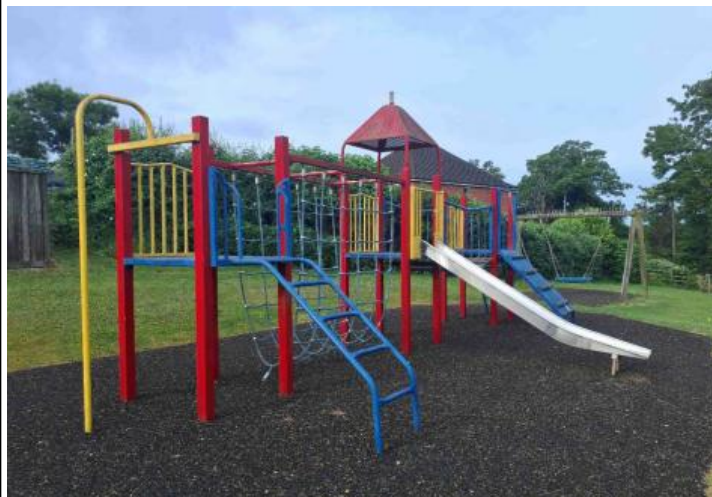
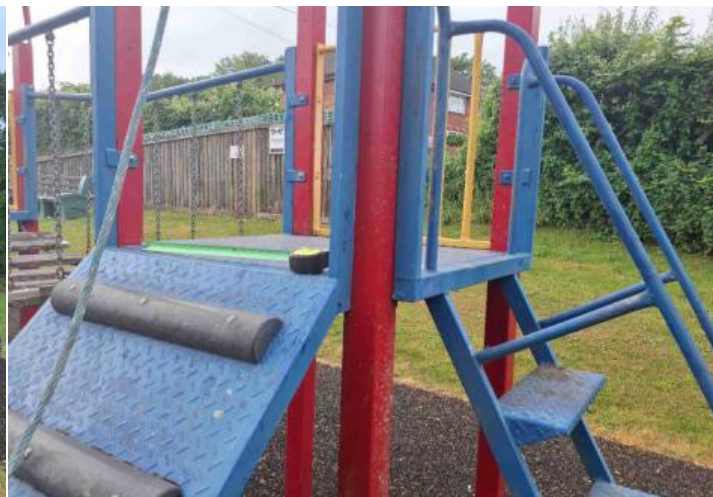
**Item:** Activity Equipment - Multi Play (Junior)  
**Manufacturer:** Not Identified

**Finding:** The unit is easily accessible and has an opening in the barrier to steep play elements in excess of 500mm in contravention of BS EN 1176 Part 1

**Action:** Monitor - No action given the risk assessment

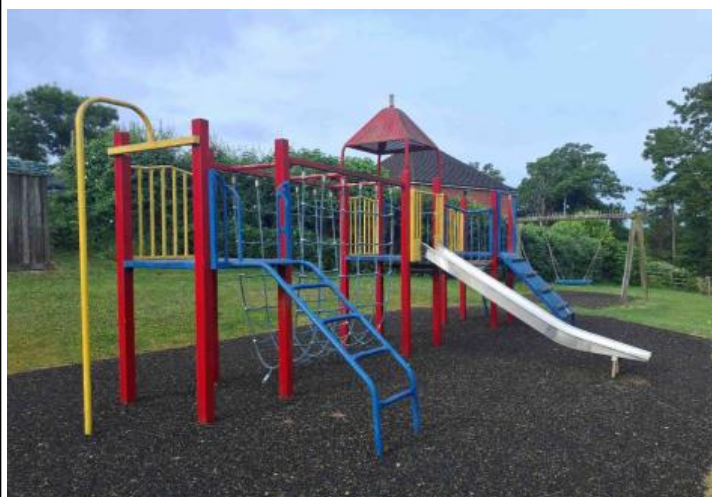
**Item:** Activity Equipment - Multi Play (Junior)  
**Manufacturer:** Not Identified

**Finding:** The paintwork on this item has been damaged or worn exposing the metal underneath which is rusting / corroding

The paintwork on this item has been damaged or worn exposing the metal underneath which is rusting / corroding - Treat affected areas and repaint

**Action:** Treat affected areas and repaint

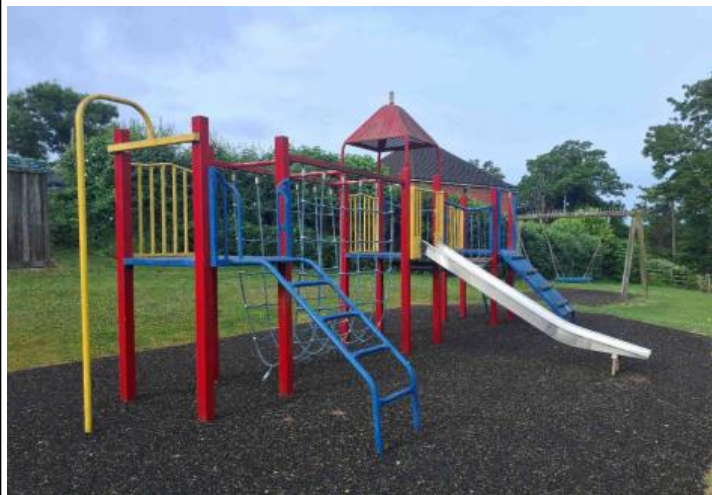
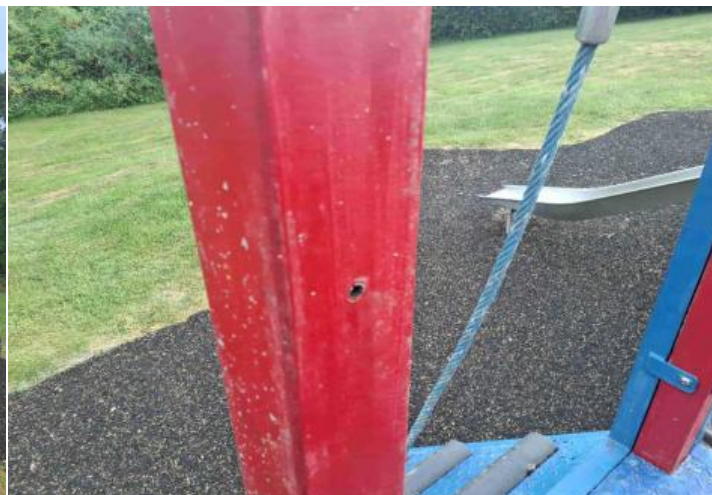
**Item:** Activity Equipment - Multi Play (Junior)  
**Manufacturer:** Not Identified

**Finding:** Insert/s missing or damaged

**Action:** Replace

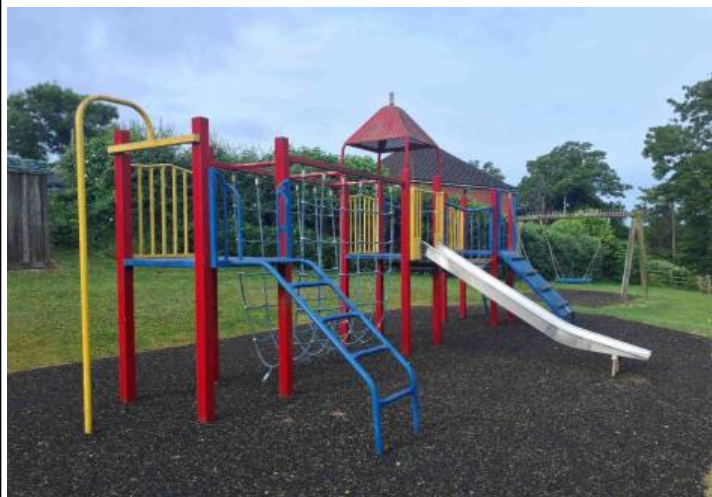
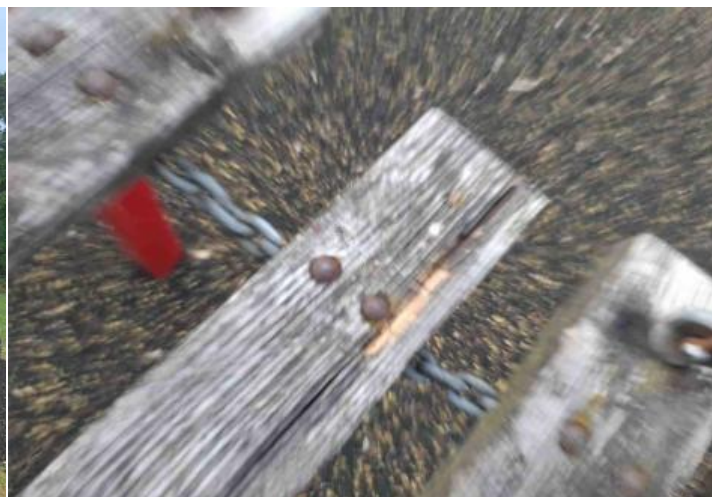
**Item:** Activity Equipment - Multi Play (Junior)  
**Manufacturer:** Not Identified

**Finding:** There is some evidence of rot in the timber

**Action:** Monitor for any further deterioration and replace as required

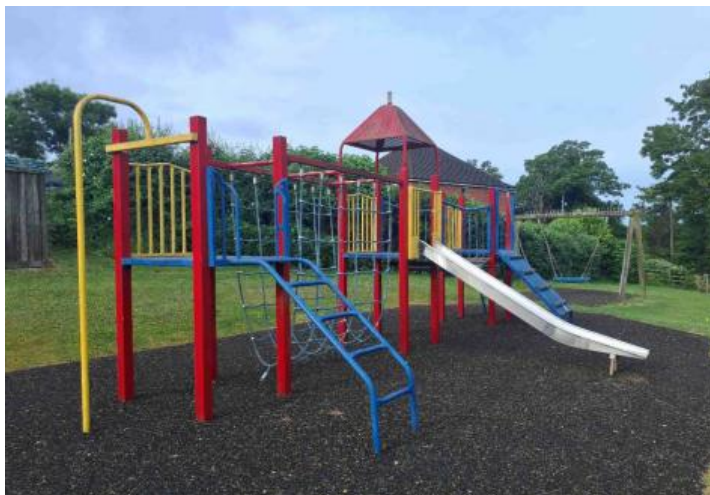
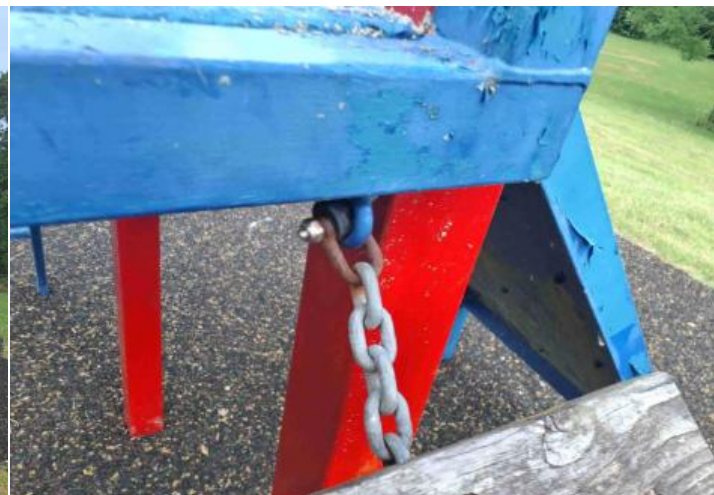
**Item:** Activity Equipment - Multi Play (Junior)  
**Manufacturer:** Not Identified

**Finding:** There is some wear to the shackles

There is some wear to the shackles - Monitor for any further deterioration and replace when 40% worn

**Action:** Monitor for any further deterioration and replace when 40% worn

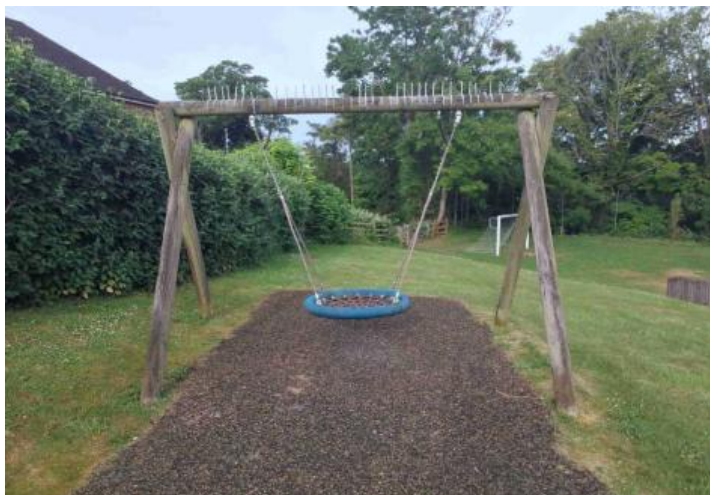
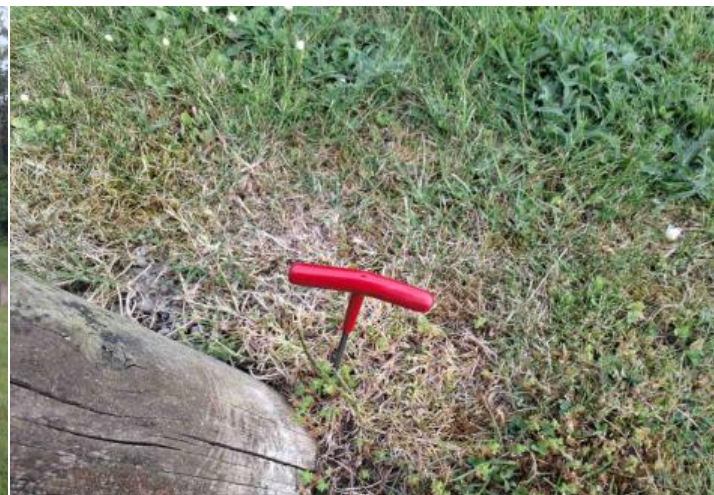
**Item:** Swings - Basket Swing - Type 1  
**Manufacturer:** Not Identified

**Finding:** There is some evidence of rot in the timber

There is some evidence of rot in the timber - Monitor for any further deterioration and replace as required

**Action:** Monitor for any further deterioration and replace as required

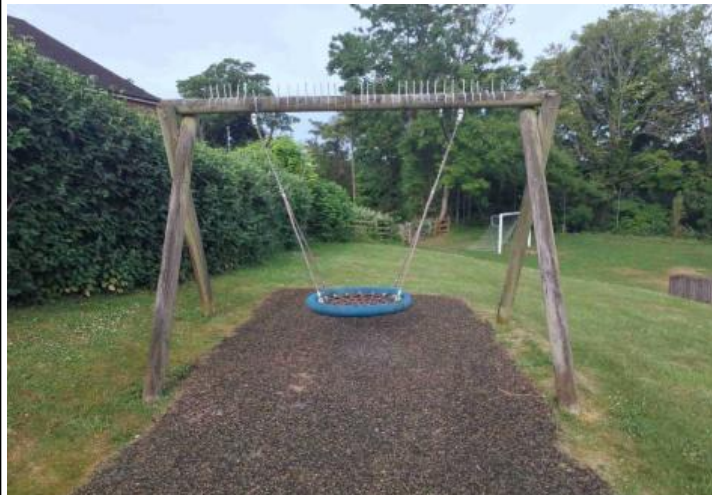
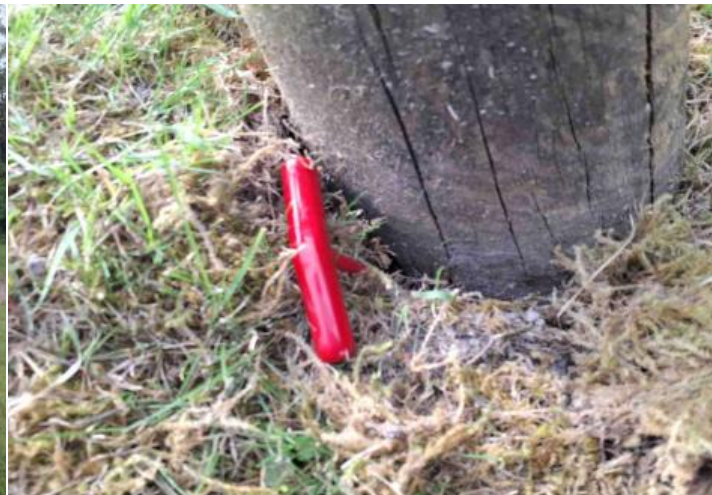
**Item:** Swings - Basket Swing - Type 1  
**Manufacturer:** Not Identified

**Finding:** There are areas or parts of the timber on the structure that have rotted

There are areas or parts of the timber on the structure that have rotted - Replace all affected timbers

**Action:** Replace all affected timbers

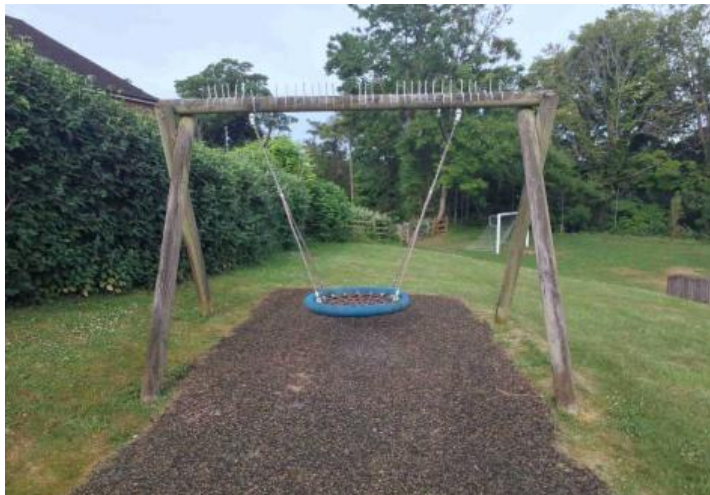
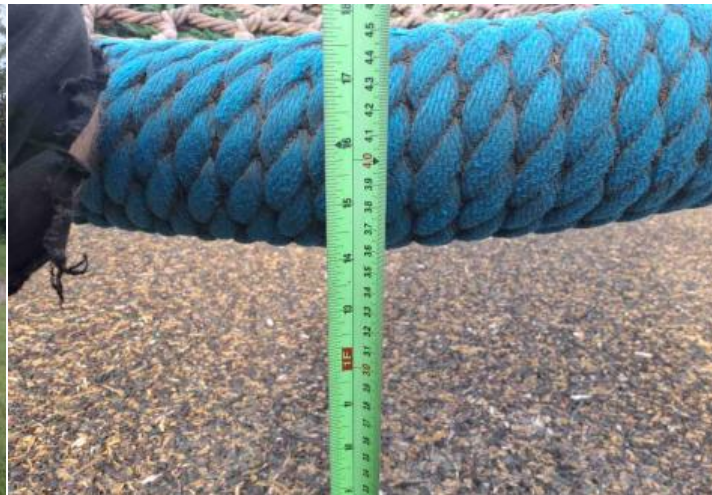
**Item:** Swings - Basket Swing - Type 1  
**Manufacturer:** Not Identified

**Finding:** The seat clearance from finished surface level to the underside of the seat is too low and does not meet the requirements of BS EN 1176 Part 2 (350mm minimum clearance required)

The seat clearance from finished surface level to the underside of the seat is too low and does not meet the requirements of BS EN 1176 Part 2 (350mm minimum clearance required) - Adjust seat height/s (400mm-500mm is recommended)

**Action:** Adjust seat height/s (400mm-500mm is recommended)

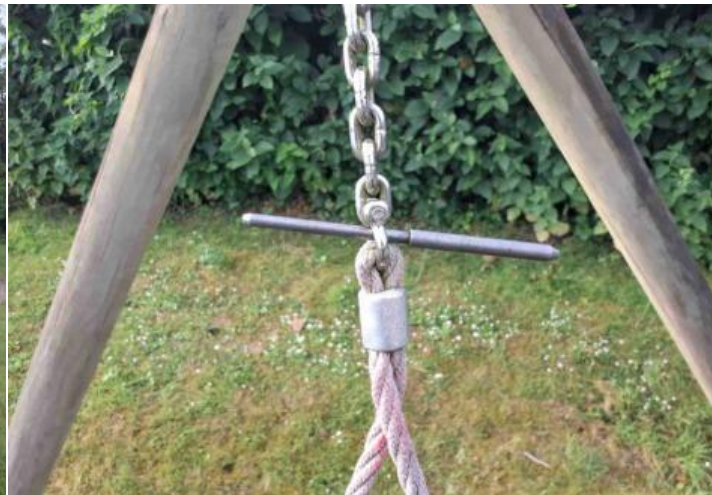
**Item:** Swings - Basket Swing - Type 1  
**Manufacturer:** Not Identified

**Finding:** The connecting links are in excess of 8.6mm and less than 12mm and fail the requirements of BS EN 1176 Part 1; clause 4.2.13, Chains

The connecting links are in excess of 8.6mm and less than 12mm and fail the requirements of BS EN 1176 Part 1; clause 4.2.13, Chains - Monitor - No action given the risk assessment

**Action:** Monitor - No action given the risk assessment

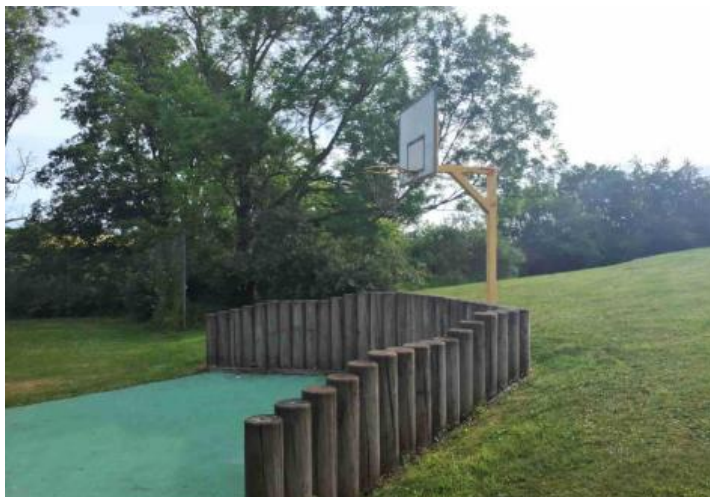
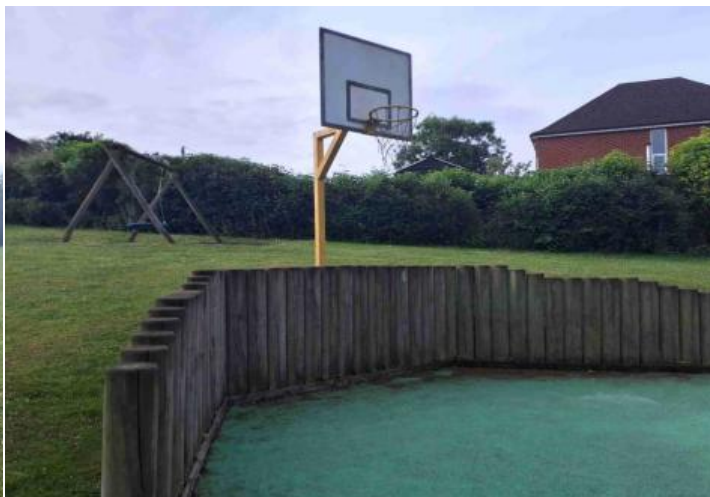
**Item:** Multi Use Games Area - Basketball Post  
**Manufacturer:** Not Identified

**Finding:** The free space between the backboard and the framework is less than 600mm and fails the requirements of BS EN15312:2007 +A1 2010

The free space between the backboard and the framework is less than 600mm and fails the requirements of BS EN15312:2007 +A1 2010 - Monitor - No action given the risk assessment

**Action:** Monitor - No action given the risk assessment

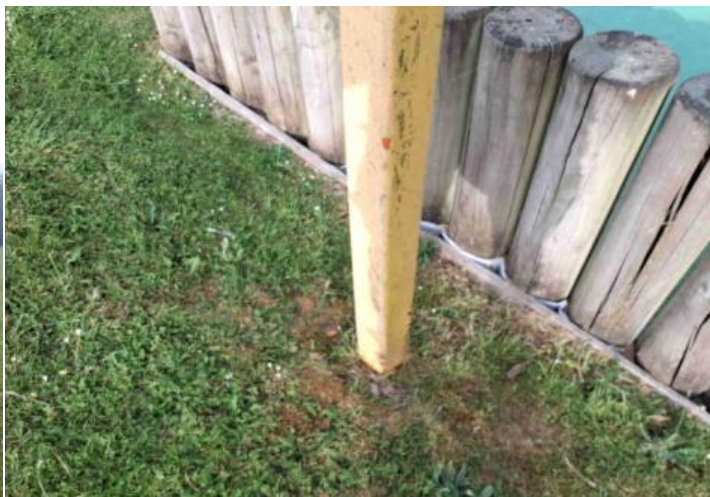
**Item:** Multi Use Games Area - Basketball Post  
**Manufacturer:** Not Identified

**Finding:** The item is slightly loose in its foundations

The item is slightly loose in its foundations - Monitor for any further deterioration and repair as required

**Action:** Monitor for any further deterioration and repair as required

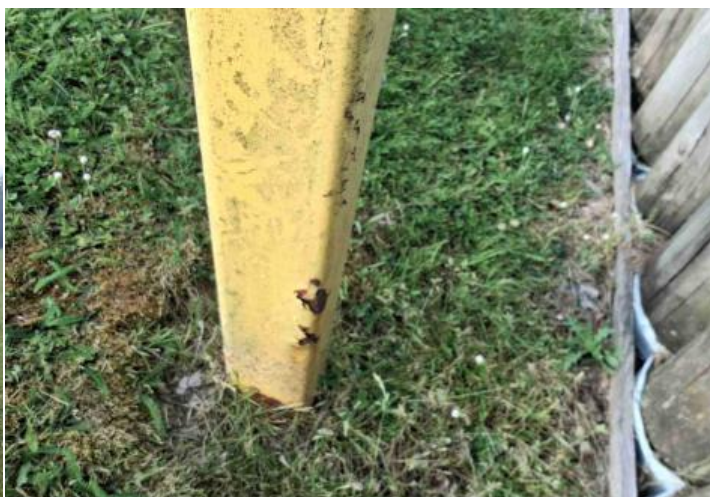
**Item:** Multi Use Games Area - Basketball Post  
**Manufacturer:** Not Identified

**Finding:** The paintwork on this item has been damaged or worn exposing the metal underneath which is rusting / corroding

The paintwork on this item has been damaged or worn exposing the metal underneath which is rusting / corroding - Treat affected areas and repaint

**Action:** Treat affected areas and repaint

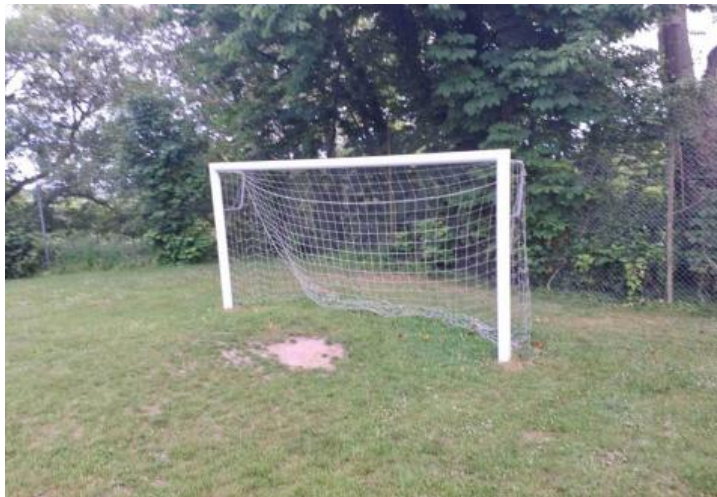
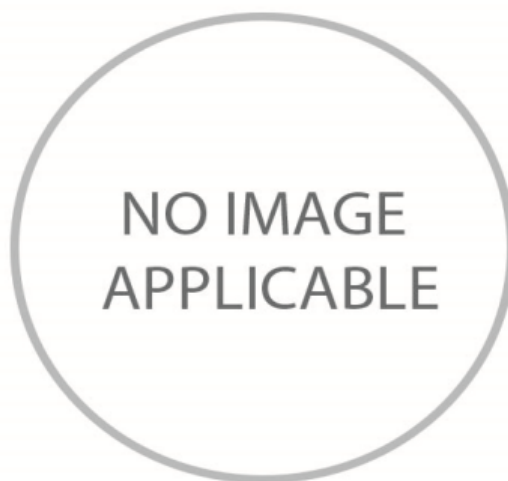
**Item:** Multi Use Games Area - Football Goal  
**Manufacturer:** Harrod

**Finding:** NB: We have undertaken a maintenance inspection only of the football goal(s); full load testing falls outside the scope of our inspection.

**Action:** Implement load testing as required

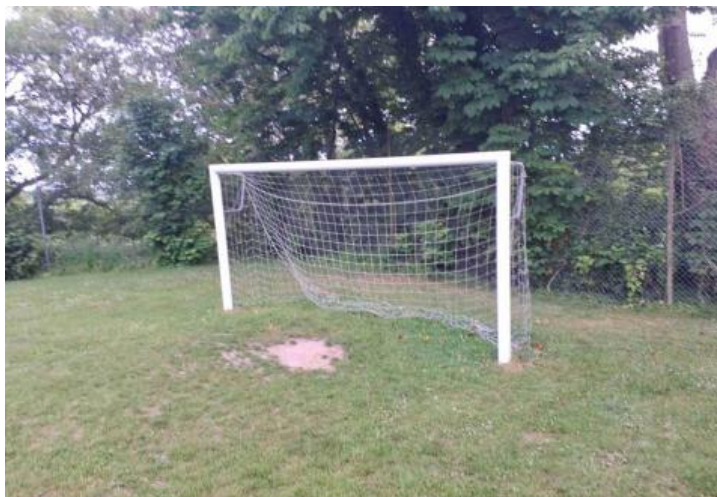
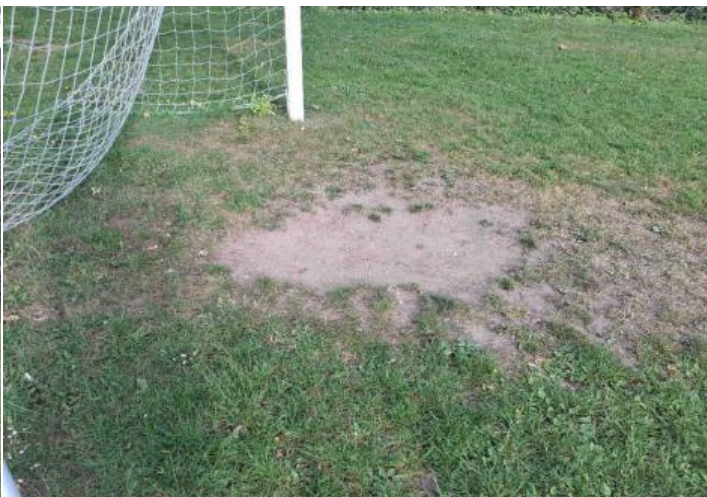
**Item:** Multi Use Games Area - Football Goal  
**Manufacturer:** Harrod

**Finding:** The area around the item has eroded and may become slippery

**Action:** Reinstate eroded area
